120-inch Water Main Break (WMB) Conclusion for the Board

120-inch Water Main Break

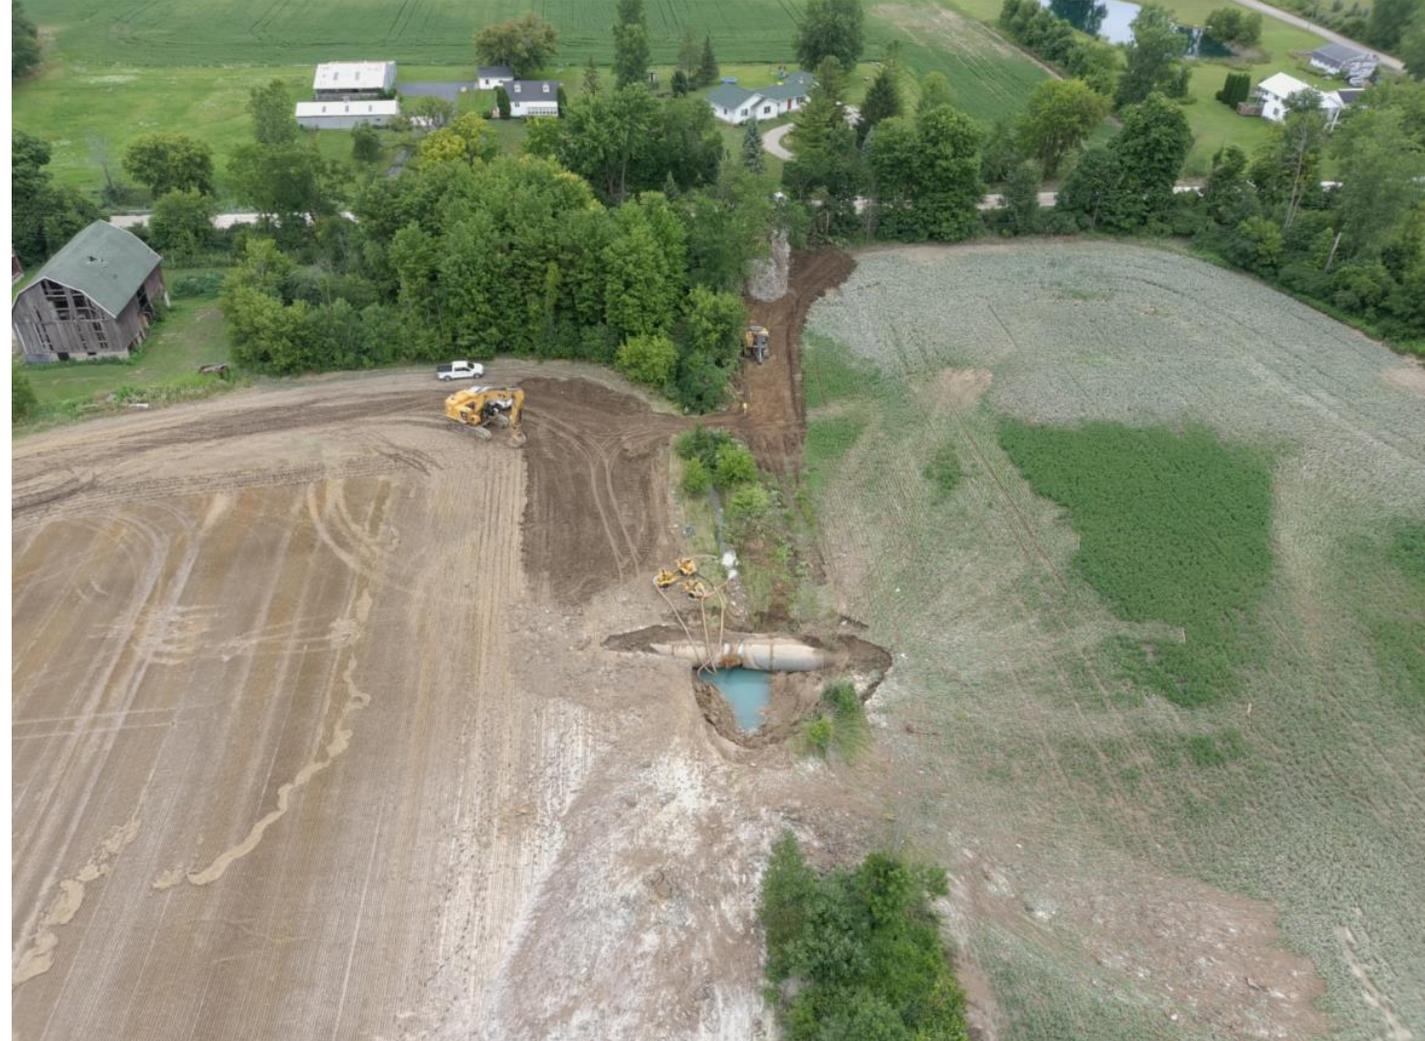
Root Cause:

- Loss of strength due to broken wire wraps damaged from corrosion and hydrogen embrittlement.
- A defect in the mortar coating developed the environmental conditions for corrosion and embrittlement.
- Lack of cover contributed to the mortar coating defect.

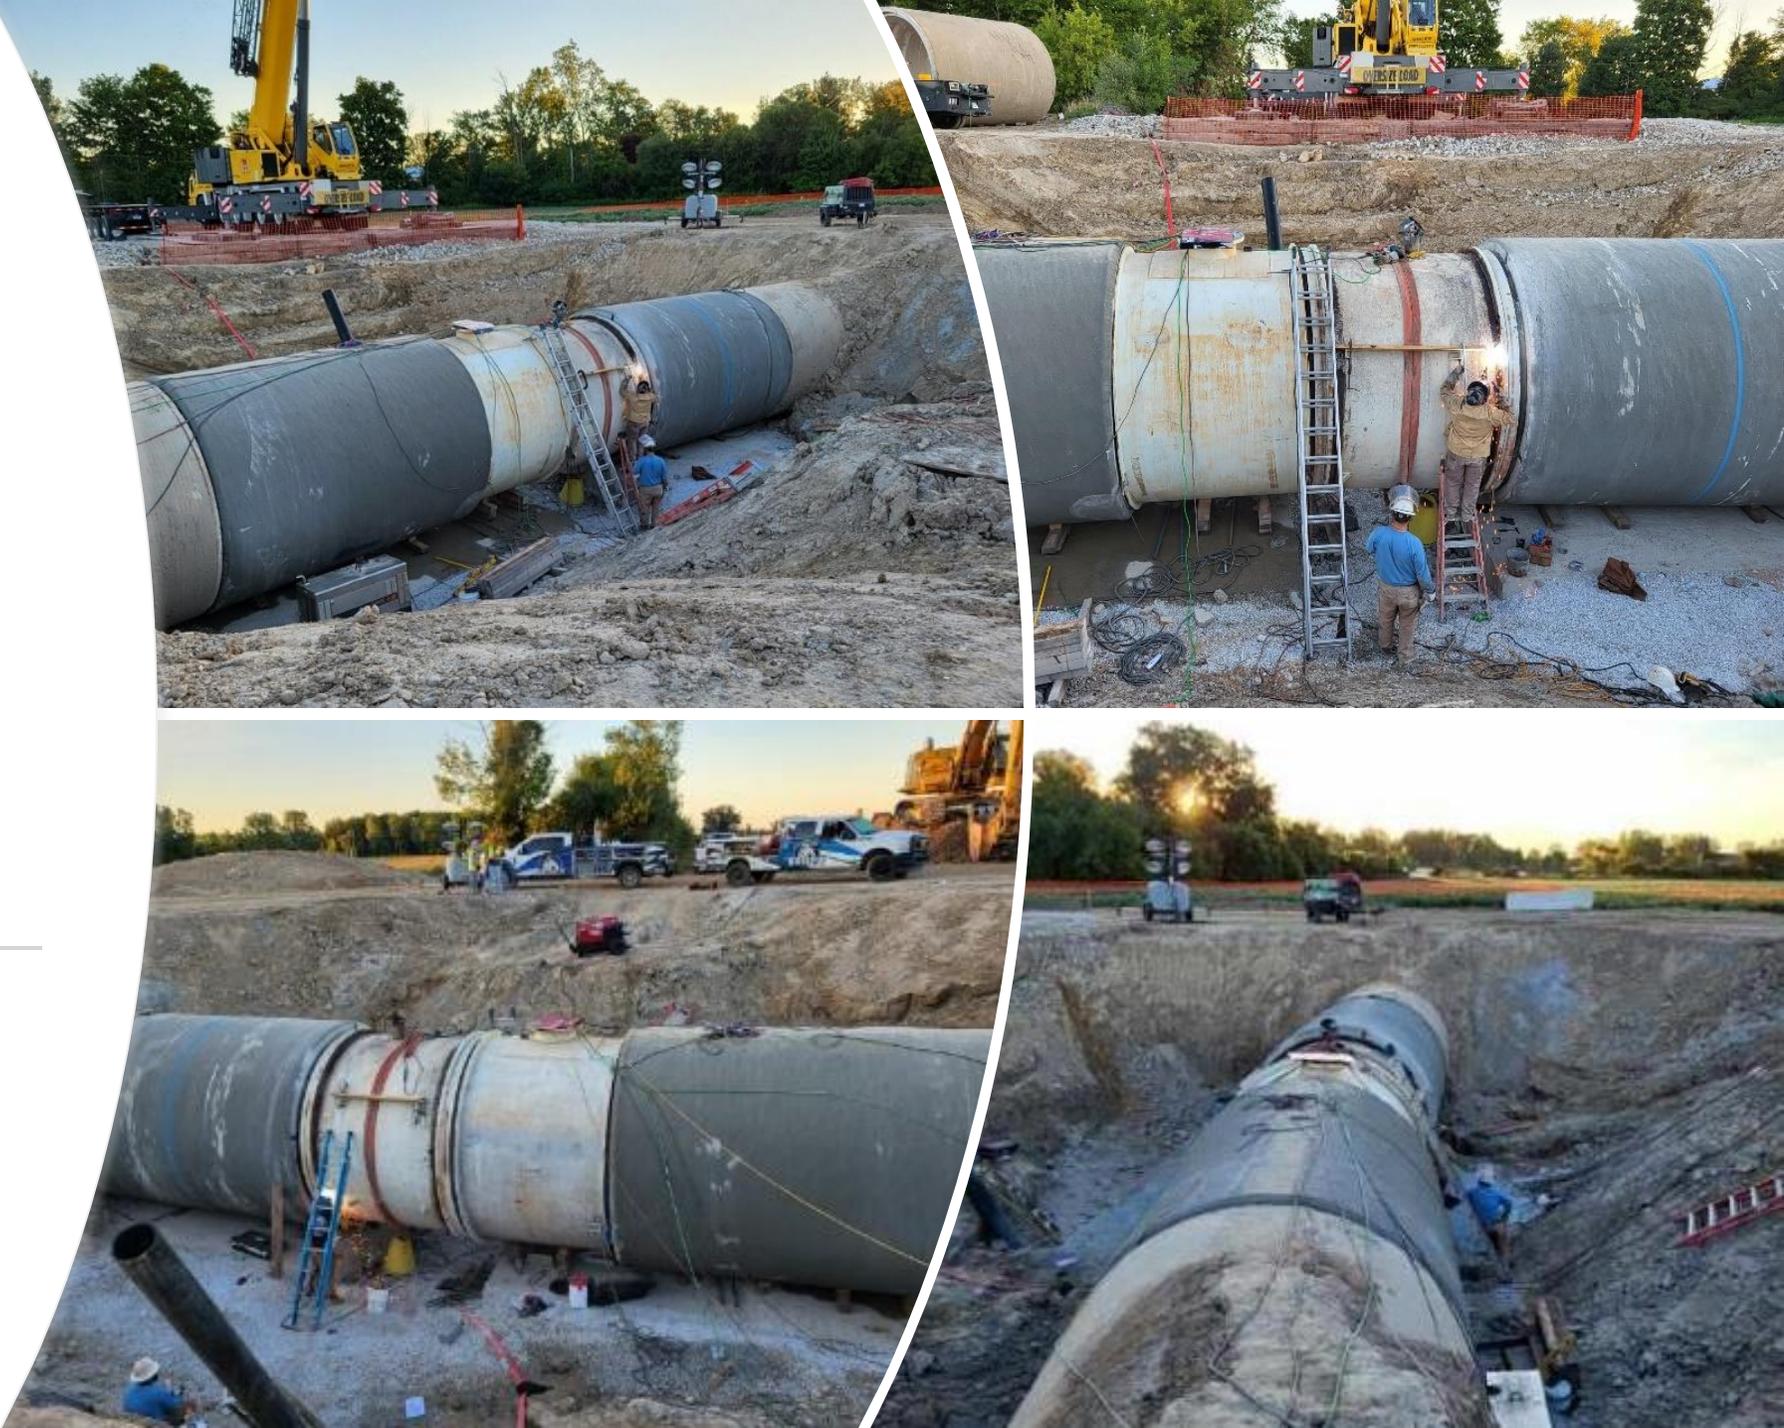
Pipe in the ground welding continues
