14 Mile Road Condition Assessment

Cheryl Porter, COO Water & Field Svcs

Todd King, Field Services Director

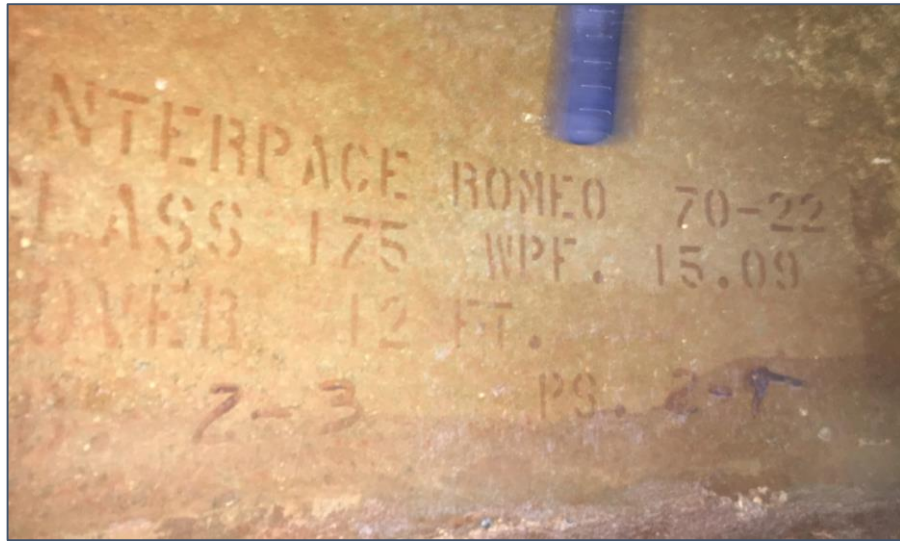
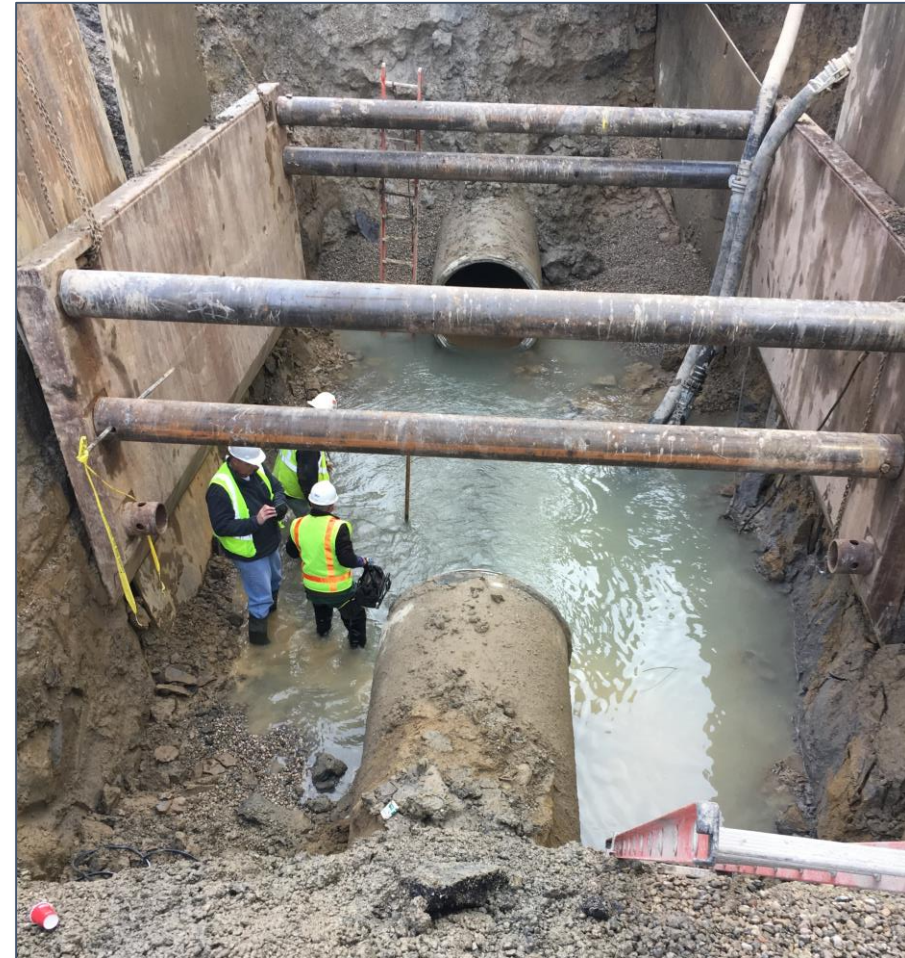
- **October 2017 Break (WS-196)**

- Impacted 300,000 customers
- Likely a power trip which initiated event
- Evidence of hydrogen embrittlement

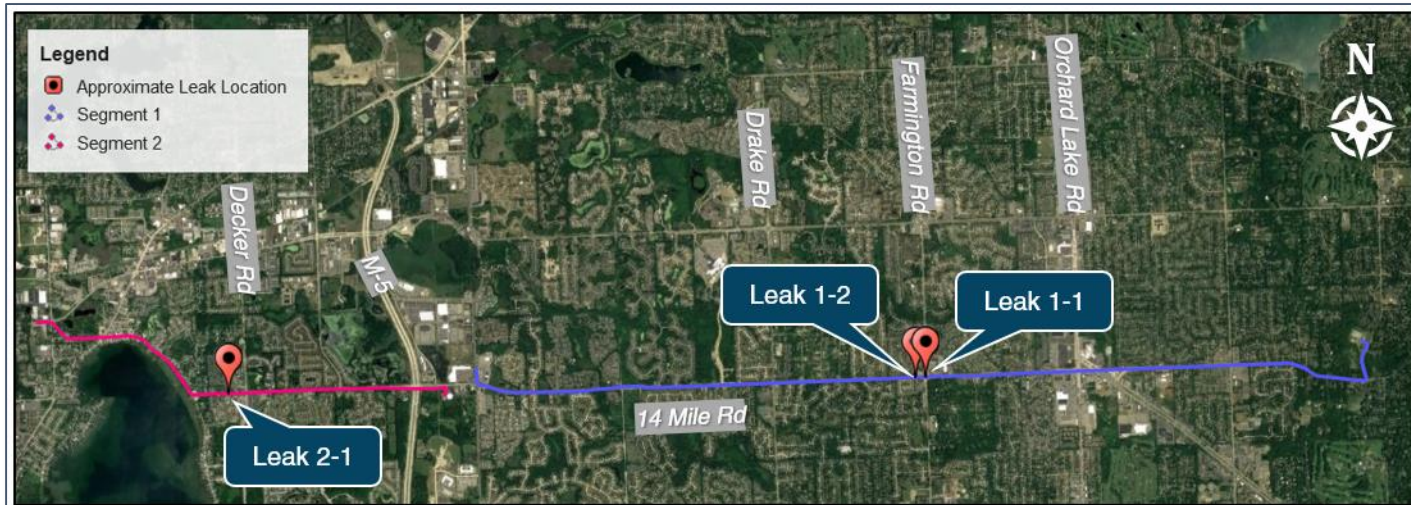
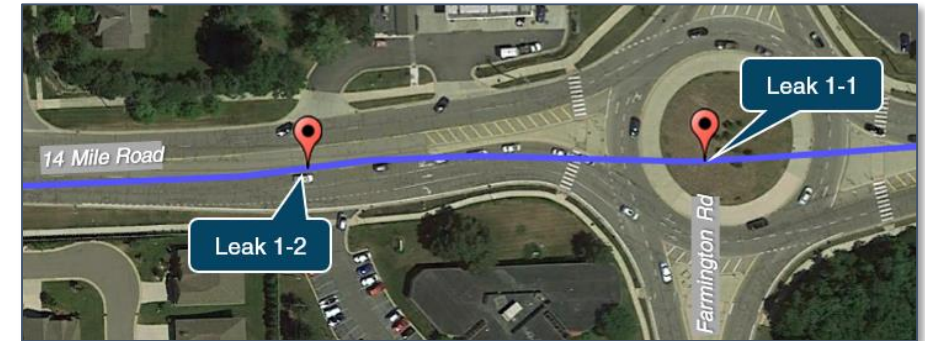
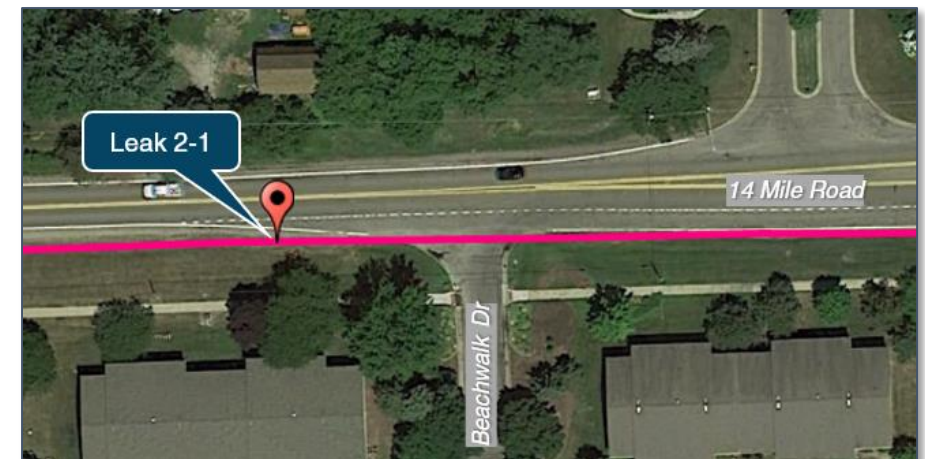
ACOUSTIC RESULTS

Critical Findings of SmartBall Inspection				
Acoustic Event	Leak Type	Size of Leak	Distance from Nearest Tracking Location	Suspected Source of Leak
Segment 1				
1-1	Feature-Related	Small	17.2 feet U/S of 54" BFV (Station 153+08.50)	24-inch valve on outlet serving FT-09 (Station 152+92.10)
1-2	Feature-Related	Small	329.2 feet D/S of 54" BFV (Station 0+16.10)	Entrance MH (Station 0+16.10)
Segment 2				
2-1	Feature-Related	Small	296.8 feet D/S of 30" GV (Station 128+25.39)	Blow-off (Station 0+30)

All addressed

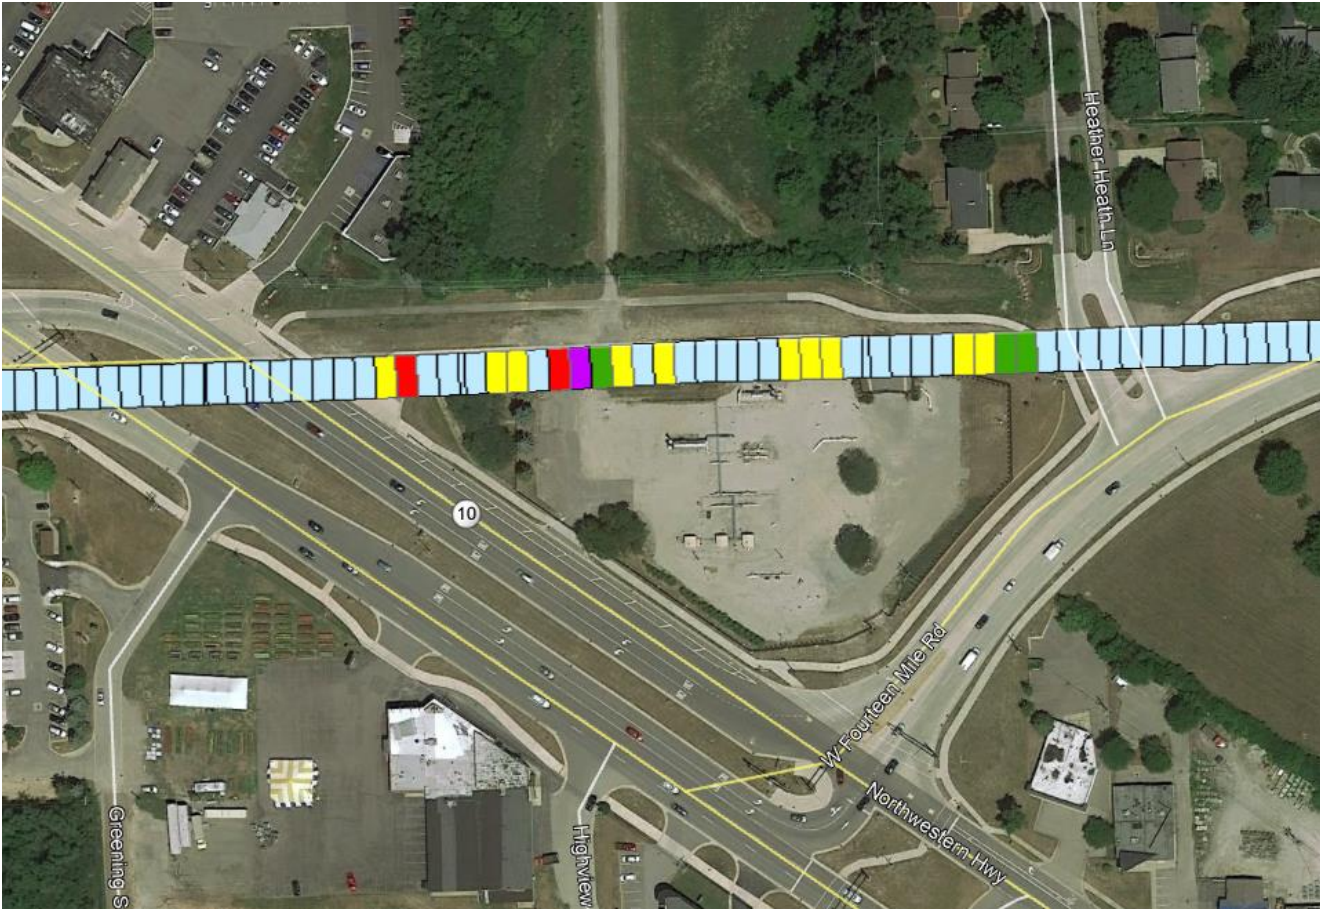
- **GIS Pipe List**

- Shows individual pipes and wire break count
 - Light blue – no wire breaks detected
 - Green – 5 wire breaks reported
 - Yellow – 10 to 25 wire breaks reported
 - Red – 30+ wire breaks reported
 - Purple – Distressed pipe “D”

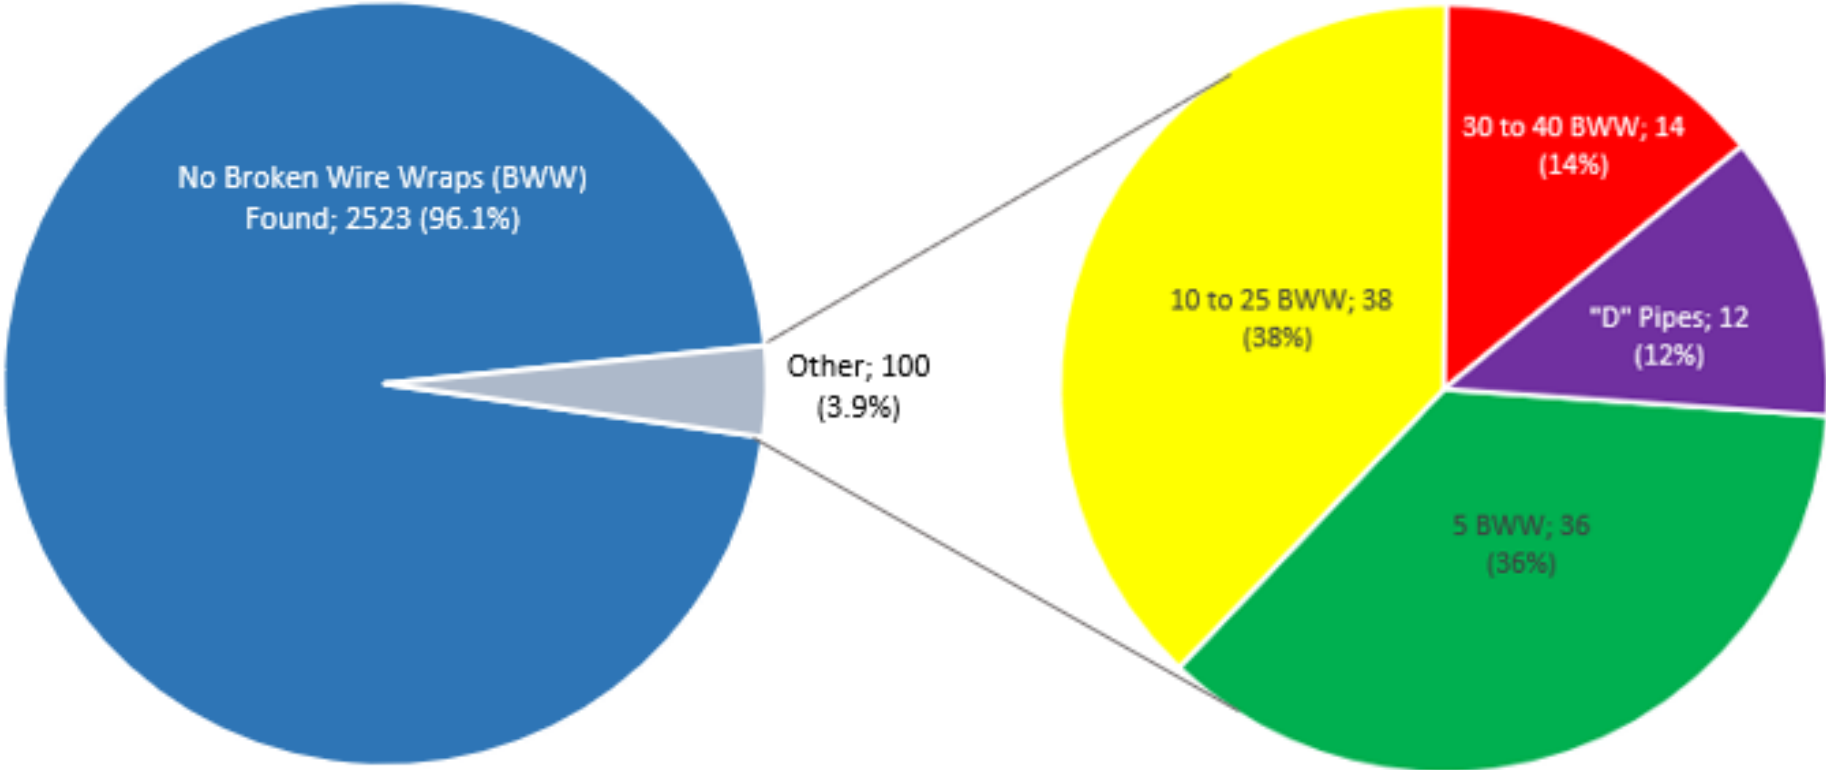
ELECTROMAGNETIC RESULTS

Segments 1 & 2: All Contracts

NOTE:

1) "D" Pipes refer to distress reported across entire length of the pipe. Due to the complexity of the analysis for these types of pipes, the Broken Wire Wraps (BWW) quantification is not available.

- Total of 3 leaks detected and repaired
- Total of 100 pipes detected with distress, ranging from 5 – 40 BWW, 12 pipes with Distress across length of pipe

- AWWA C301 was satisfied for all five (5) of the pipe classes analyzed
- AWWA C304 was satisfied for WS-167 and WS-332 Class A
- AWWA C304 indicated that Serviceability Limiting Criteria was not satisfied for WS-196 Classes A and B, and WS-332 Class B
- FEA evaluation indicated:
 - For Operating Pressure:
 - 8 pipes exceeded the yield limit
 - 0 pipes exceeded the strength limit
 - For Operating plus Surge Pressure:
 - 21 pipes exceeded the yield limit
 - 11 pipes exceeded the strength limit

- Repair or replace 21 pipes which were found to exceed the yield limit at surge + operating pressure
- Install AFO monitoring system to monitor prestressing wires
- If replacements are made, provide forensics of pipe for updated analysis
- Install continuous high-frequency pressure monitoring
