Overview of 54-Inch Main Break

March 26, 2025

Overview of 54-Inch

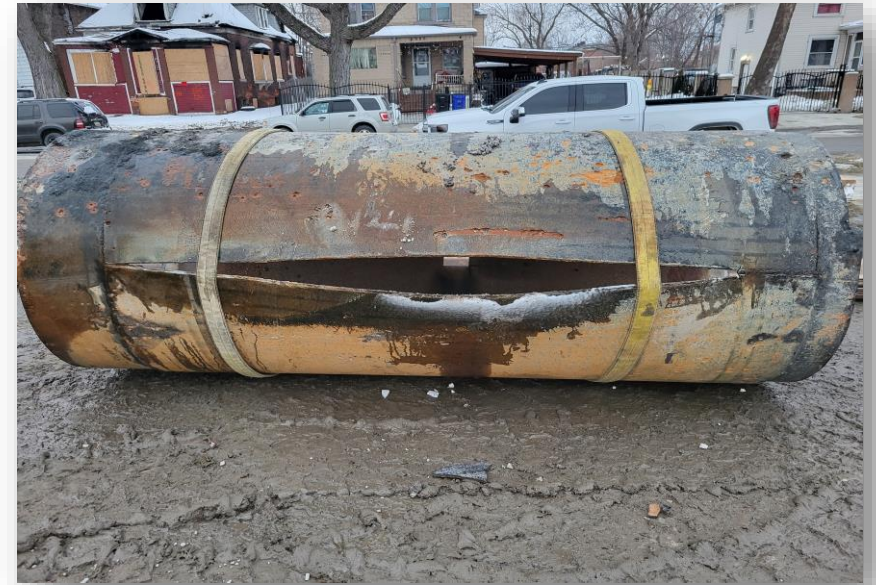
- On February 17, 2025, the 54-inch transmission main experienced a catastrophic break at the intersection of Beard Street and Rowan Street in Southwest Detroit.
- The 54-inch transmission main was constructed in 1930 and the pipe material is welded steel.
- The failure was along the longitudinal weld and was ~9 feet in length at the 6 o'clock position.
