GLWA Board of Directors Meeting

October 27, 2021

June 25/26 and July 16, 2021
Post Event Analysis

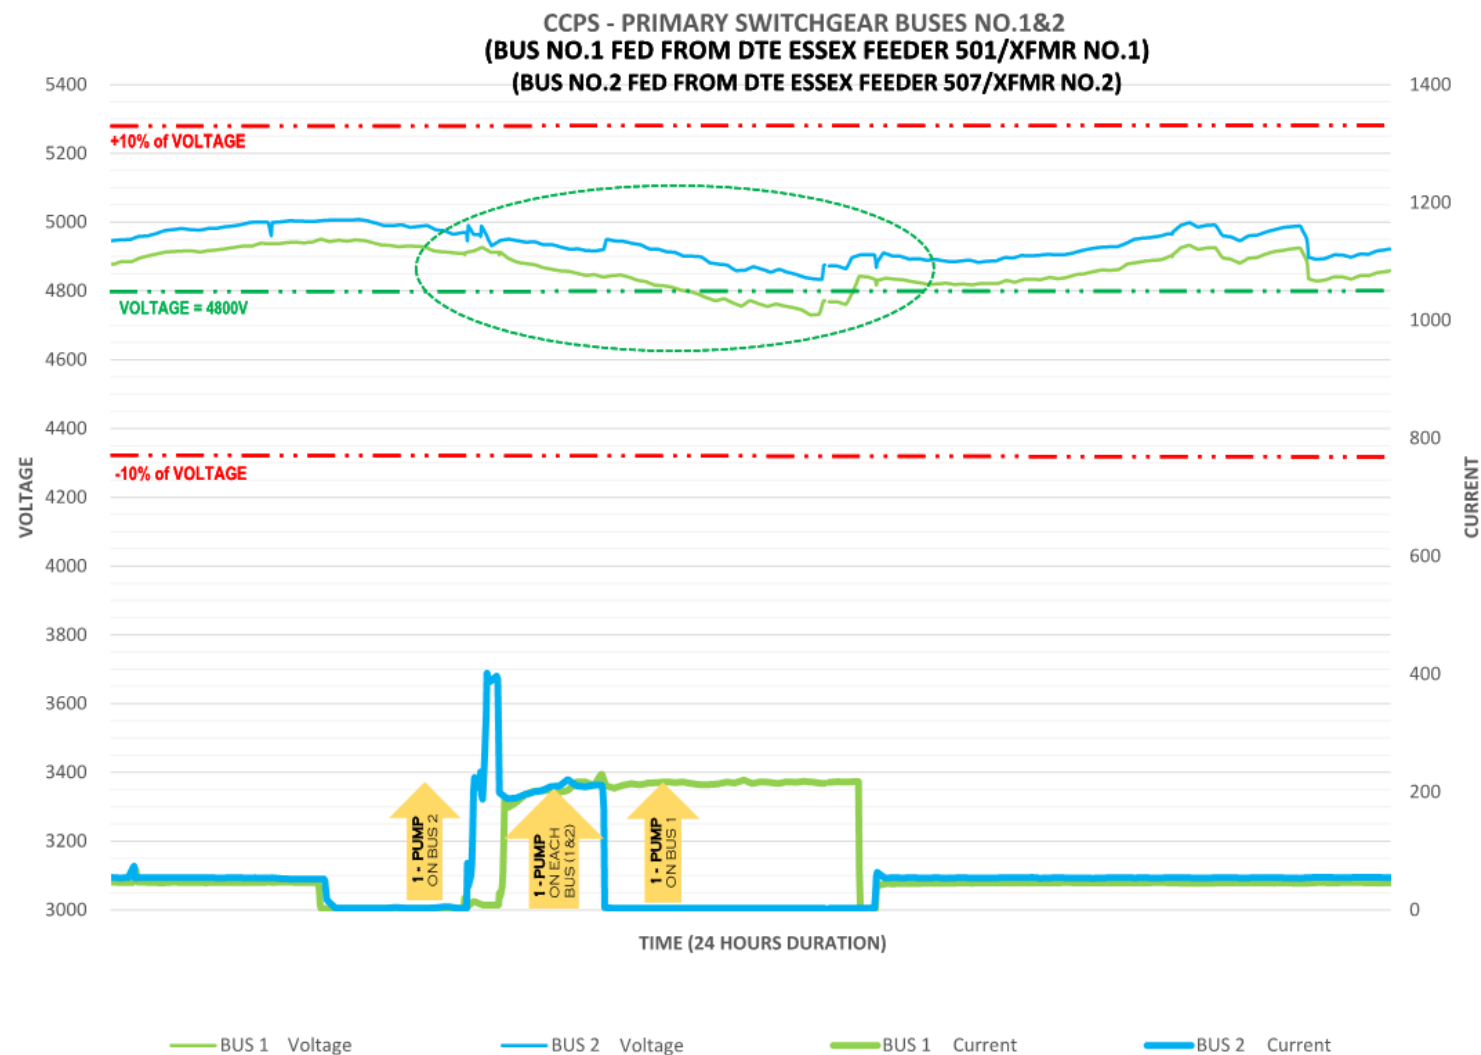
Power Quality – Conners Creek Pump Station

- Power Source = DTE Substation
- “Strong” Power Supply
 - Voltage recovery (good)

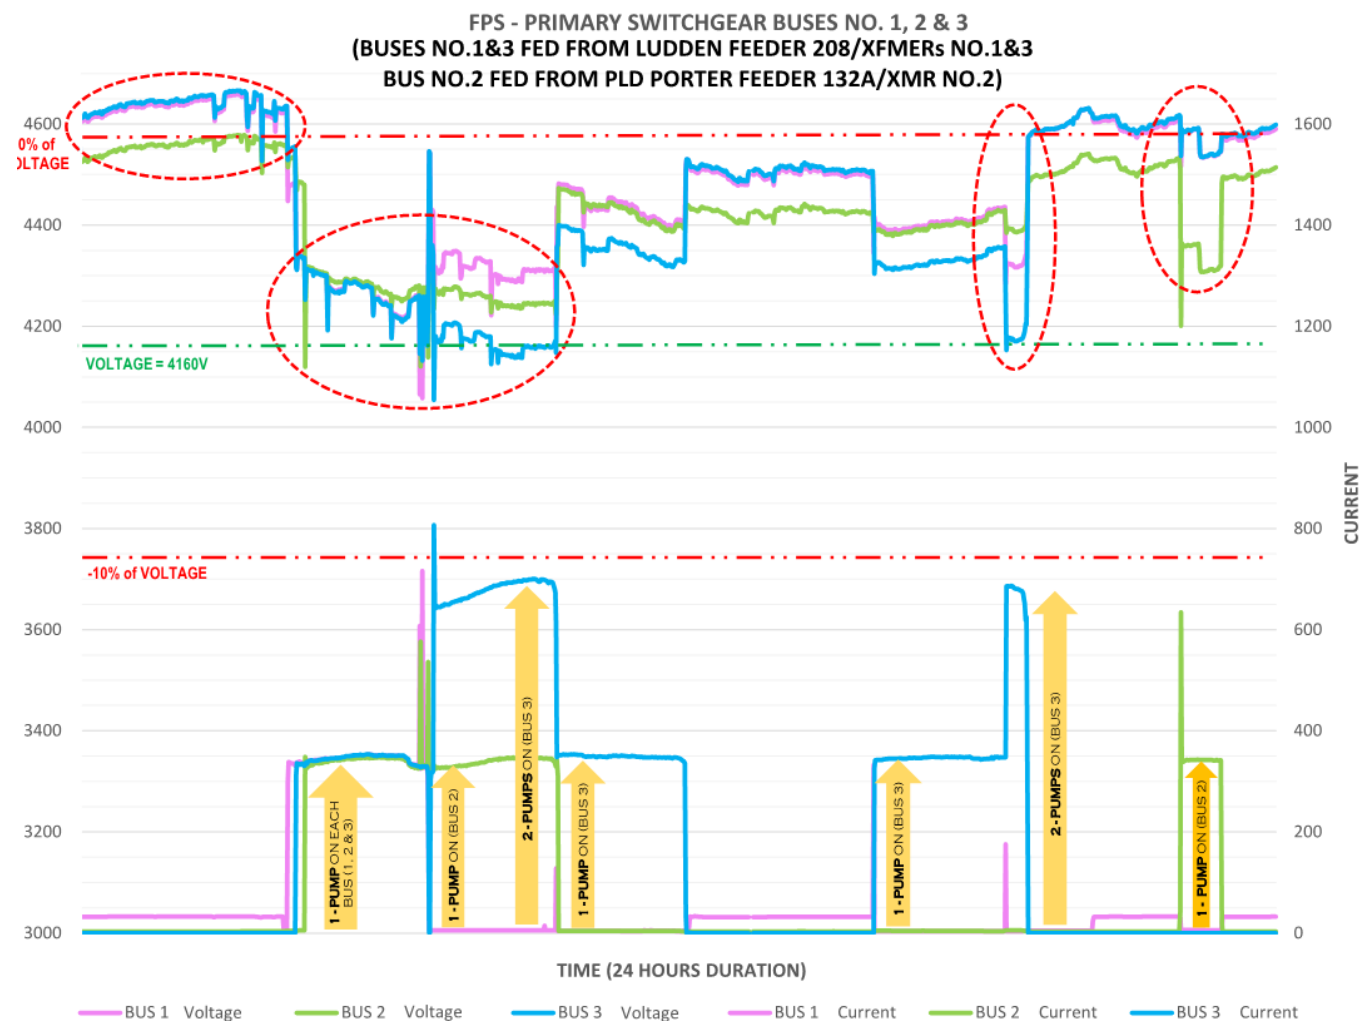
Power Quality – Freud Pump Station

- Power Source = PLD Substations
- “Weak” Power Supply:
 - Sustained voltage dip
 - Lack of power supply “stiffness”

- What is the Impact of Poor Power Quality?
 - Unintended pump stoppages (pump trips)
 - In the June 25-26 event at Freud, this delayed GLWA's ability to get a third pump running.
 - Other faults that require manual intervention
 - In the July 16 event at Bluehill, this created an electrical upset which resulted in a reduced number of pumps running during the event.

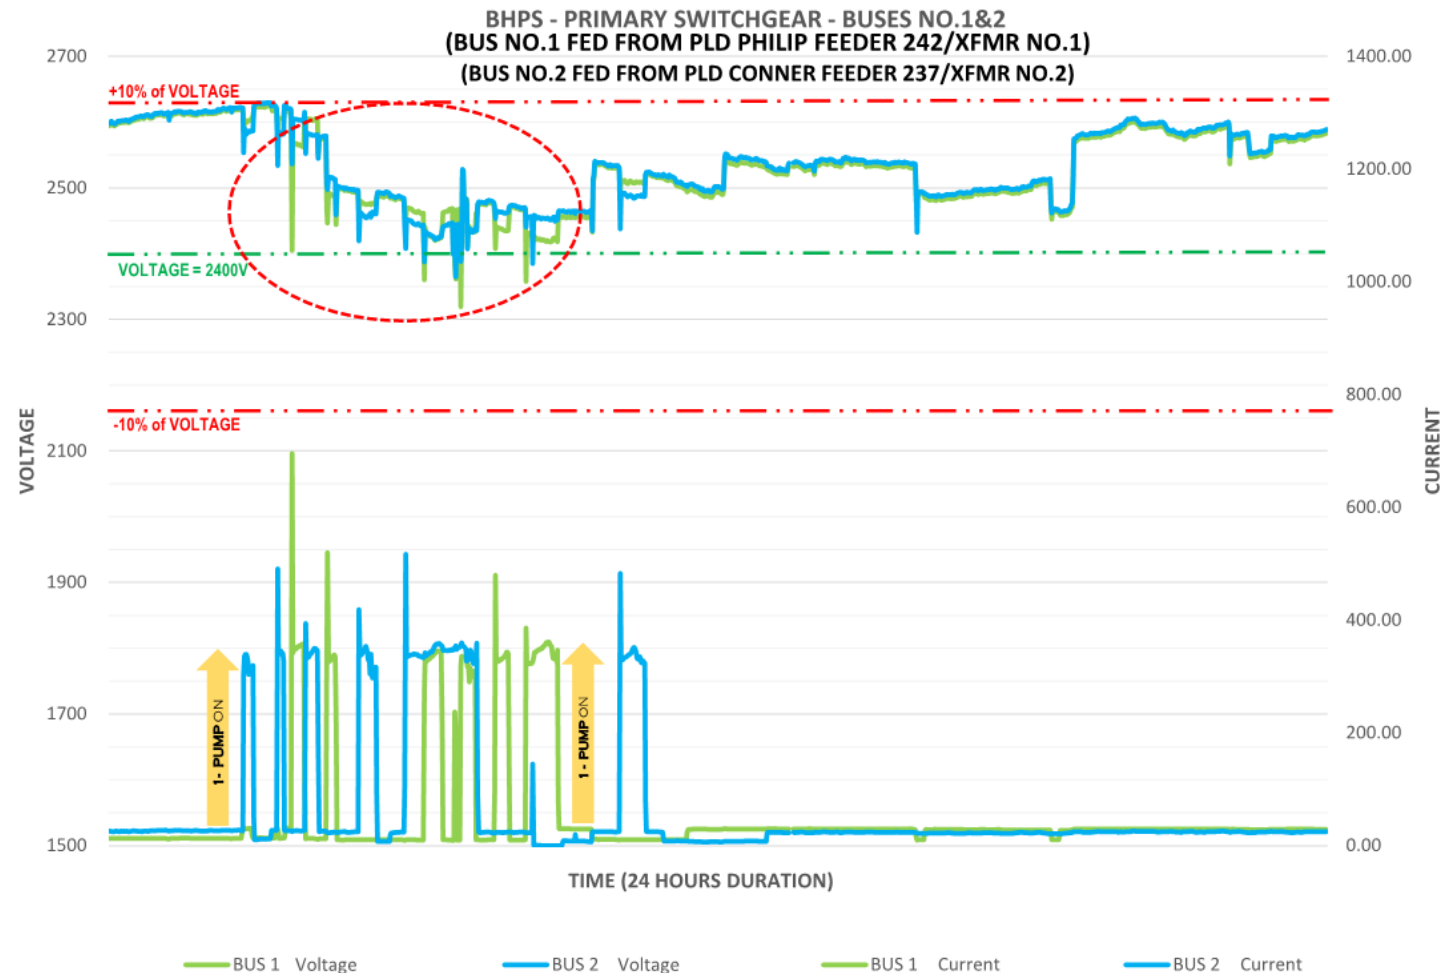
Power Quality – Bluehill Pump Station

- Power Source = PLD Substations
- “Weak” Power Supply:
 - Sustained voltage dip
 - Lack of power supply “stiffness”

3. During the July 16, 2021 event, external power supply and power quality issues (a brownout) at Bluehill Pump Station played a large role in reported water-in-basements upstream of that location
4. This presentation summarizes our analyses. A more detailed written technical report will follow.

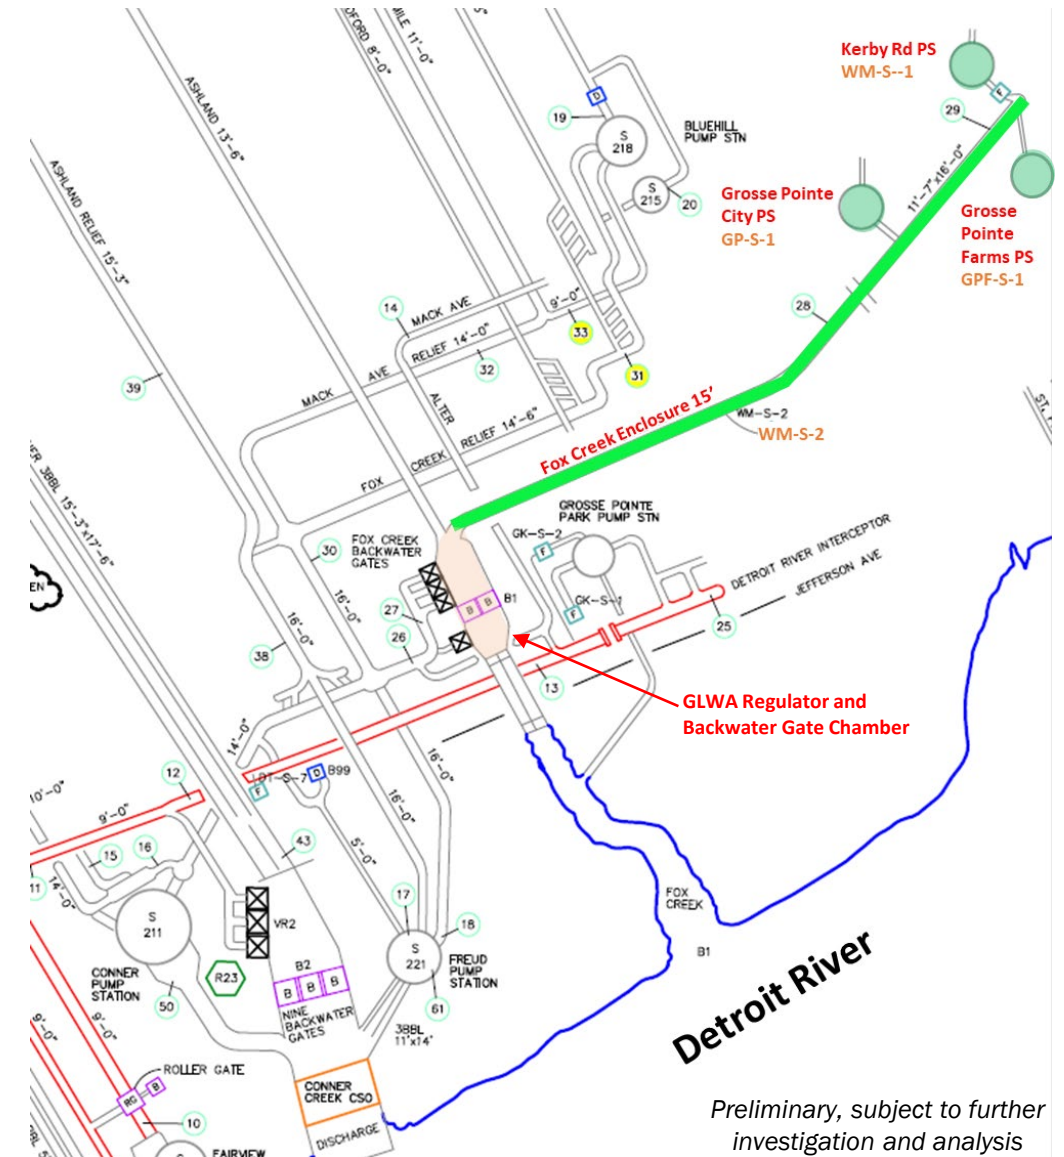
Fox Creek Enclosure

- Not owned and operated by GLWA
- Location and Size
 - Extends from Kerby Road and Chalfonte Ave. on the northeast to Ashland Street near Jefferson Ave. on the west
 - Approximately 3.25 miles in length
 - Shallow sewer (4-5' below grade in some locations)
 - Conveyance capacity of about 5-year storm
- Member Partners Served
 - Southeast Macomb Sanitary District
 - Grosse Pointe Farms
 - Grosse Pointe City
