# Water Transmission Incident Review & Response

Review of the 36", 42", and 54" Water Main Breaks

Peter Fromm, *Director of Water Transmission*

November 20, 2025

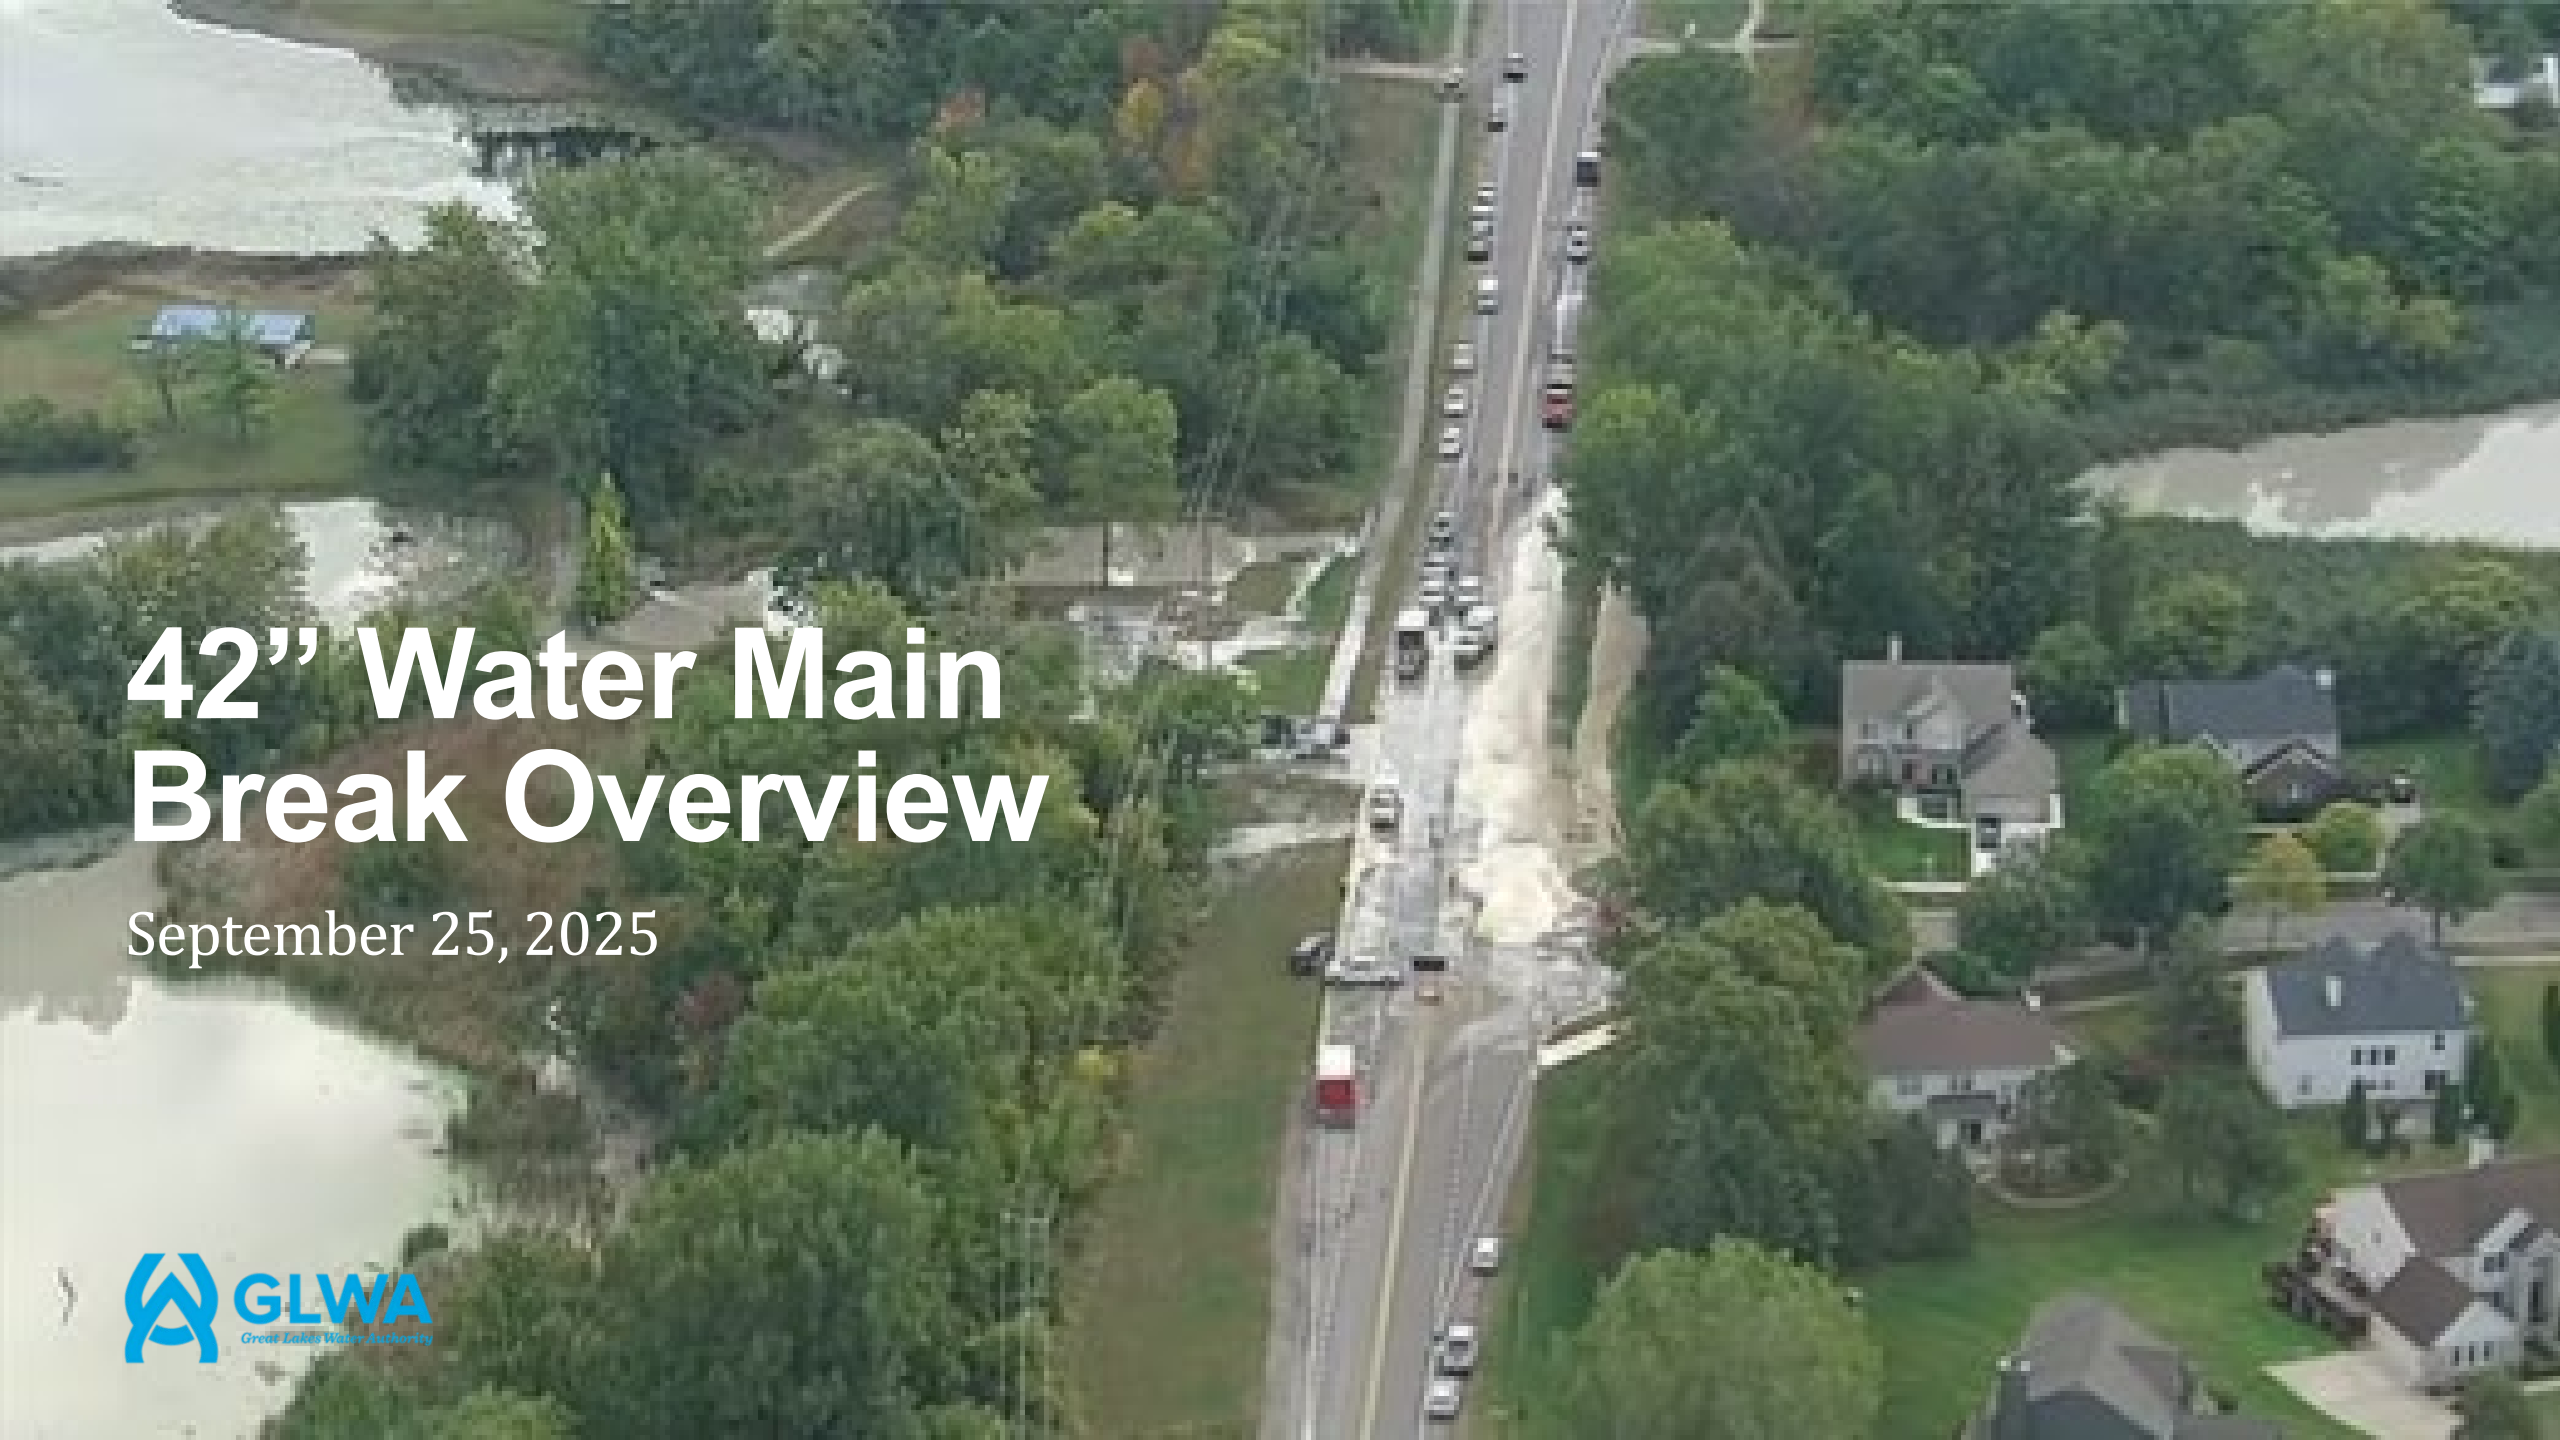
An aerial photograph showing a multi-lane road with a significant water main break. A large, turbulent plume of white water is erupting from the center of the road, creating a massive splash that extends across several lanes. The surrounding area is lush with green trees and vegetation. To the right of the road, there are several residential houses with dark roofs and light-colored siding. The overall scene depicts a major infrastructure failure in a suburban or rural setting.
