### **GLWA-SCP-DB-112 Change Order No. 1**

#### **Springwells Water Treatment Plant**

#### **Emergency Grating and Structural Steel Replacement**

Item No.: **2018-689**

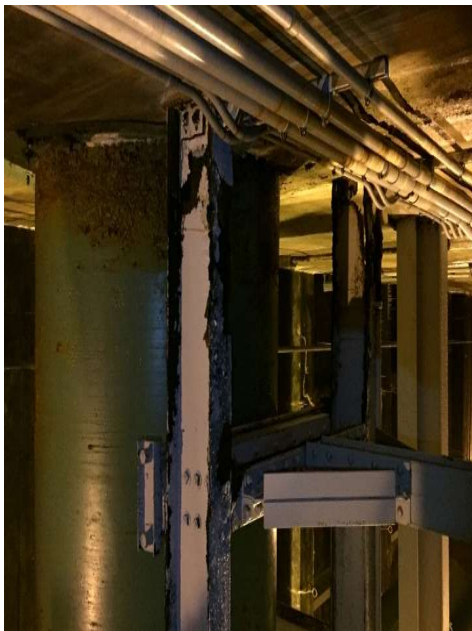
Location F - rehabilitation of discharge header supports. Photo No.1 shows an existing condition where the complete

structural support section has deteriorated to the point that its structural integrity is lost and the support is in need of replacement.

*Photo 1: Compromised Discharge Header Support*

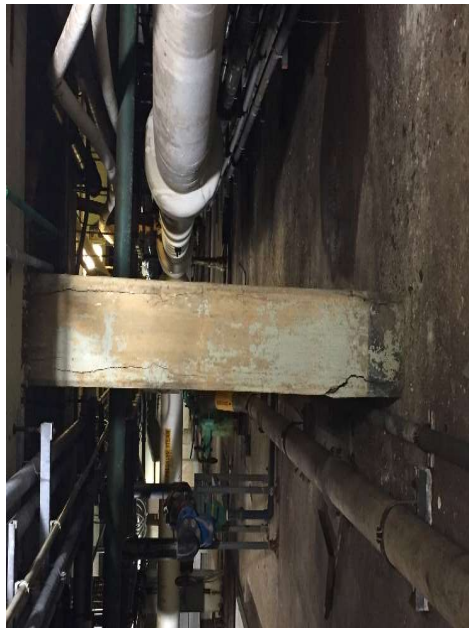
Location G - rehabilitation of a failed column supporting the Administration Building is necessary to prevent settling of the building superstructure. Photo No. 2 shows the failed concrete column in the 1930 Weir Chamber. Additional movement due to the failed column could cause damage to the Administration Building (above) and the 1930 Weir Chamber (below) that carries filtered water to the High Lift Station.

*Photo 2: Failed Concrete Column in Administration Building Basement*

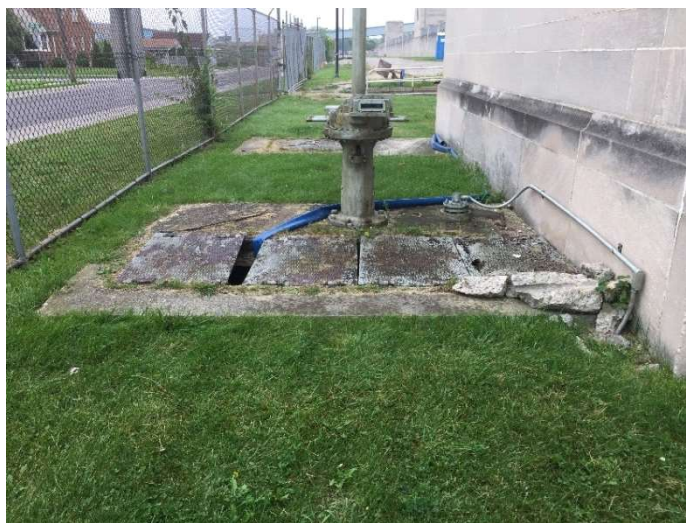
Location H - replacement of exterior concrete slabs and hatches at the Drain Pump House is necessary for safety reasons. All filter waste wash water drains through the conduits beneath the slabs, and failure of the slabs would require shutting the entire plant down for cleaning. Photo No. 3 shows the condition of the concrete slabs and that the existing steel grating has deteriorated to the point where one can see through the checkered steel plate.

*Photo 3: Deteriorated Concrete Slabs and Hatches at Drain Pump House*
