# 14 Mile Road Transmission Main Management

March 22, 2023

# 14 Mile Transmission Main

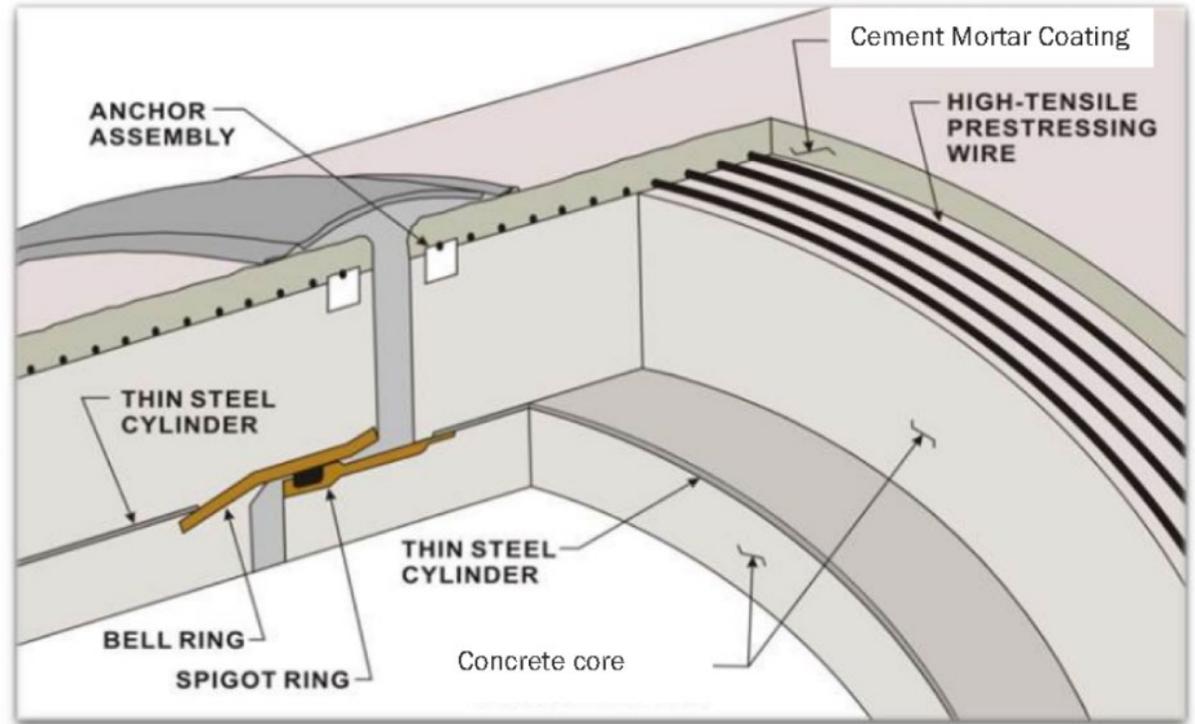
# Prestressed Concrete Cylindrical Pipe (PCCP)

- 💧 Custom built “Pipe System”
- 💧 Primary failure mode is broken wire wraps due to corrosion and/or hydrogen embrittlement
- 💧 Determination of the number of broken wire wraps in each pipe segment is critical to understanding the remaining pipe strength

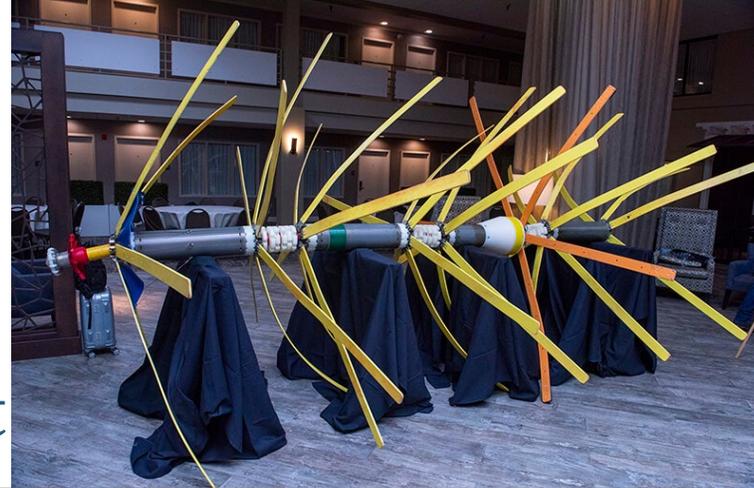
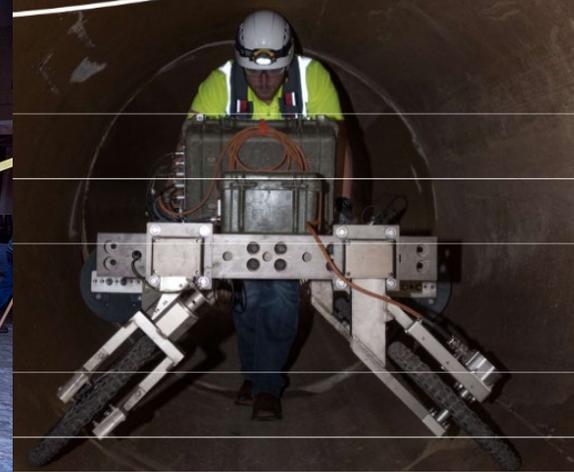
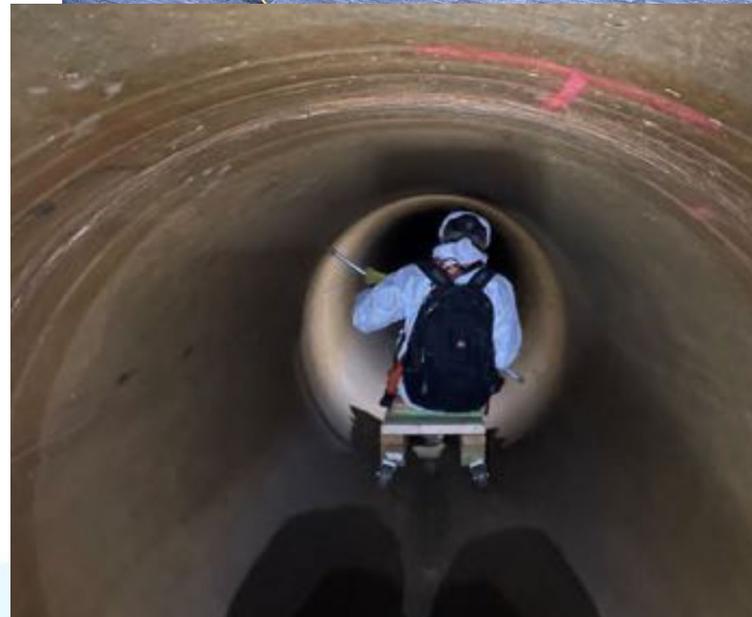
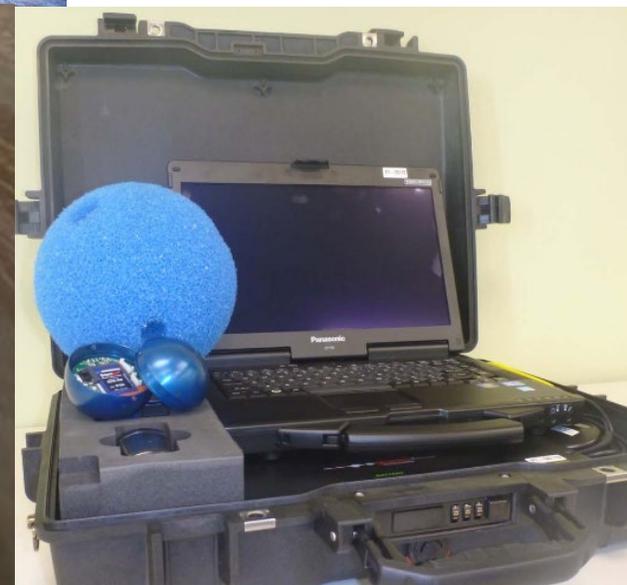
- 💧 Electromagnetic Inspection
  - 💧 Free-Swimming Xylem PipeDiver
  - 💧 Piloted Xylem PipeWalker
- 💧 Acoustic Inline Leak & Air Pocket Detection - Xylem SmartBall
- 💧 Visual & Sounding Inspection
- 💧 Engineering Analysis

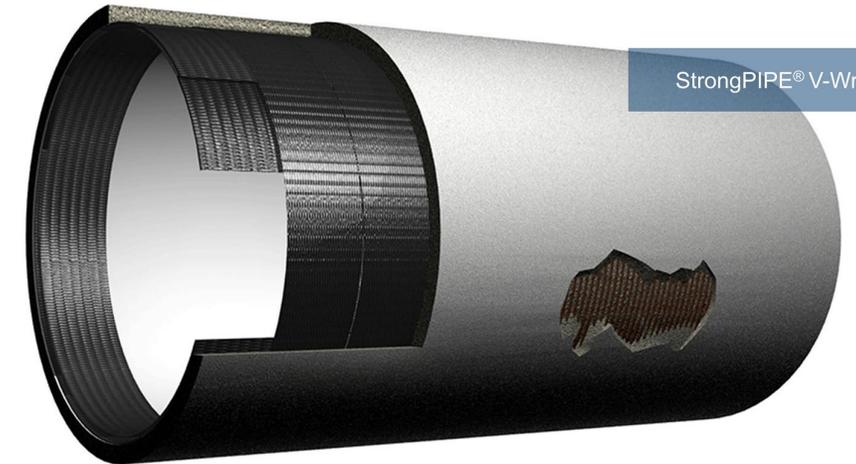
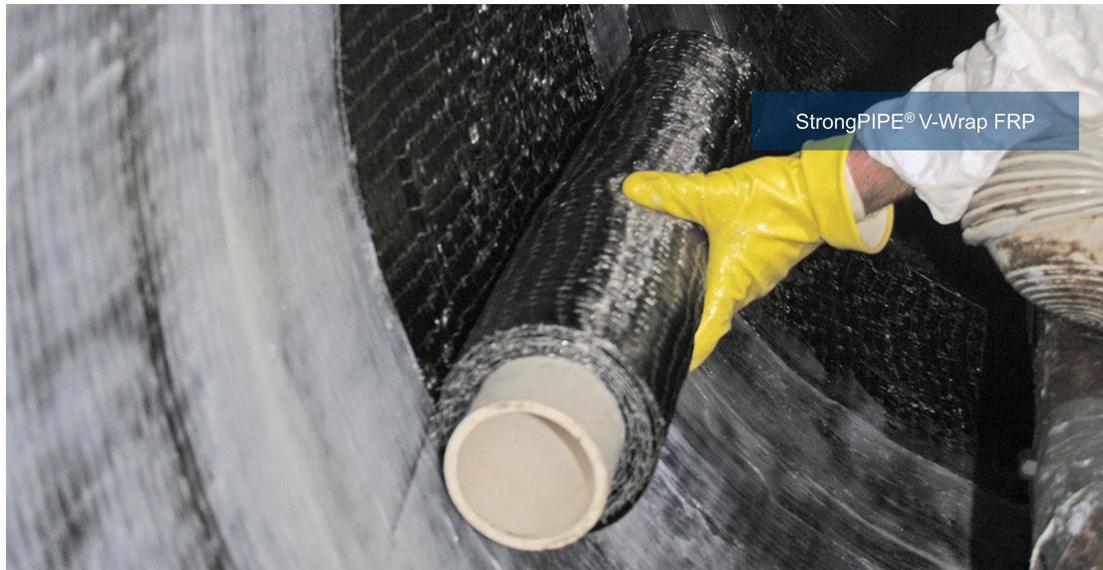
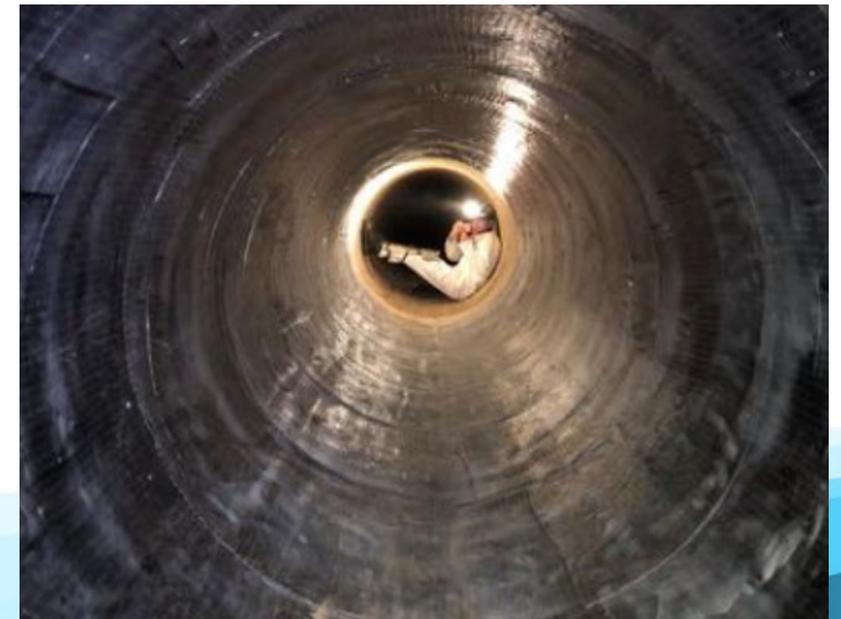
# Pipeline Renewal/Strengthening Technologies

- 💧 Carbon Fiber Reinforced Polymer (CFRP)
- 💧 Targeted Pipe Segment Renewal Based on Inspection Results & Engineering Analysis
- 💧 Extend the Effective Useful Life >50 Years

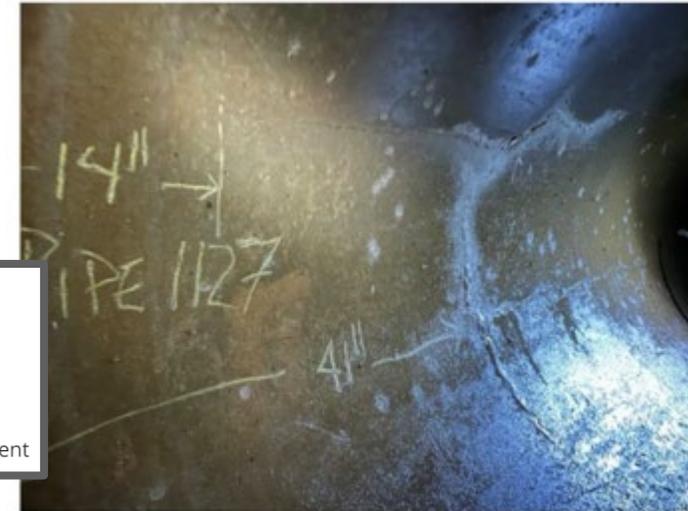
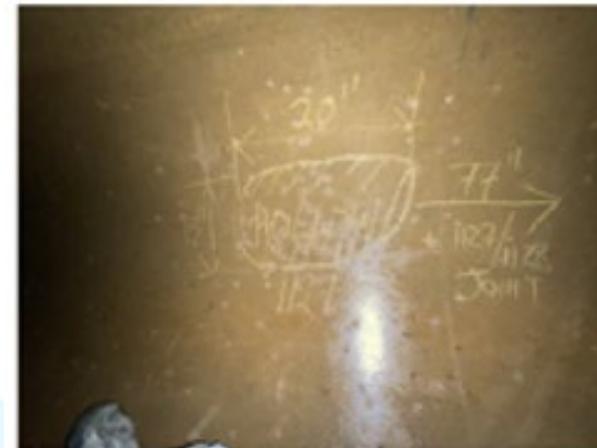
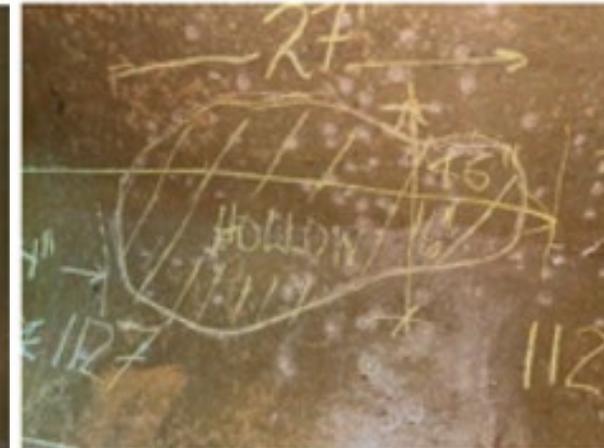
- Visual & Sounding Inspection

- Identified a pipe in “Incipient” Failure

- Longitudinal cracking and hollows

- Immediate renewals necessary

- Plan for renewals prior to loop

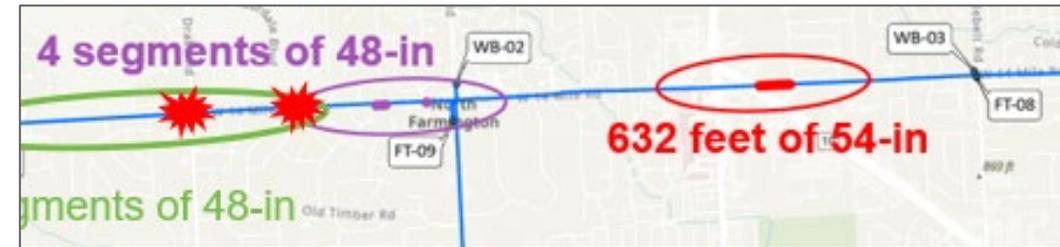
- Due to the recent disruptions, inspection results, and consequence of this pipeline failing, these renewals were prioritized & expedited
- Without the 14 Mile Loop in service, operational challenges were overcome which required:
  - Modifications of GLWA and member partner operations
  - Temporary booster pump station within Farmington Hills
- Renewals completed March 2023
  - 4 segments of 48-inch and
  - 632 feet of 54-inch renewed
  - Using Carbon Fiber Reinforced Polymer (CFRP)
- Pipeline is anticipated to be back into service by April 1, 2023

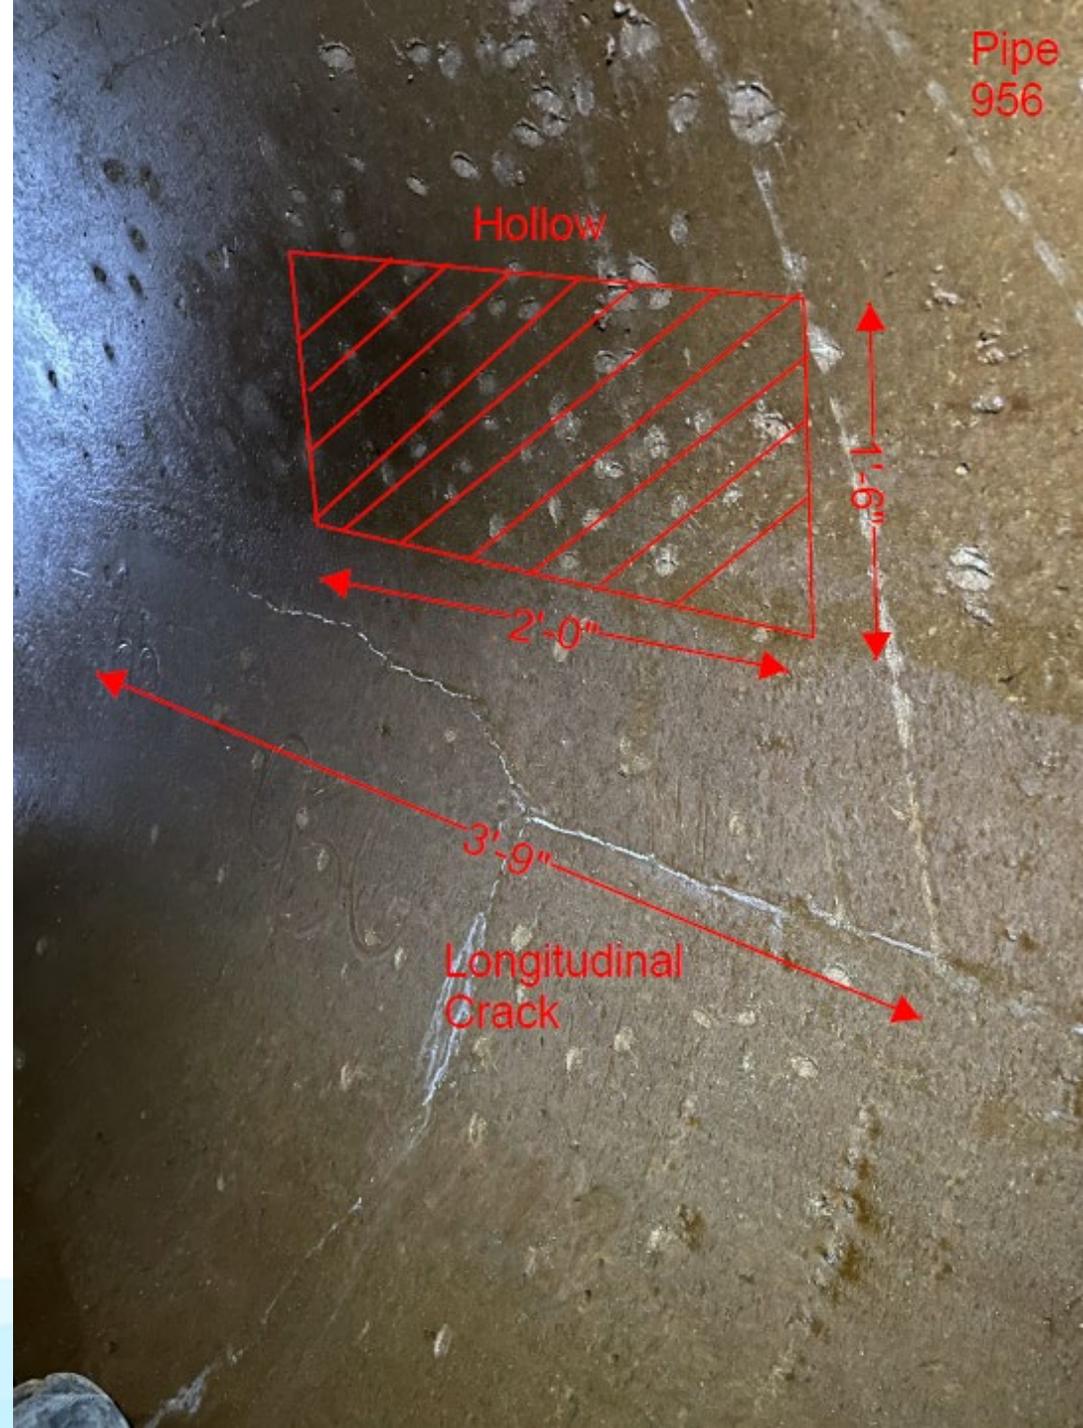
## 💧 2023 Partial Visual & Sounding Inspection

- 💧 Identified a pipe in “Incipient” Failure
- 💧 Longitudinal cracking and hollow

- 💧 Confirmed the urgent need to proactively renew these pipe segments prior to the completion of the 14 Mile loop

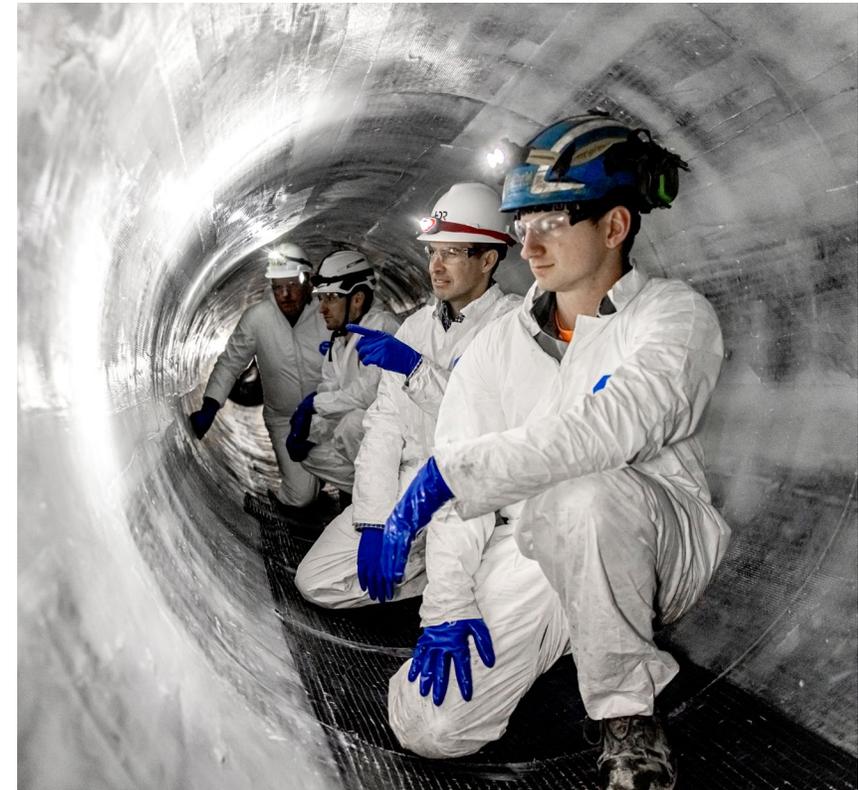
- 💧 102 of 2,623 pipes with broken wire wraps (3.9%)
- 💧 Renewals recommended for 48 of those pipes

- 💧 66 pipes renewed
  - 💧 Additional pipes strengthened near the DTE high-pressure gas facility
- 💧 54 pipes remaining with acceptable levels of broken wire wraps to manage into future
