WRRF Incineration (N-Belt) Fire

October 28, 2020

N-Belt Fire

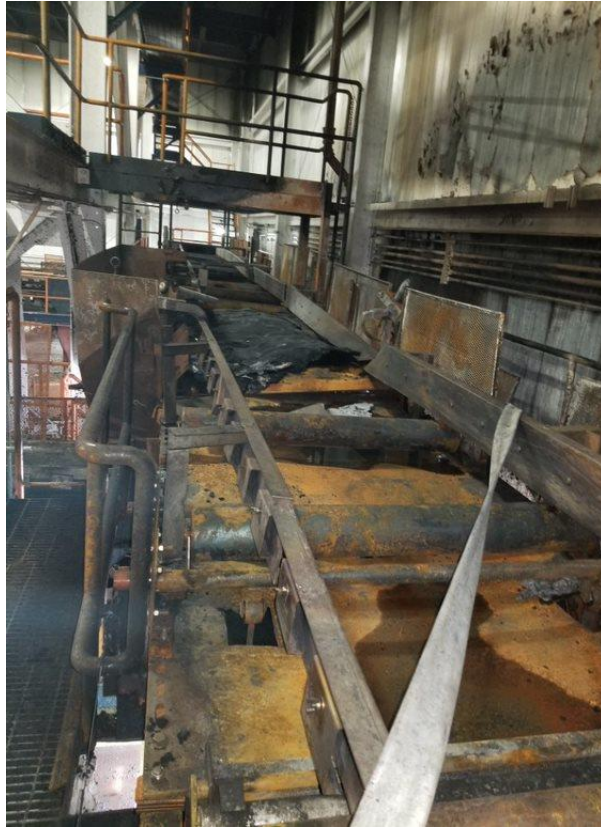
Along the N-belt

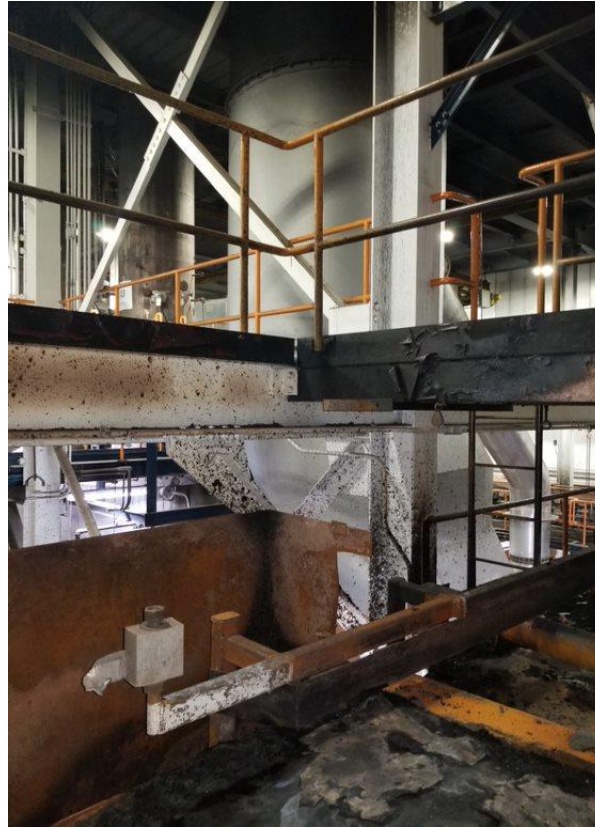
Above the Hopper

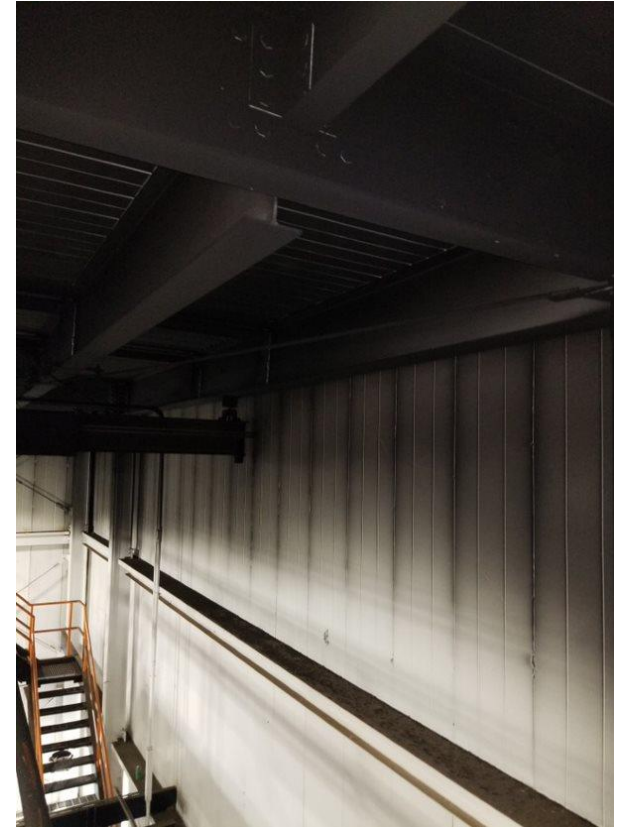
Soot on Ceiling

- Cleaning and Painting of Walls and Ceiling
- Deeper Inspection of Potential Structural/Insulation/Roof Damage
