Title: GLWA-SCP-DB-112 Change Order No. 1
Springwells Water Treatment Plant
Emergency Grating and Structural Steel Replacement

RE: **Contract No. GLWA-SCP-DB-112 Change Order No. 1**
Springwells Water Treatment Plant
Emergency Grating and Structural Steel Replacement

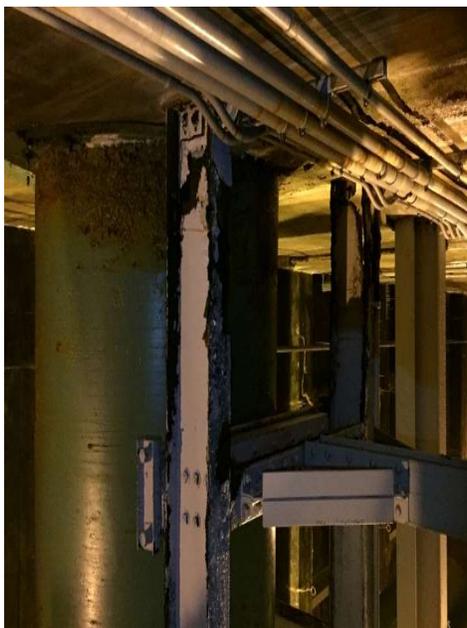
Photo 1: Compromised Discharge Header Support

Location F - rehabilitation of discharge header supports. Photo No.1 shows an existing condition where the complete structural support section has deteriorated to the point that its structural integrity is lost and the support is in need of replacement.

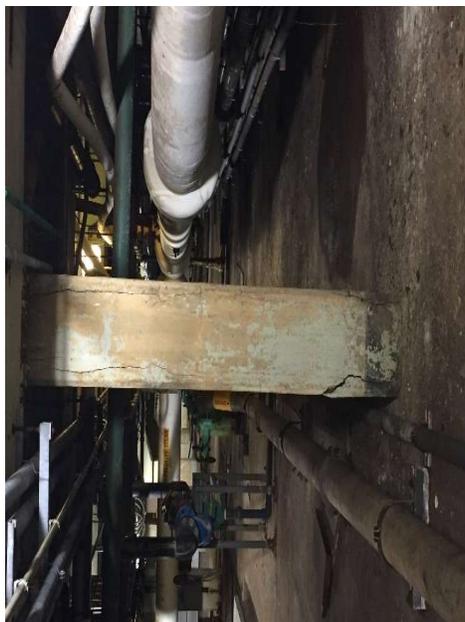
Photo 2: Failed Concrete Column in Administration Building Basement

Location G - rehabilitation of a failed column supporting the Administration Building is necessary to prevent settling of the building superstructure. Photo No. 2 shows the failed concrete column in the 1930 Weir Chamber. Additional movement due to the failed column could cause damage to the Administration Building (above) and the 1930 Weir Chamber (below) that carries filtered water to the High Lift Station.

Structural failures at Locations F and G will compromise SPW production.

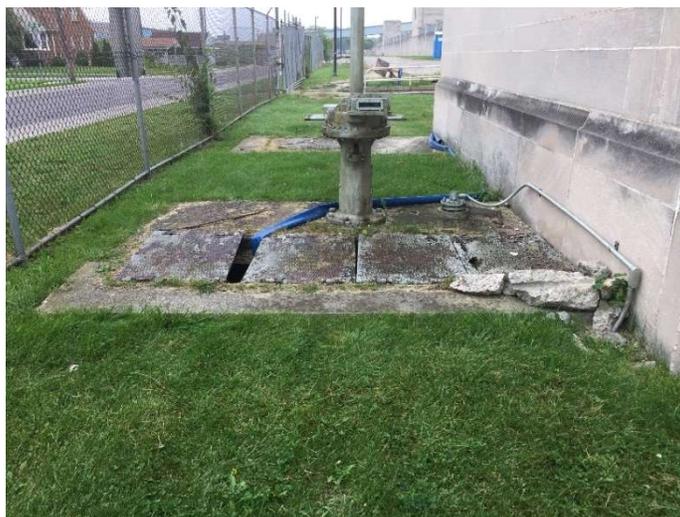
Photo 3: Deteriorated Concrete Slabs and Hatches at Drain Pump House

Location H - replacement of exterior concrete slabs and hatches at the Drain Pump House is necessary for safety reasons. All filter waste wash water drains through the conduits beneath the slabs, and failure of the slabs would require shutting the entire plant down for cleaning. Photo No. 3 shows the condition of the concrete slabs and that the existing steel grating has deteriorated to the point where one can see through the checkered steel plate.
