**Title:** GLWA-SCP-DB-112 Change Order No. 1  
Springwells Water Treatment Plant  
Emergency Grating and Structural Steel Replacement

### GLWA-SCP-DB-112 Change Order No. 1

### Springwells Water Treatment Plant

### Emergency Grating and Structural Steel Replacement

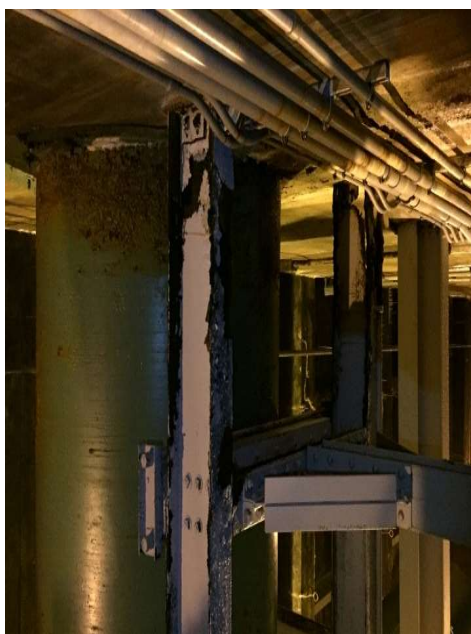
Location F - rehabilitation of discharge header supports. Photo No.1 shows an existing condition where the complete structural support section has deteriorated to the point that its structural integrity is lost and the support is in need of replacement.

*Photo 1: Compromised Discharge Header Support*

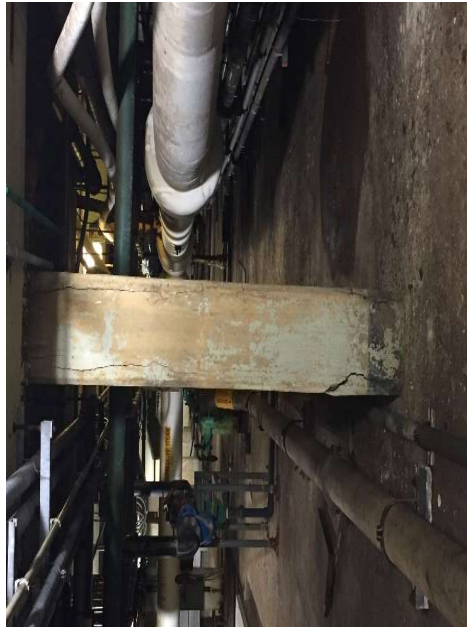
Location G - rehabilitation of a failed column supporting the Administration Building is necessary to prevent settling of the building superstructure. Photo No. 2 shows the failed concrete column in the 1930 Weir Chamber. Additional movement due to the failed column could cause damage to the Administration Building (above) and the 1930 Weir Chamber (below) that carries filtered water to the High Lift Station.

Structural failures at Locations F and G will compromise SPW production.

*Photo 2: Failed Concrete Column in Administration Building Basement*

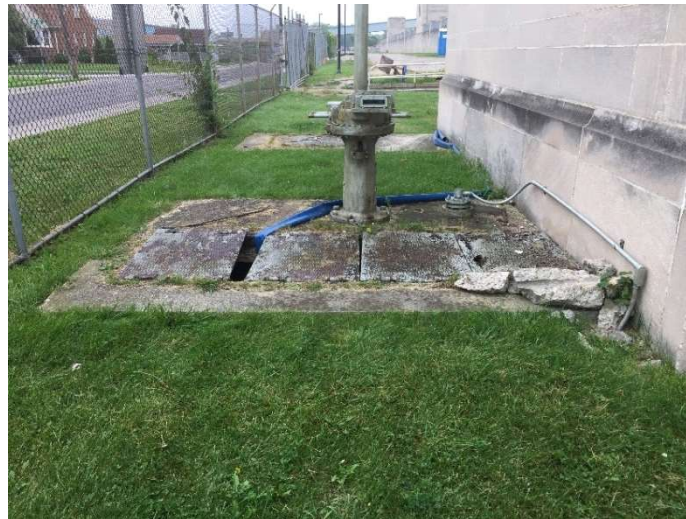
Location H - replacement of exterior concrete slabs and hatches at the Drain Pump House is necessary for safety reasons. All filter waste wash water drains through the conduits beneath the slabs, and failure of the slabs would require shutting the entire plant down for cleaning. Photo No. 3 shows the condition of the concrete slabs and that the existing steel grating has deteriorated to the point where one can see through the checkered steel plate.

*Photo 3: Deteriorated Concrete Slabs and Hatches at Drain Pump House*
