14 Mile Road Condition Assessment

Cheryl Porter, COO Water & Field Svcs

Todd King, Field Services Director

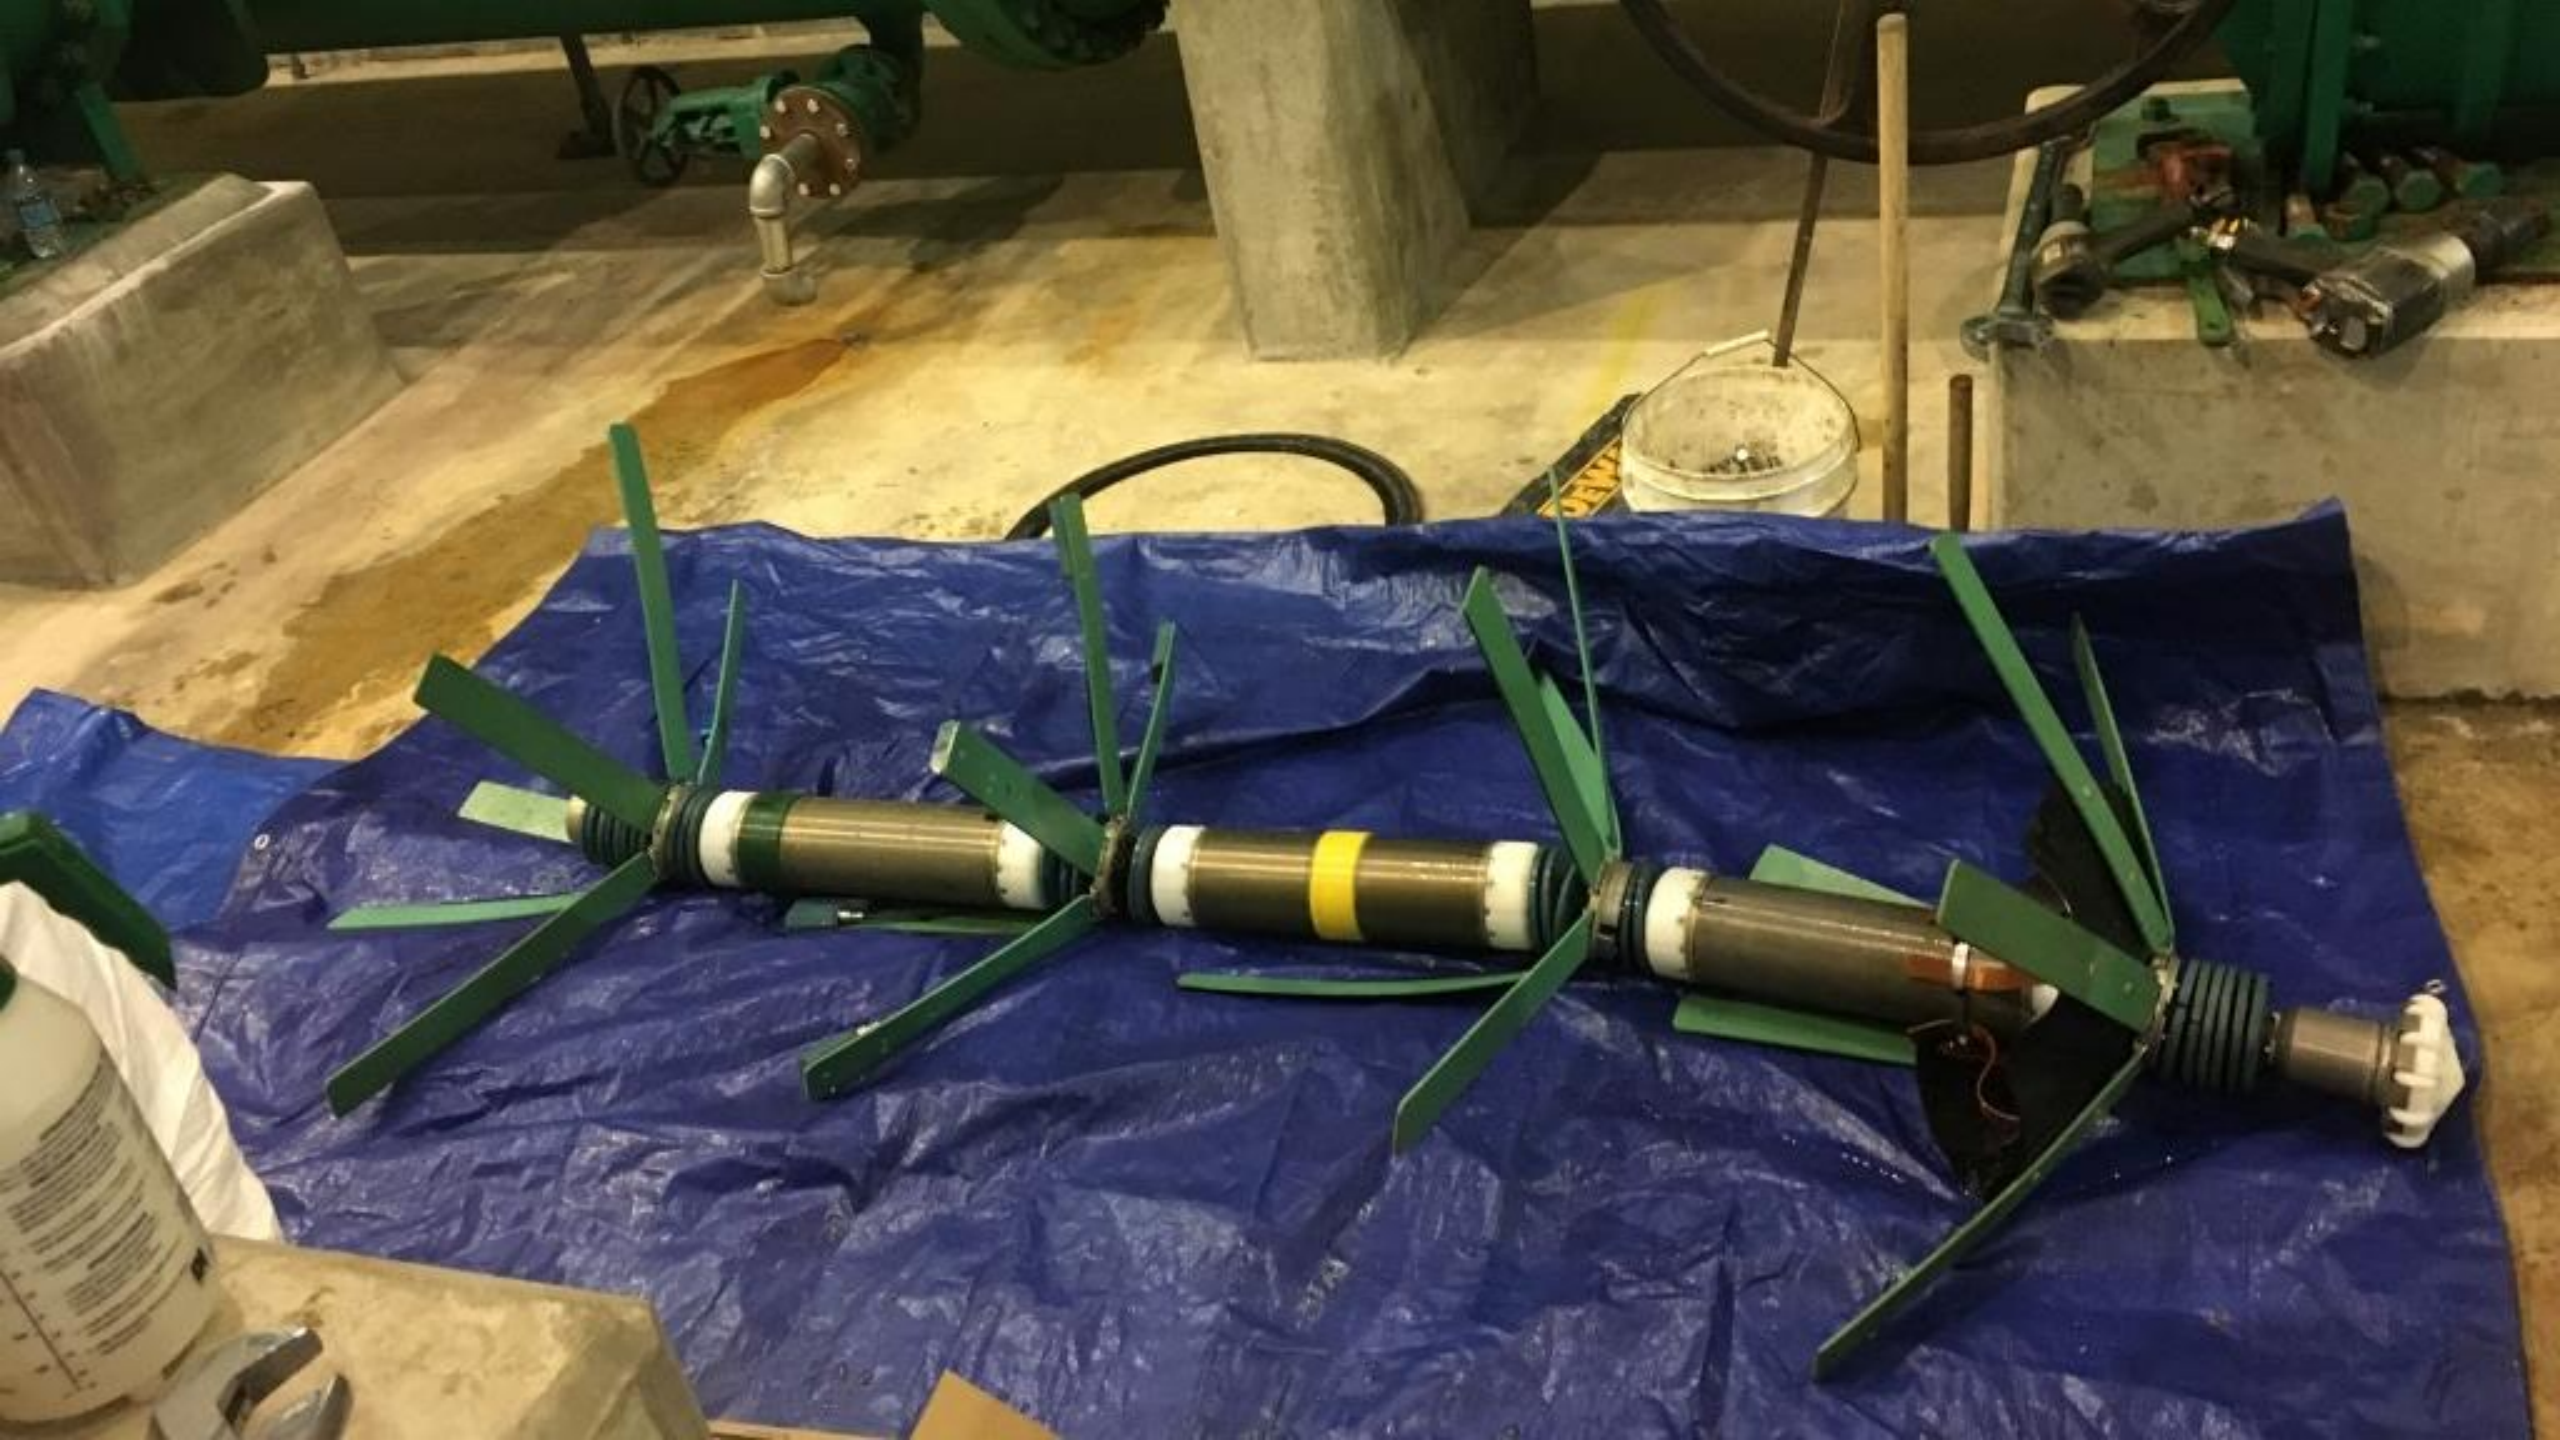
- **GIS Pipe List**

- Shows individual pipes and wire break count
 - Light blue – no wire breaks detected
 - Green – 5 wire breaks reported
 - Yellow – 10 to 25 wire breaks reported
 - Red – 30+ wire breaks reported
 - Purple – Distressed pipe “D”
