GLWA Board of Directors Meeting

October 27, 2021

June 25/26 and July 16, 2021
Post Event Analysis

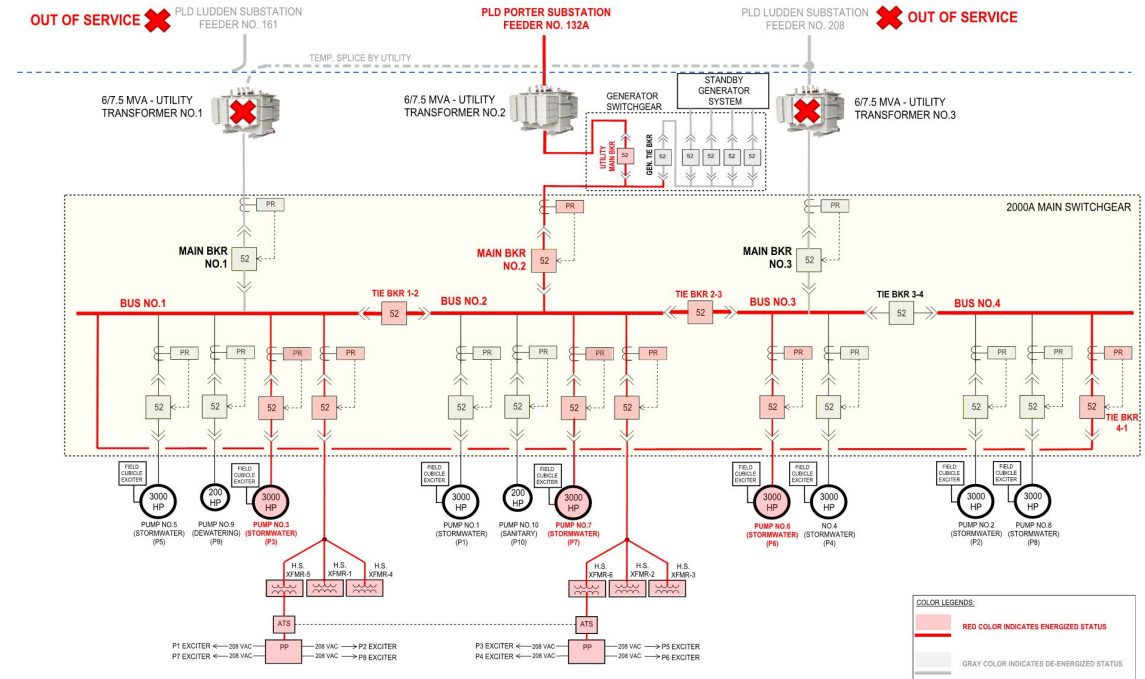
Power Considerations - Overview

- Power Supply Reliability
 - Freud PS – Feeder Ludden 161
 - Freud PS – Feeder Ludden 208
 - Standby Generator Systems
 - Outage Repair Time
 - Supply Conversion to DTE
- Power Quality

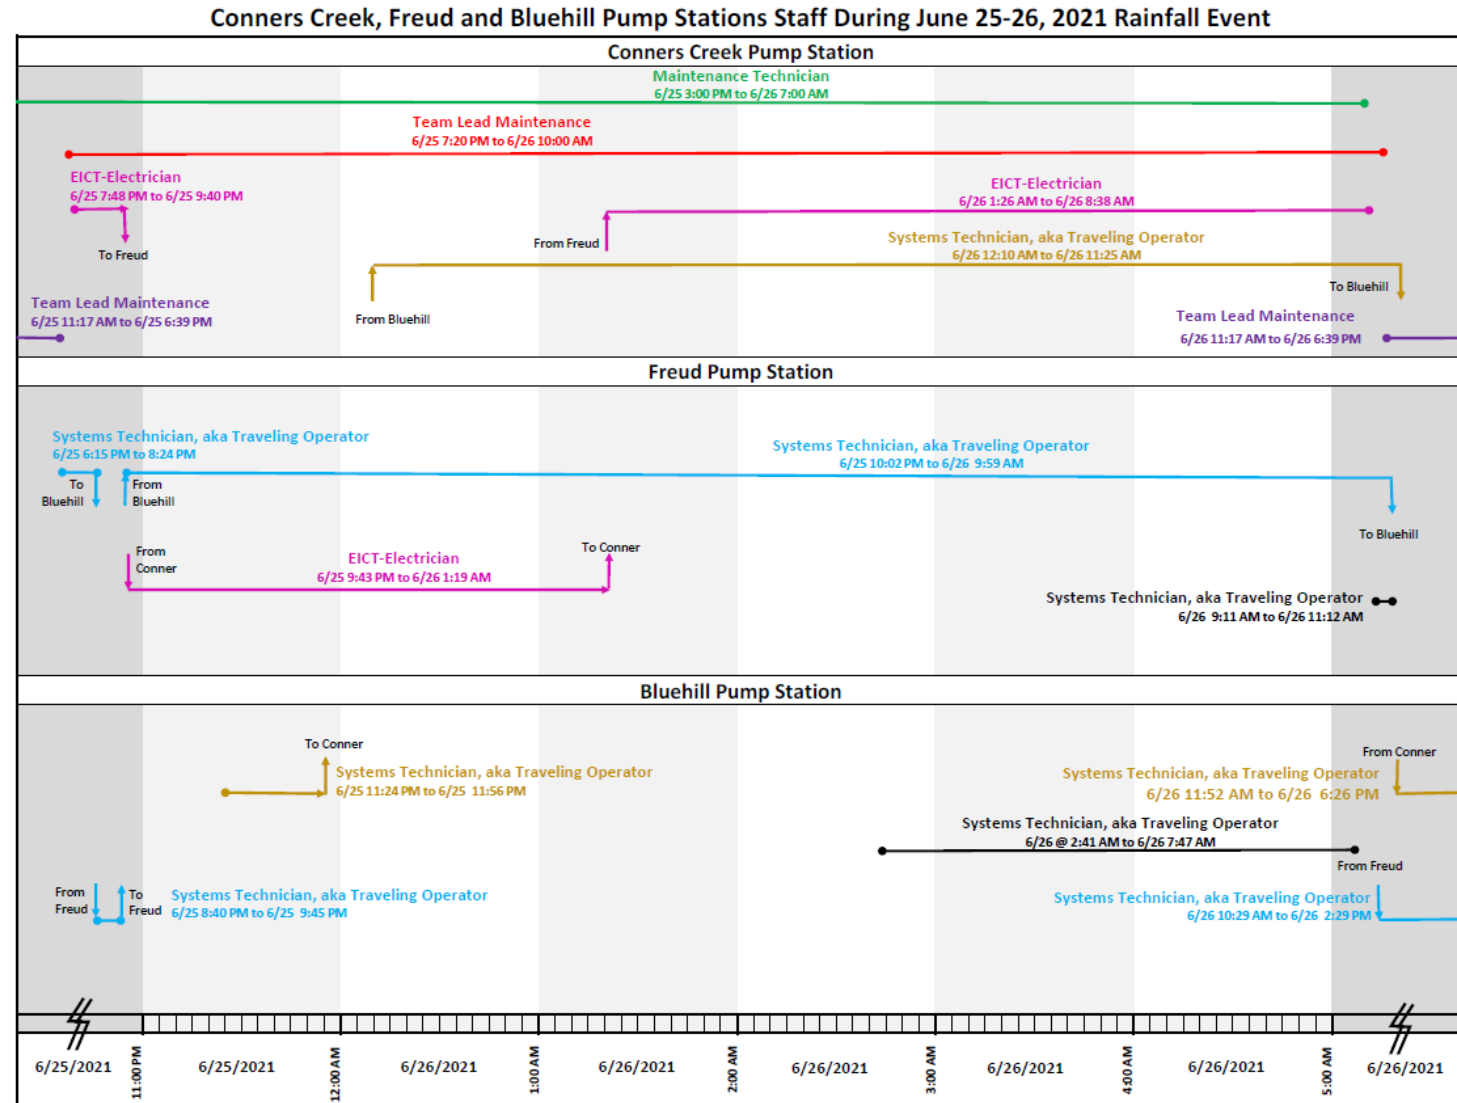
GLWA Staffing

Conners Creek and Freud Pump Stations were staffed throughout the storm event

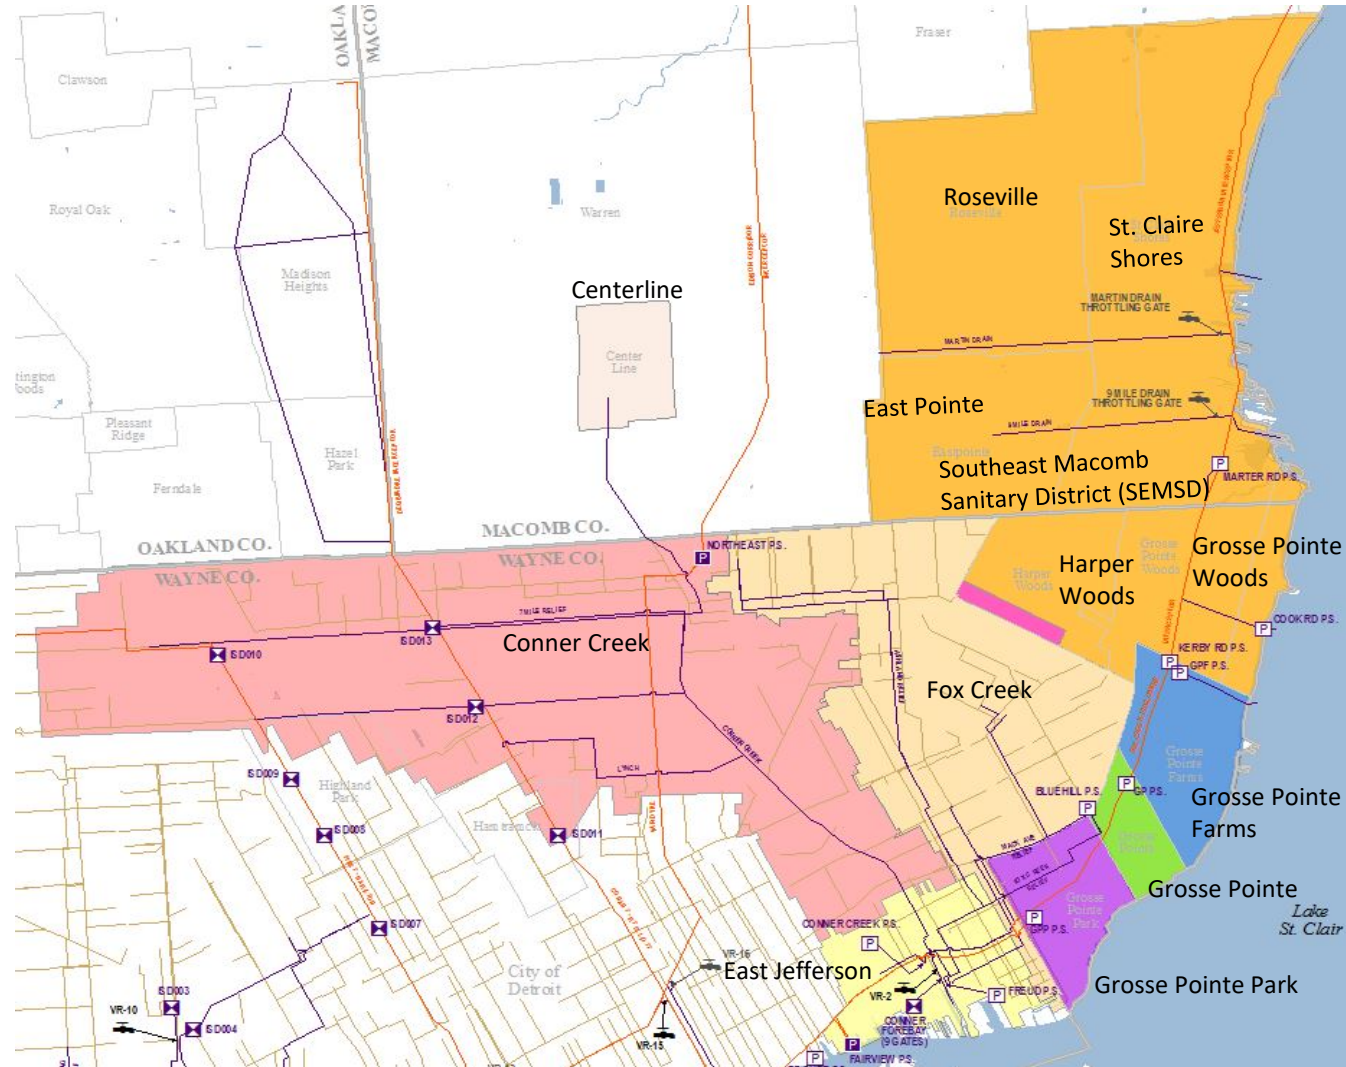
Fox Creek Enclosure

- Not owned and operated by GLWA
- Location and Size
 - Extends from Kerby Road and Chalfonte Ave. on the northeast to Ashland Street near Jefferson Ave. on the west
 - Approximately 3.25 miles in length
 - Shallow sewer (4-5' below grade in some locations)
 - Conveyance capacity of about 5-year storm
- Member Partners Served
 - Southeast Macomb Sanitary District
 - Grosse Pointe Farms
 - Grosse Pointe City

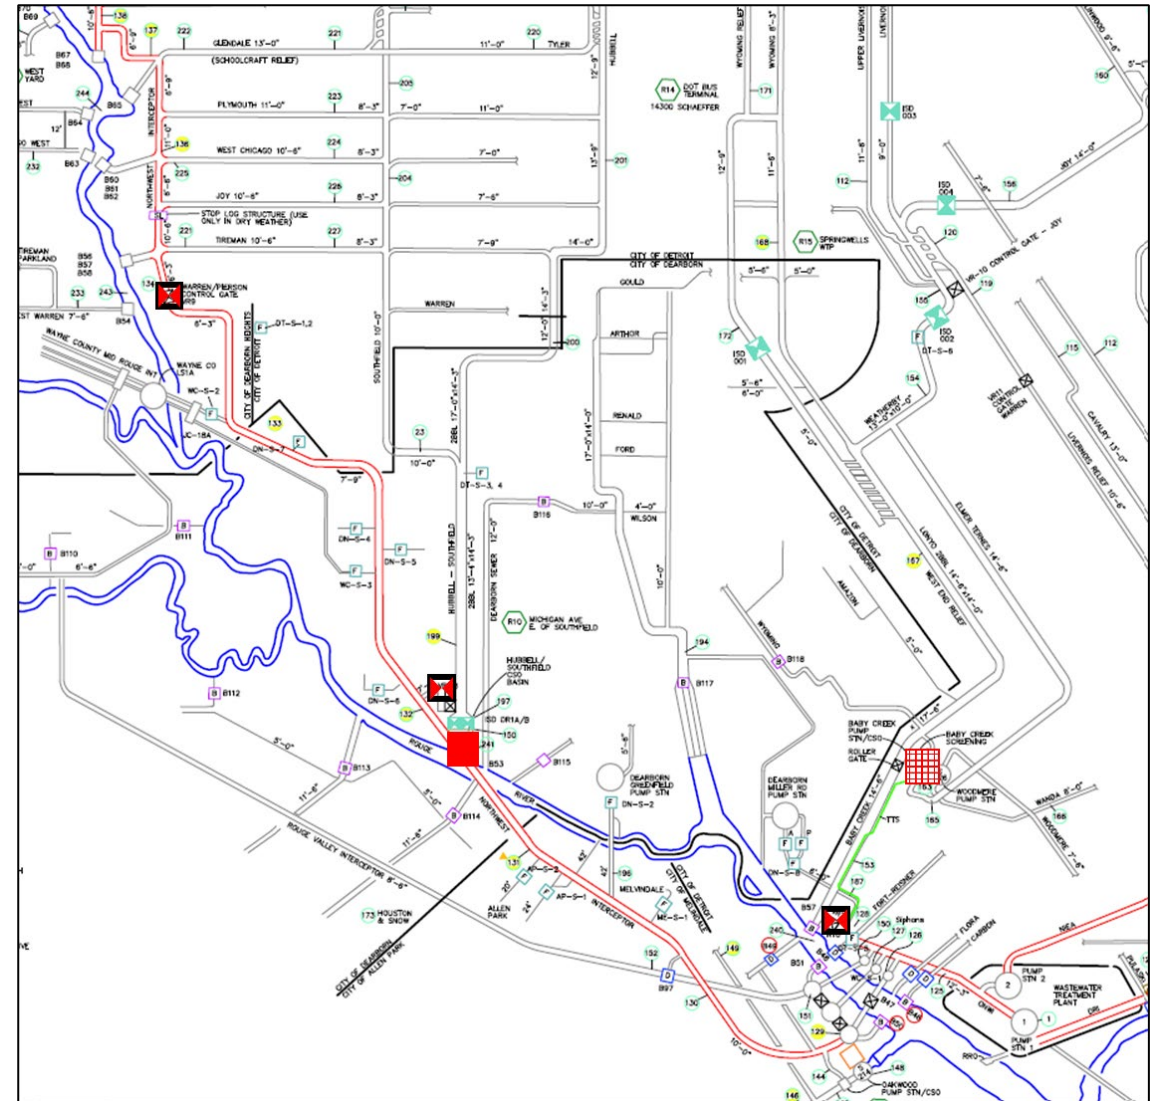
CSO Facilities

□ 17 Gravity Outfalls

■ Hubbell Southfield RTB

⊠ Valve Remotes

- VR-7
- VR-8
- VR-9

▣ Baby Creek SDF
