GLWA Linear System Integrity Program Update

Linear System Integrity Program

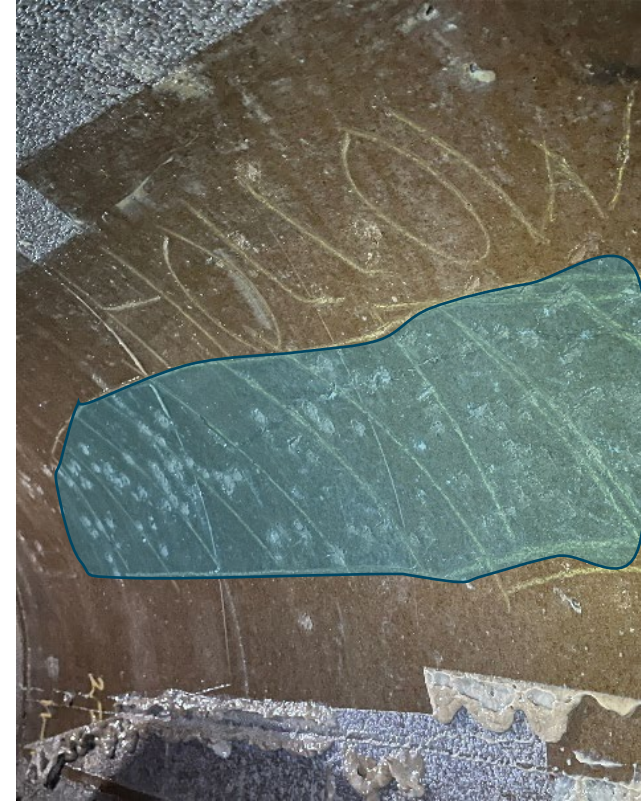
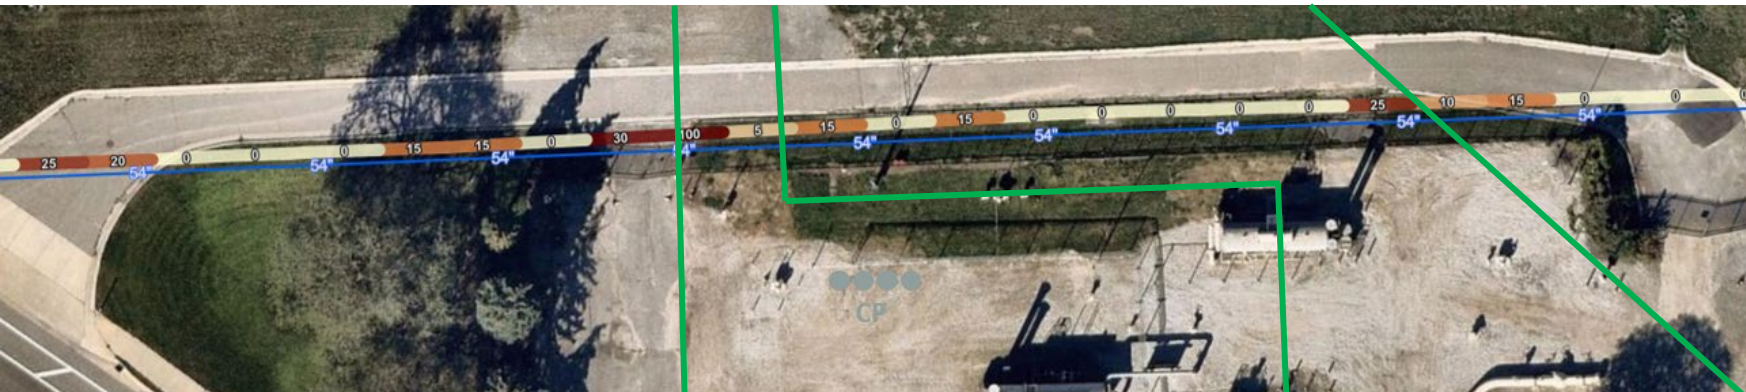
LSIP Progress (Cont'd)

💧 Pipe segments renewed:

- 💧 Pipes failed (cracks/hollows)– 20 (400 feet)
- 💧 Pipes with significant distressed – 57 (1,043 feet)
- 💧 Pipes nearing or exceeding strength limit– 97 (1,939 feet)
- 💧 Pipes under the influence of cathodic protection system – 33 (632 feet)

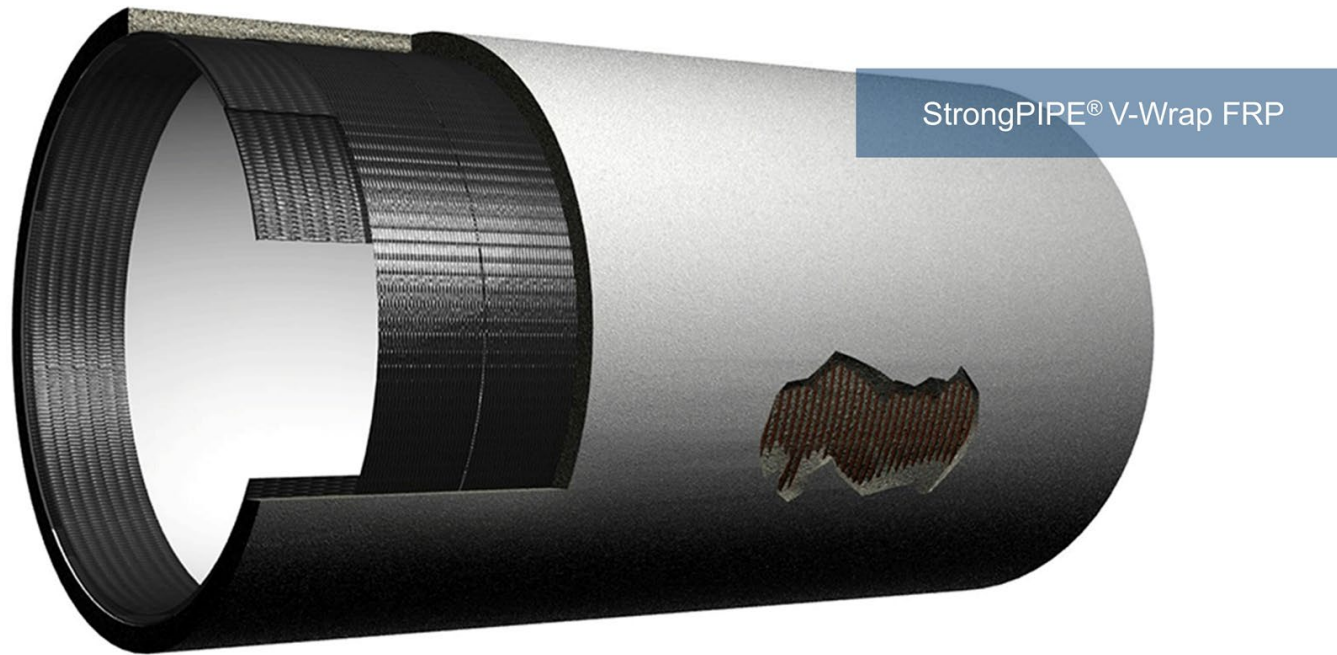
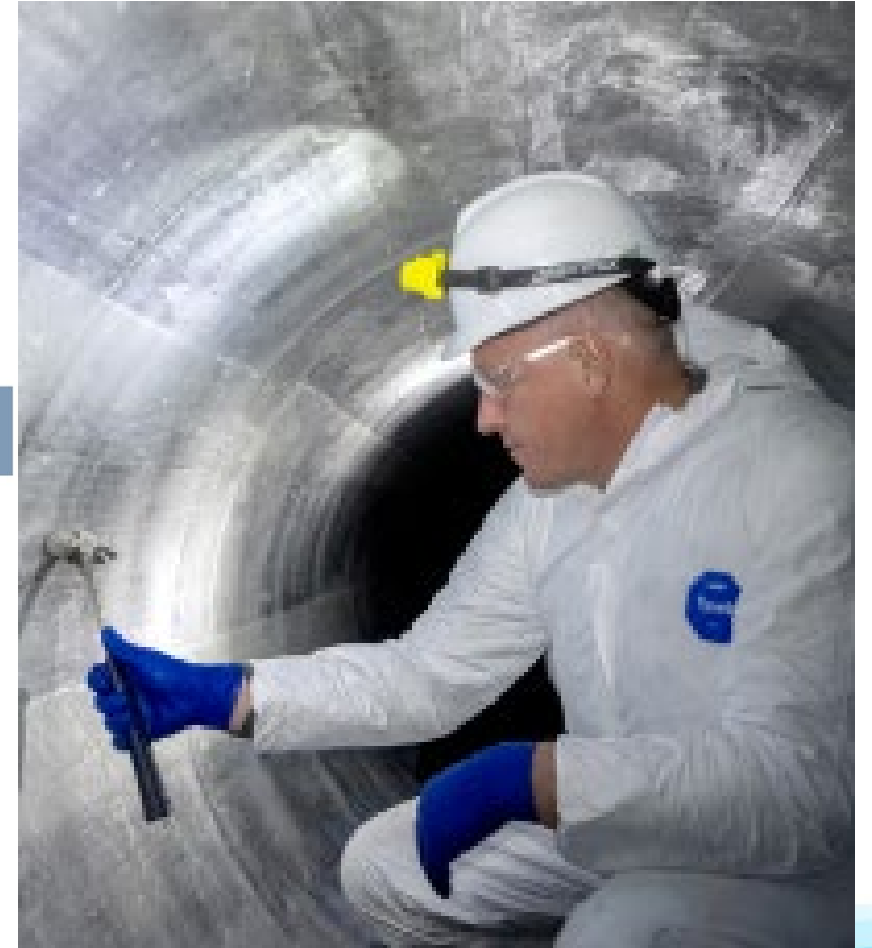
LSIP Progress (Cont'd)

💧 Pipe segments renewed:

- 💧 Primary renewal strategy has been with Carbon Fiber Reinforced Polymer (CFRP) (3,785 feet)
