**UNITS OF SERVICE FOR NON-
MASTER METERED CUSTOMERS
OF GREAT LAKES WATER
AUTHORITY AND SYSTEM WATER
AUDIT:
PHASE TWO REPORT**

GLWA PROJECT CS-039

Great Lakes Water Authority

29 NOVEMBER 2018

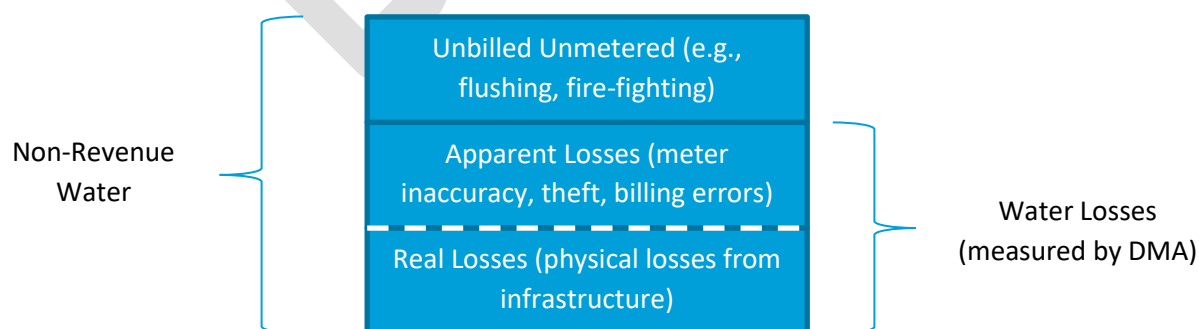
Figure 2-1 DMAs and Non-Revenue Water.

The dashed line in Figure 2-1 indicates that apparent losses cannot be easily separated from real losses based on DMA monitoring alone; therefore, the DMA measures both types of losses together with an unknown split between these two pieces of the water balance. The Unbilled Unmetered component represents authorized use that generally represents unusual or infrequent uses of water. Since the DMAs were operational for a short period of time (typically ten to fourteen days) it is recommended that the DMAs are utilized to represent Water Losses and not total NRW, because the shorter duration is unlikely to capture a representative sample of flushing and fire-fighting activity. It is recommended that regular flushing activity in the DMA area is not conducted while it is being monitored. If fire-fighting or specific flushing is necessary during the study period, the event should be reviewed, and the volume of water used should be estimated and adjusted in the DMA balance (either added to consumption, or removed from the input volume).

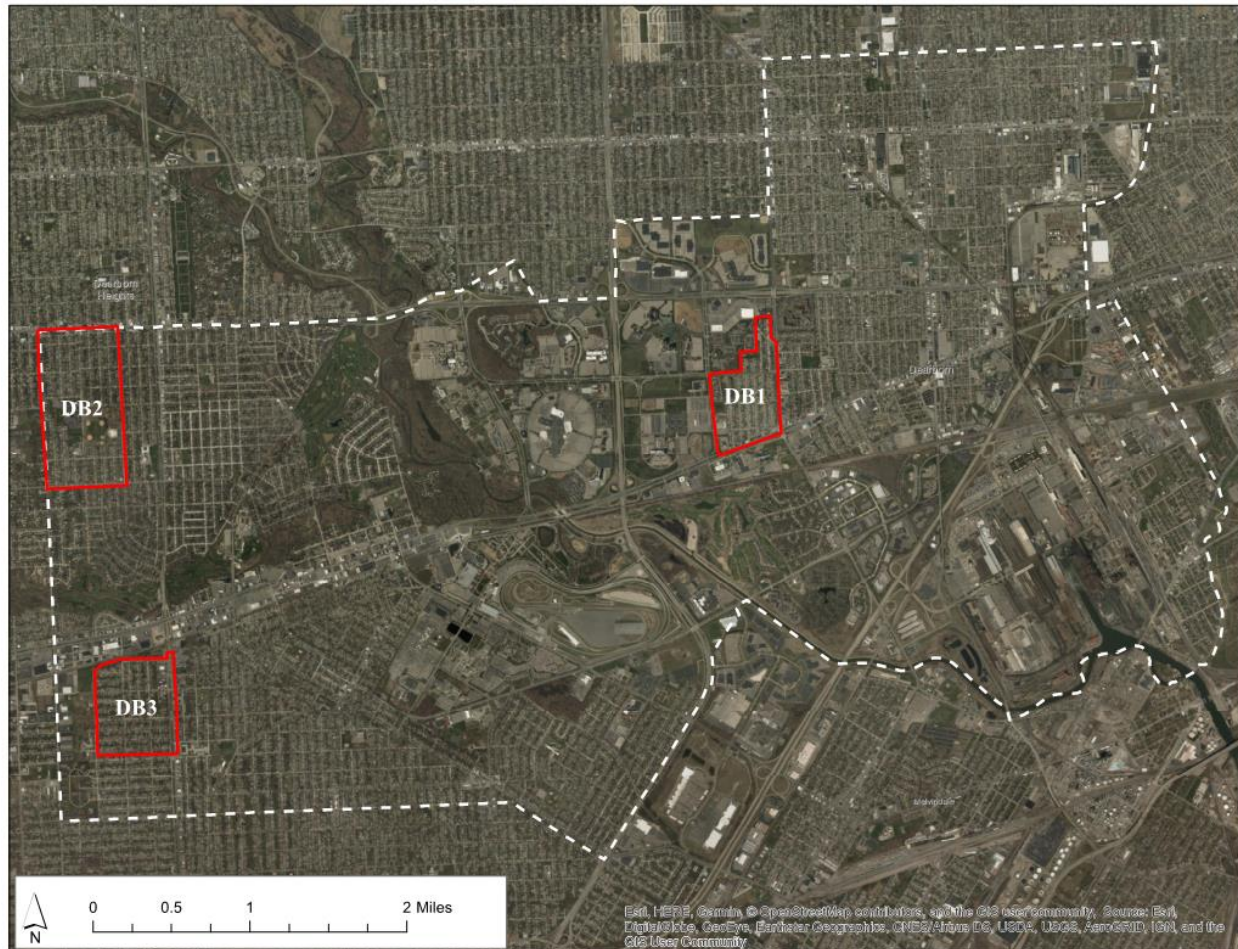
DB1 and DB2 were the preferred locations as these provided a contrast of newer and older pipe material.

Figure 2-2 DMA Areas Evaluated for the City of Dearborn

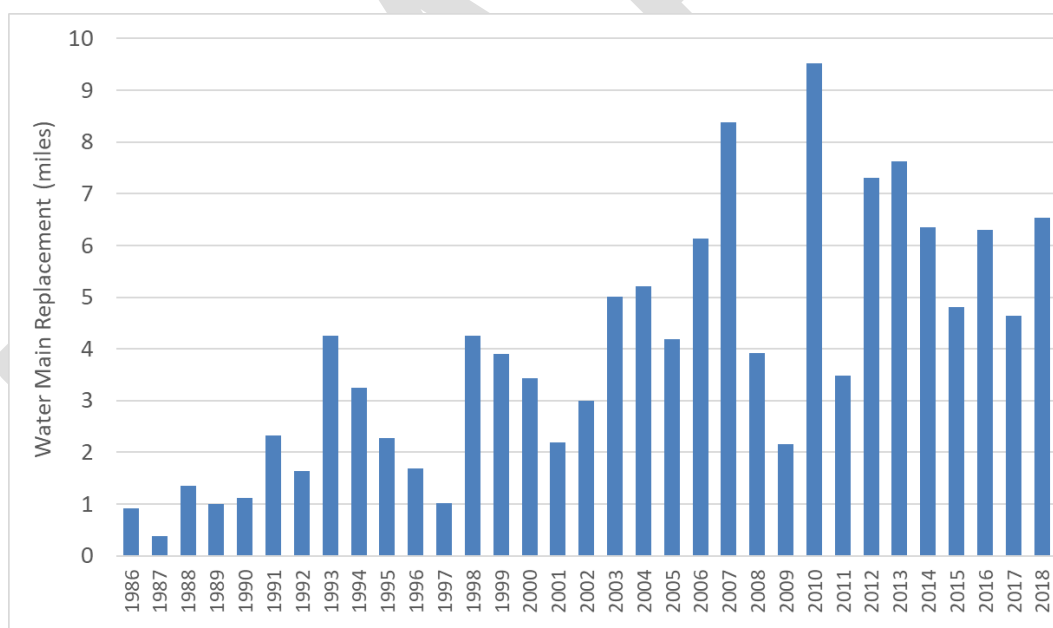
Based on a review of Dearborn's GIS data and the hydraulic model during Phase 1, there is minimal information on pipe condition using variables such as pipe material and pipe age. Based on discussions with Dearborn, approximately 60% of the system is cast iron and approximately 40% is ductile iron with a minimal amount of concrete and HDPE pipe. During Phase 2, additional data was provided by Dearborn to document the extent of mains replacement over the past several decades. A map showing the replaced pipe is included in Appendix 10.1, and a time series chart showing mains replacement over the past 32 years is shown in Figure 2-3.

Figure 2-3 Miles of Water Main Replaced per Year in Dearborn

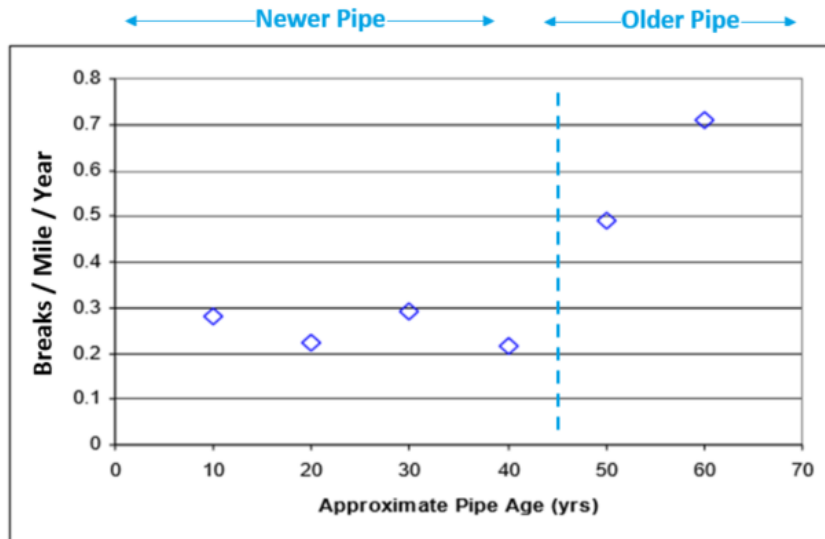
In the 2008 Master Plan prepared for Dearborn by OHM Advisors, an analysis of the frequency of water main breaks by approximate pipe age noted the frequency of breaks increased significantly in pipes 40 years or older, as can be seen in Figure 2-4 (annotation in light blue added by B&V).

Figure 2-4 Variation in Number of Breaks with Pipe Age. Source: 2008 Master Plan (OHM)

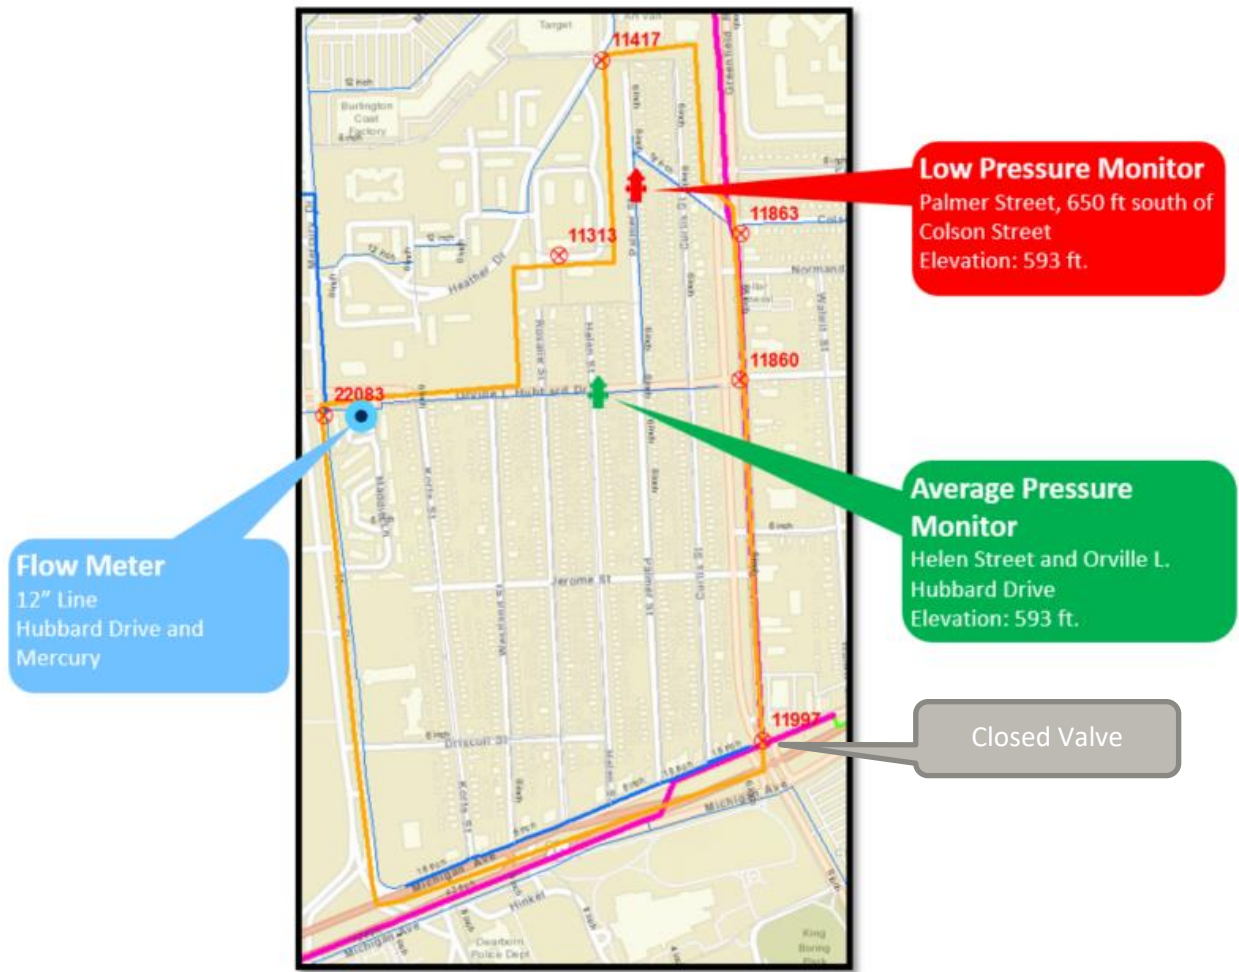
Figure 2-6 Configuration of Dearborn DMA DB1

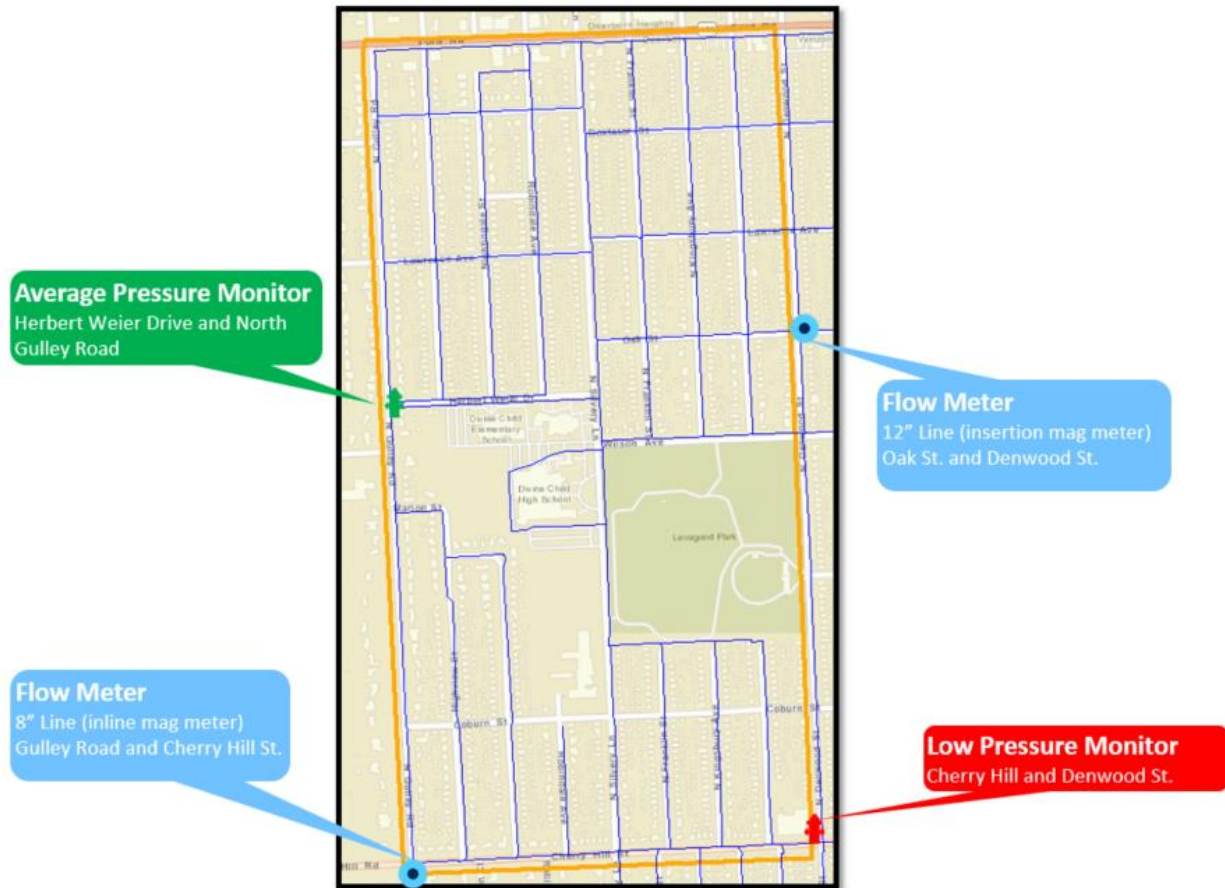
- IMM Flow Meter on 12" line on Oak Street, east of Denwood Street
- Inline 8" mag meter on Gulley Road and Cherry Hill Street
- Average Pressure Location: Herbert Weier Drive and North Gulley Road
- Low Pressure Location: Cherry Hill Street and Denwood Street

Figure 2-7 Configuration of DMA DB2

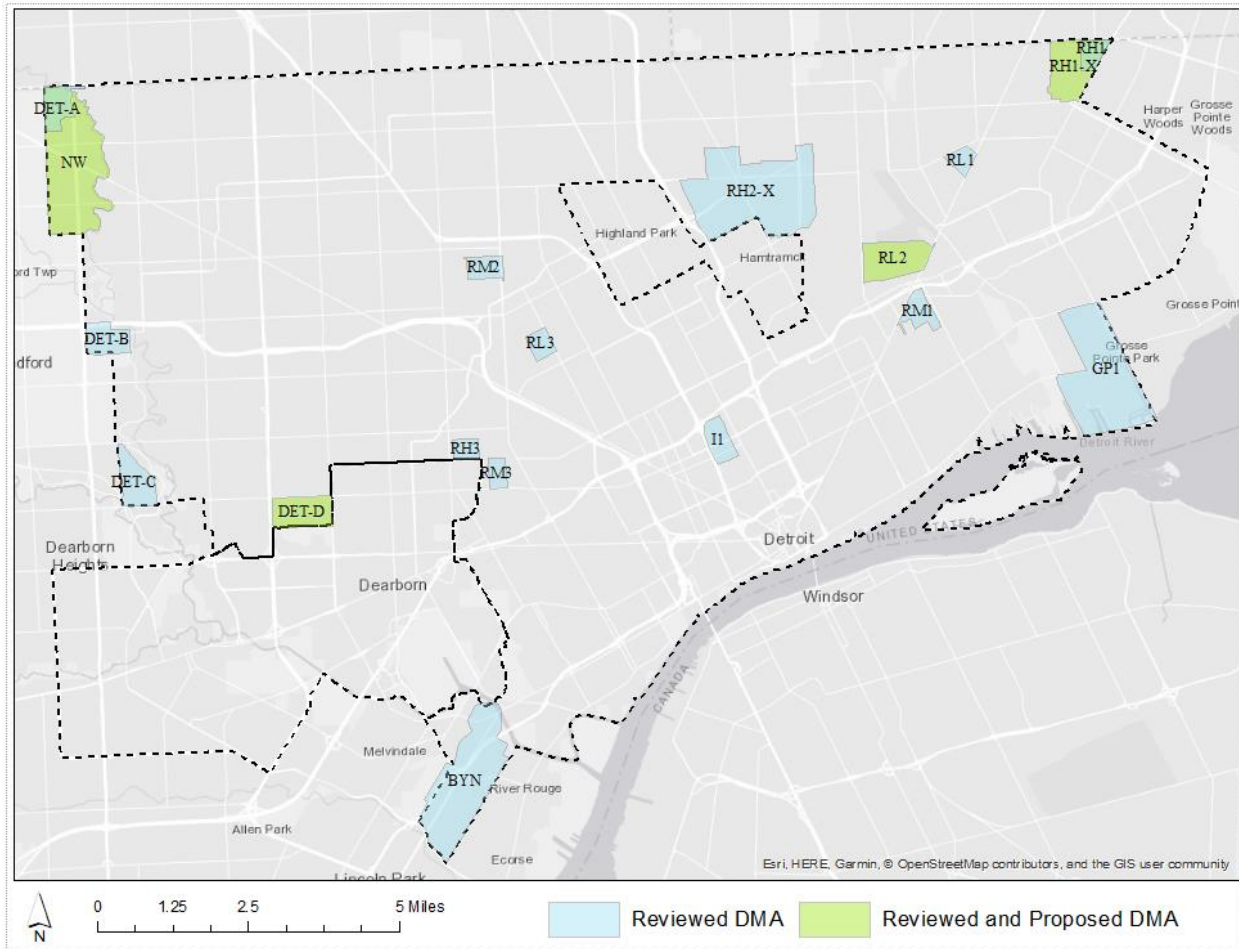
Figure 2-8 Reviewed and Proposed Detroit DMAs

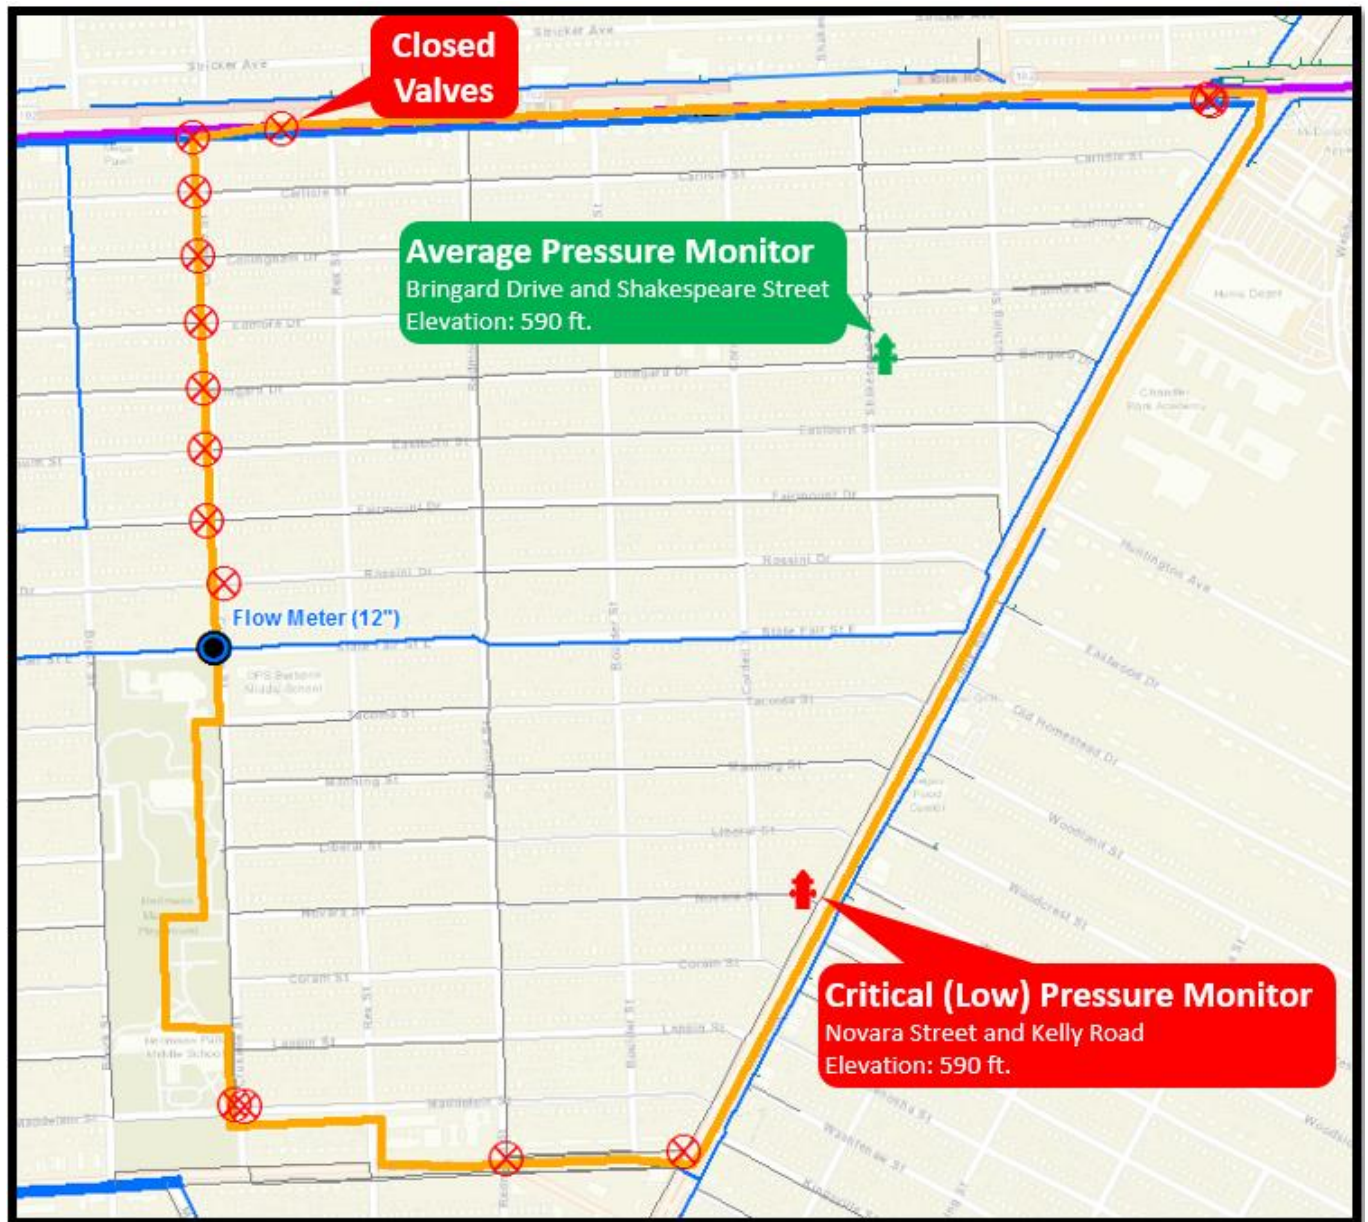
- Flow Meter on 12" line at State Fair and Crusade Street
- Average Pressure Location: Bringard Drive and Shakespeare Street
- Low Pressure Location: Novara Street and Kelly Road.

Figure 2-11 RH1-X DMA Flow Meter and Pressure Monitor Locations

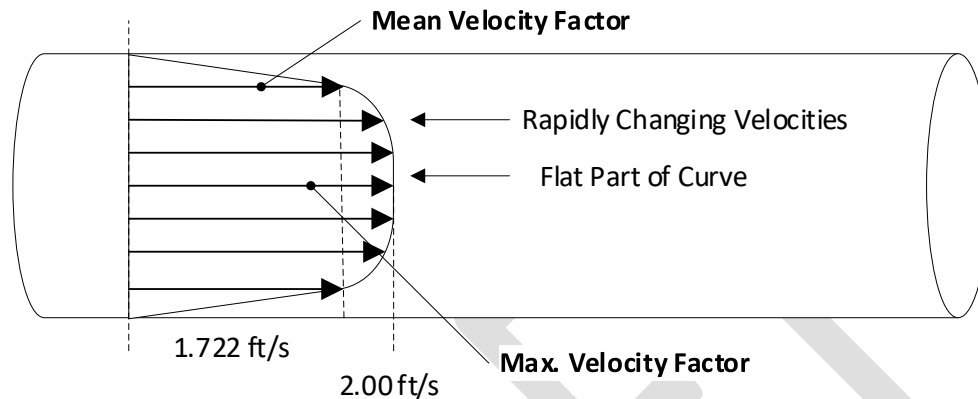
A flow profile for a pipe is determined by taking measurements of flow velocity at multiple intervals within the pipe to build a profile of the flow. Typically, velocity is greater at the center of the pipe and less at the edges of the pipe due to friction. Figure 2-16 shows the ideal conditions of a fully developed turbulent flow profile. Field investigations were performed to find the optimal insertion meter location for each DMA close to the modeled points. In the case of DB1, a clean run of pipe was tapped specifically for the insertion meter installation which also required the addition of an access

Figure 2-16 Turbulent Flow Profile

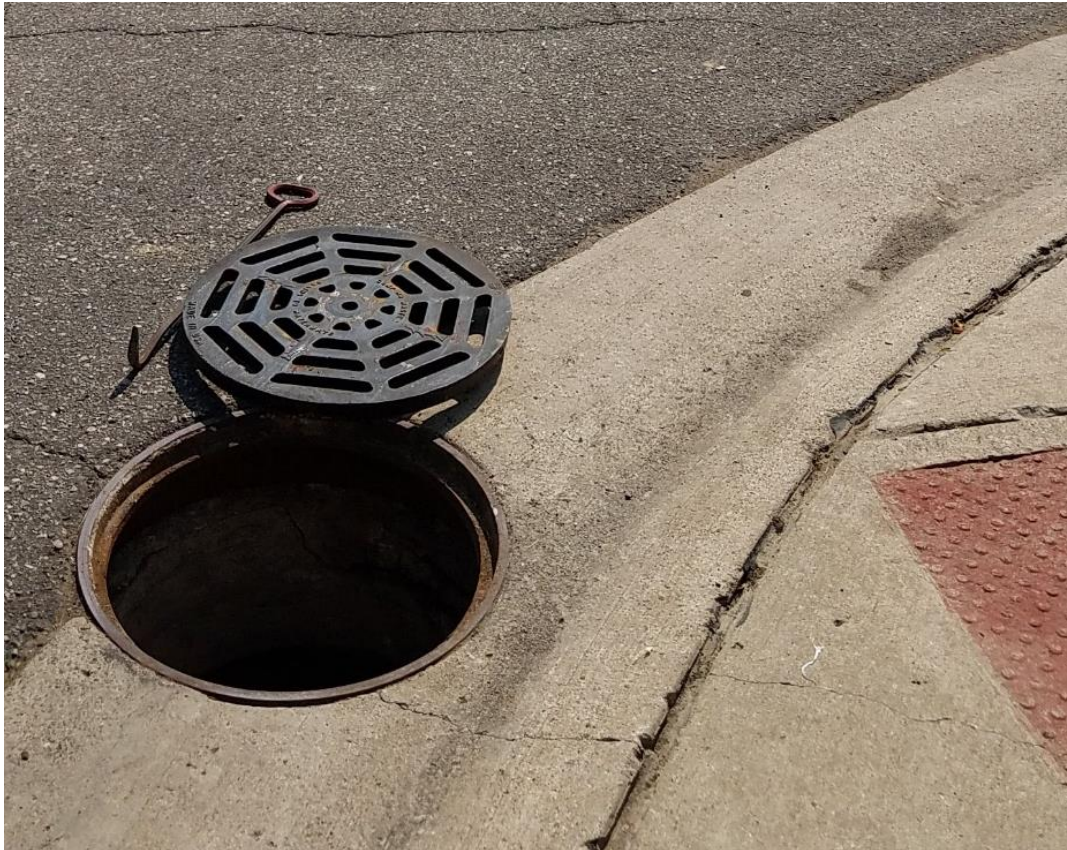
The goal was to automate as much of the data logging and collection as possible; therefore, equipment with cell capability and an existing online visualization platform was chosen for the data capture and review. To benefit from these systems, the wireless signal needs to reach its collector or tower. The existing manhole covers needed to be replaced with the grate-style covers as shown in Figure 2-18. These covers were used throughout the DMAs in Dearborn and Detroit to allow the signals to consistently send to the cell towers from the gate well chambers.

Figure 2-18 Grated Manhole to Enable Cellular Communication of DMA data

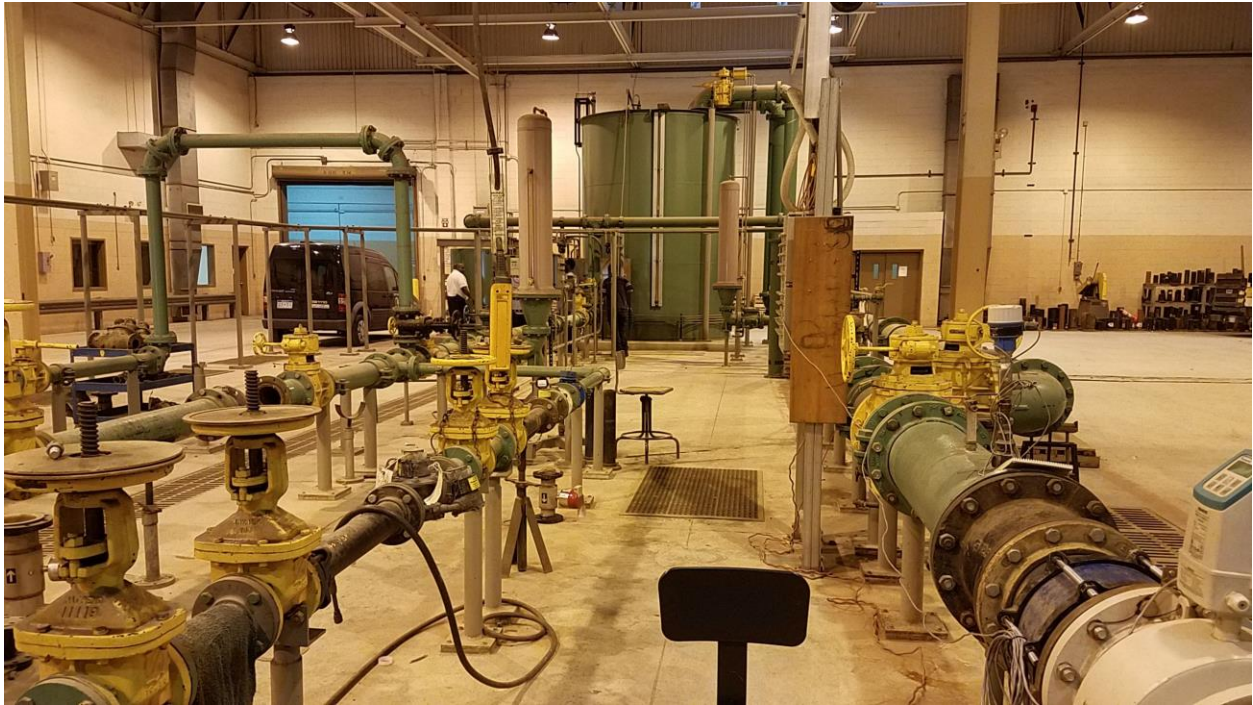
Figure 2-19 GLWA Large Meter Testing Facility

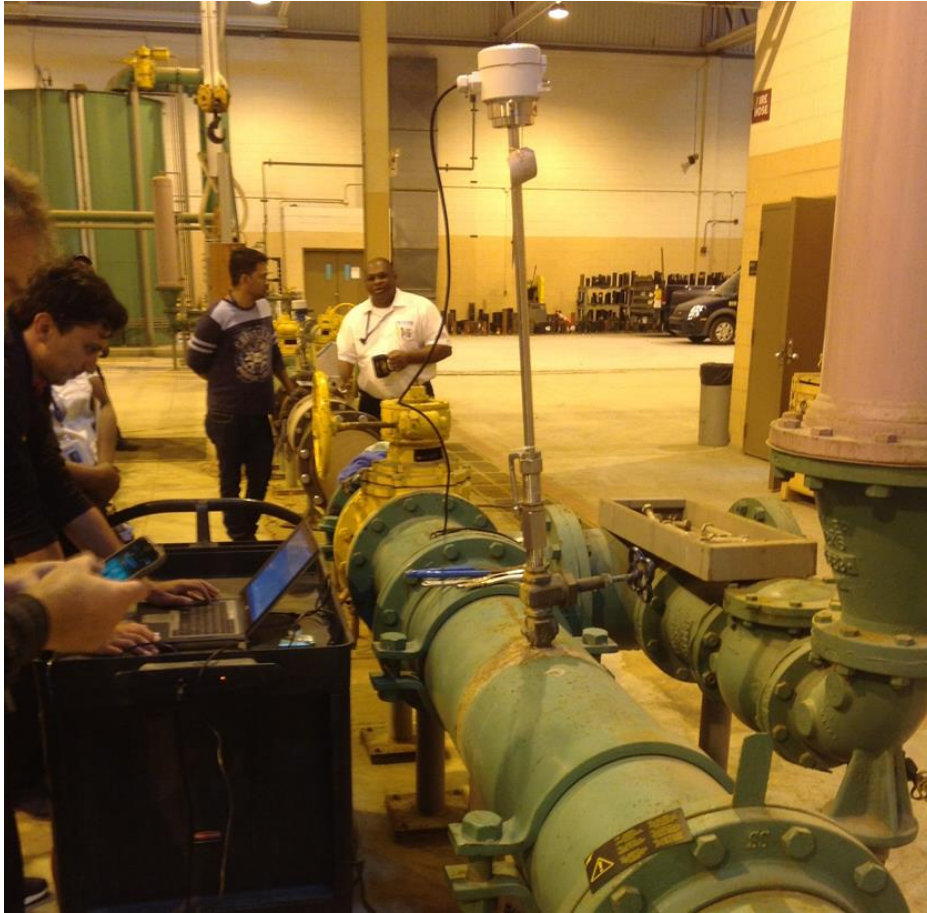
A 1-inch corporation was installed within a segment of pipe to mimic what would be found in the field and all the meters tested in the same configuration as shown in Figure 2-20.

Figure 2-20 Insertion Flow Meter Test Bench Configuration

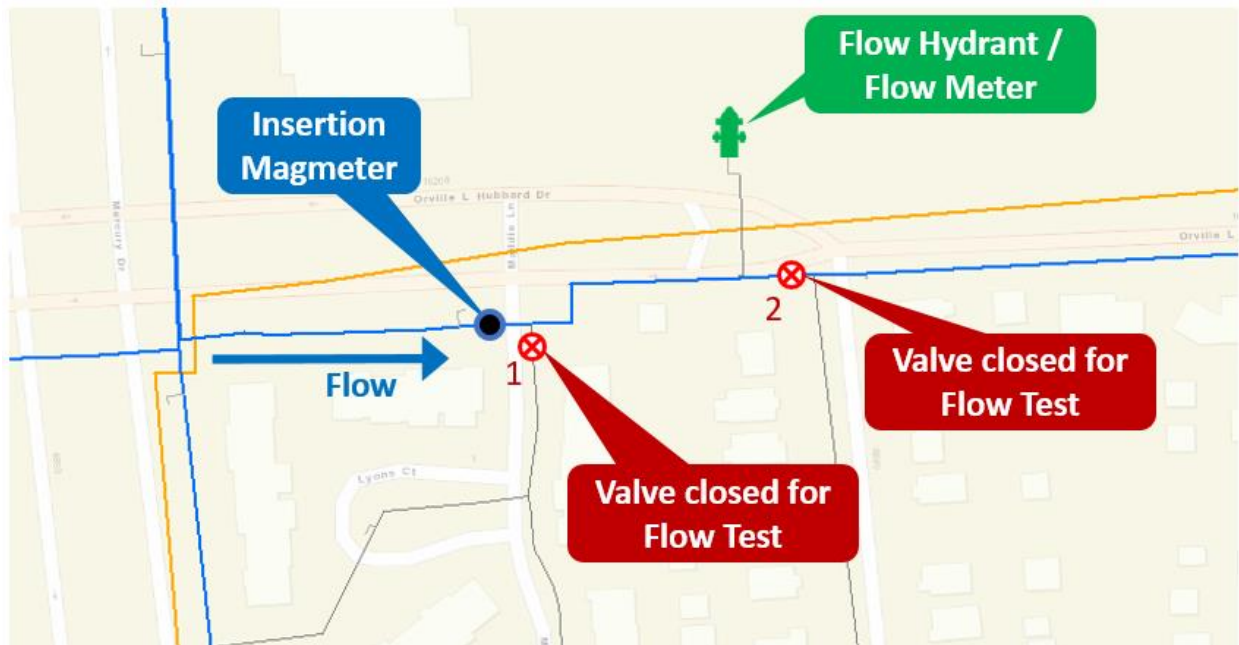
Figure 2-21 Hydrant Test Example Configuration

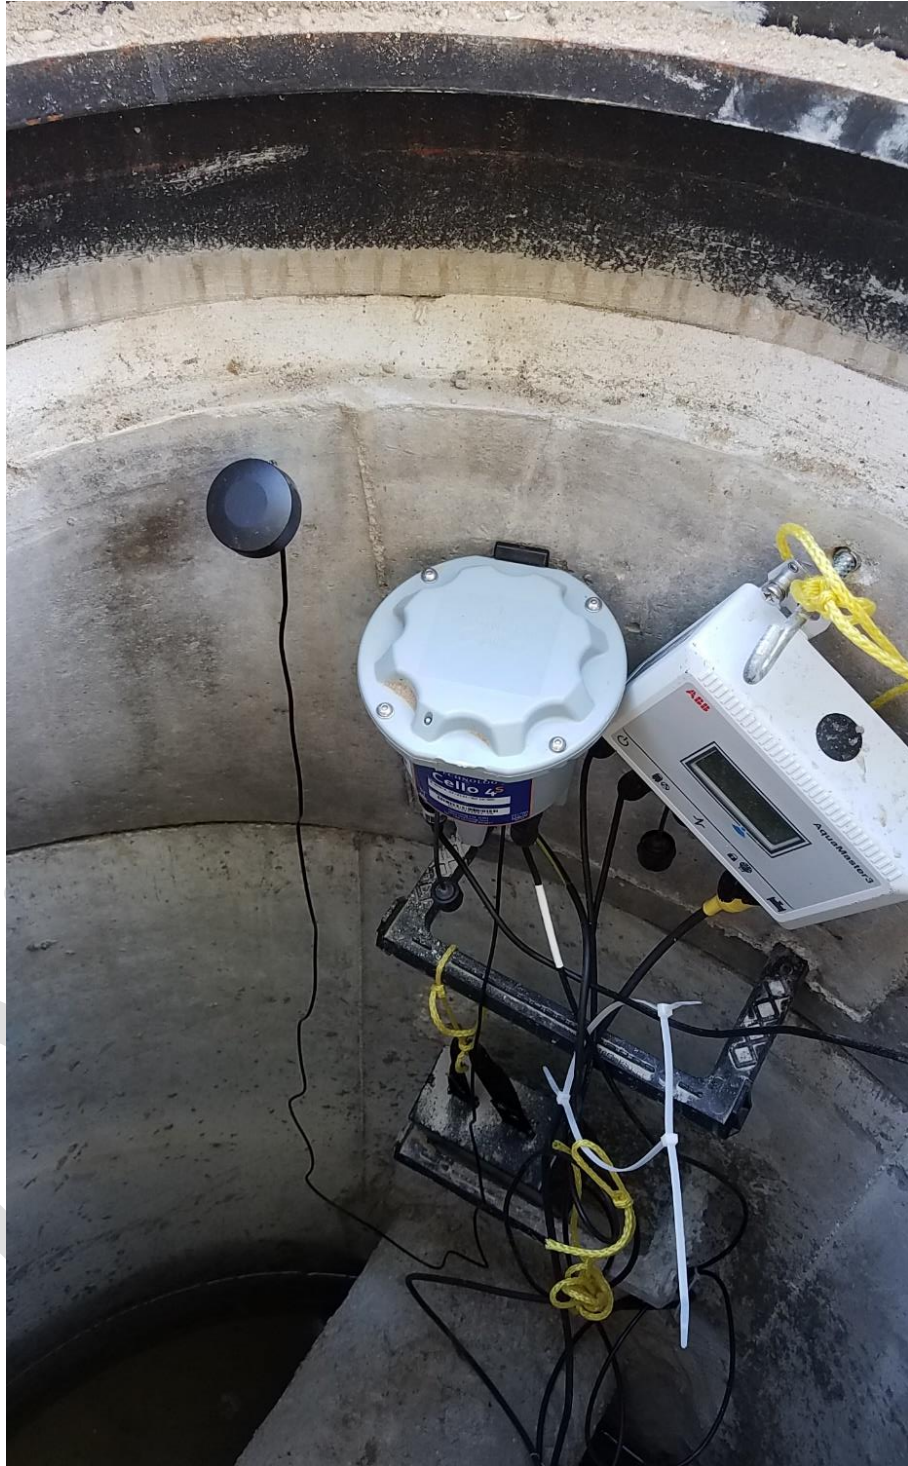
All flow was measured through the insertion of electro-magnetic meters (IMM), except for one input into DB2 which was measured through an in-line mag meter. The internal logging system on the IMM was connected to the automated logging unit which sent the data via a cell-based system to the visualization platform noted previously. The in-line mag meter in DB2 was connected directly to GLWA's WAMR reporting system through their radio network.

Figure 2-23 Example Installation of Flow Logging Infrastructure (from DB1)

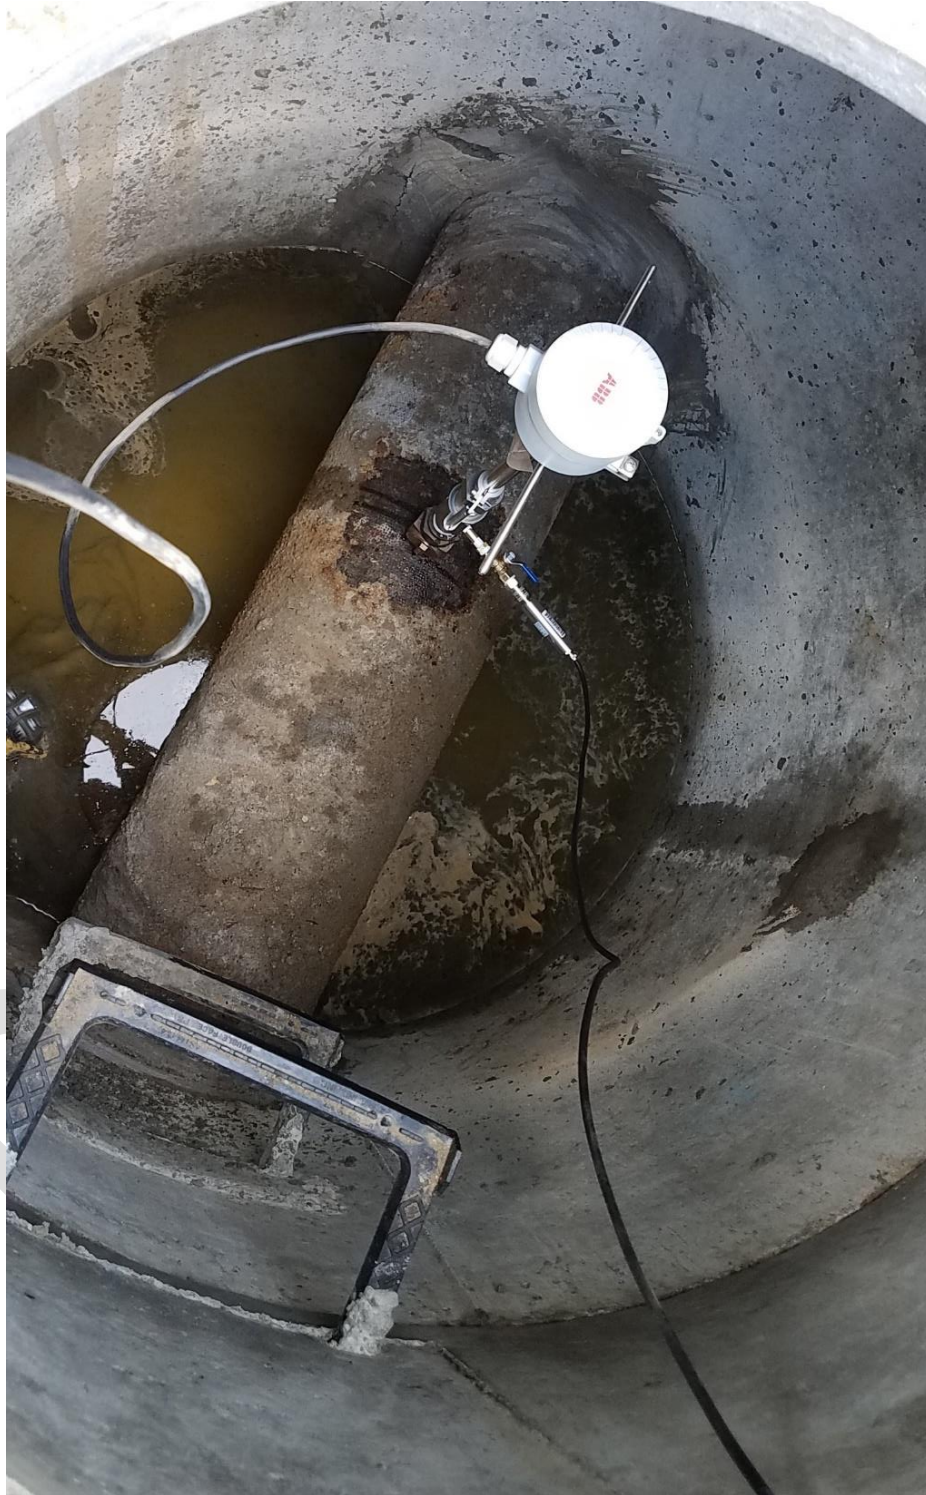
Figure 2-24 Insertion Mag Flow Meter Installation in Dearborn DB1

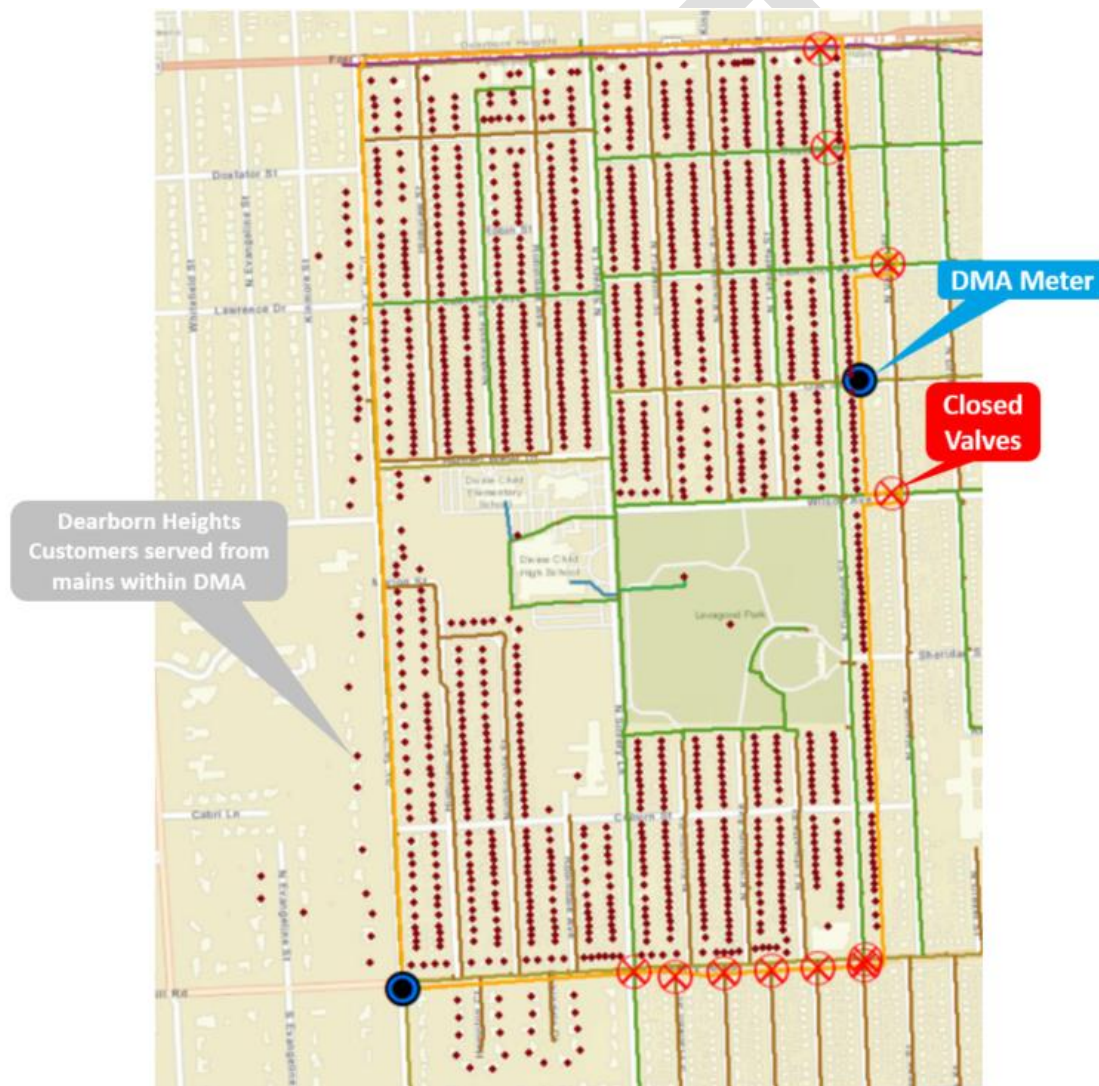
Retail consumption within the DMA for the monitoring period is subtracted from the volume of measured input to the DMA as the key basis of the water balance; other adjustments are made to separate apparent and real water losses. Therefore, it is important to accurately identify those accounts served from the distribution network within each DMA. B&V provided the final DMA boundaries to Dearborn and Detroit who then returned GIS files containing customer and meter information to B&V for further review. In some cases, a customer metering location appeared outside of the DMA boundary. This can happen when a service line extends beyond the DMA spatial boundary but the source of supply to the customer is from within the DMA. In such cases, these metering points were discussed in more detail with Dearborn and Detroit. An example of the types of issues that were reviewed is shown in Figure 2-25.

Figure 2-25 Review of Customer Accounts within a DMA

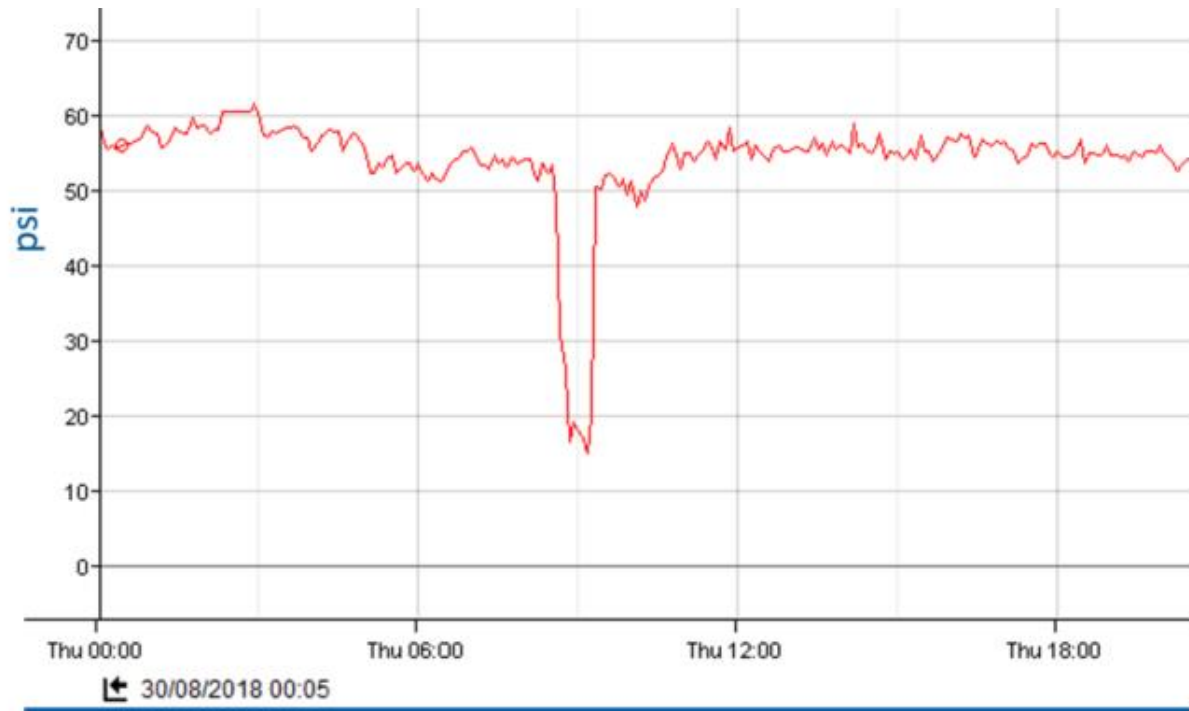
Dearborn's DMA DB1 was the first to be implemented. The meter was installed and a hydrant test performed on 8/3/2018. The hydrant test was performed to provide an in-situ calibration of the IMM. Any discrepancy between the IMM measurement and the hydrant meter measurement could be addressed through an adjustment curve (as described below). Additional pressure monitoring equipment was installed and configured in the DMA. Issues related to the cell signal strength on the communications equipment were addressed by the use of external antennae (still within the gate well structure) and the use of grated manhole covers – this allowed near real-time data to be viewed remotely through Technolog's online monitoring platform known as WaterCore. Alarms were configured on the pressure monitoring equipment and protocols for action in the event of a low-pressure alarm being triggered were put into place and tested. Retail meter reads were also initiated each business day starting 8/20/2018. The DMA was isolated and a pressure drop test performed on 8/30/2018 to confirm isolation (see Figure 2-26); monitoring began immediately after the successful pressure drop test. Pressures were dropped to approximately 15psi. Pressures in the DMA were highly sensitive to a 1/8 turn of the 12" supply valve to the DMA providing confidence that this was the only feed to the DMA.

Figure 2-26 Pressure Drop Test in DB1 Confirming DMA Isolation

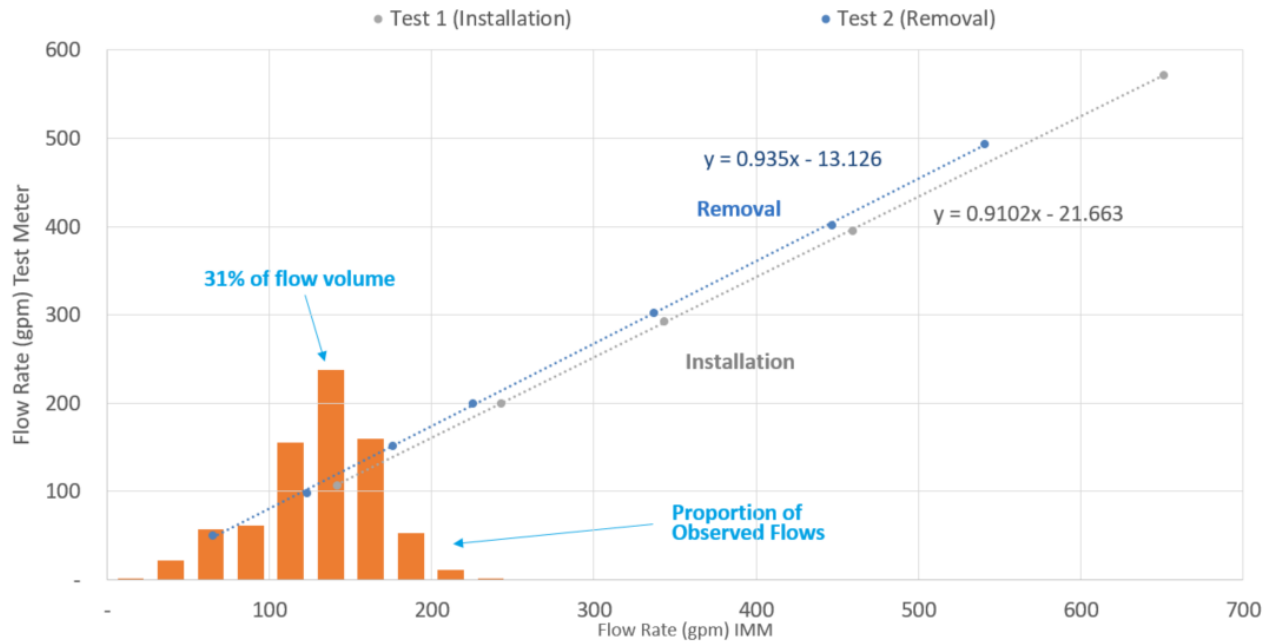
The results of the two hydrant tests are shown in Figure 2-28. Test 2 (removal test) captured more data points within the observed range of flows. For this reason, and because it appeared the meter may have moved slightly since installation, it was determined that the results of this second test would be used to adjust the flow meter data. The project team also agreed that it would be prudent to conduct a second DMA evaluation period using a second meter for an additional 14 days.

Figure 2-28 DB1 Meter 1 Hydrant Test Comparison

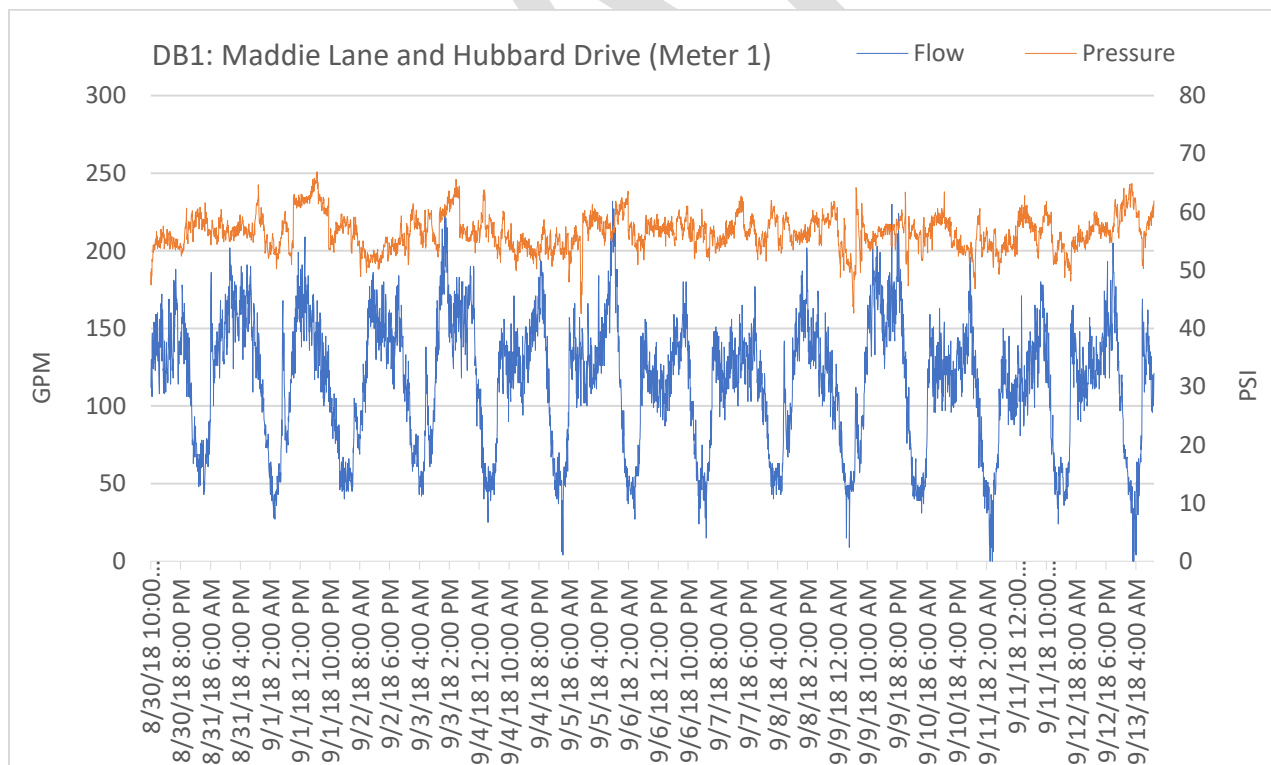
Figure 2-29 Flow and Pressure at DB1 Input Location (Meter 1)

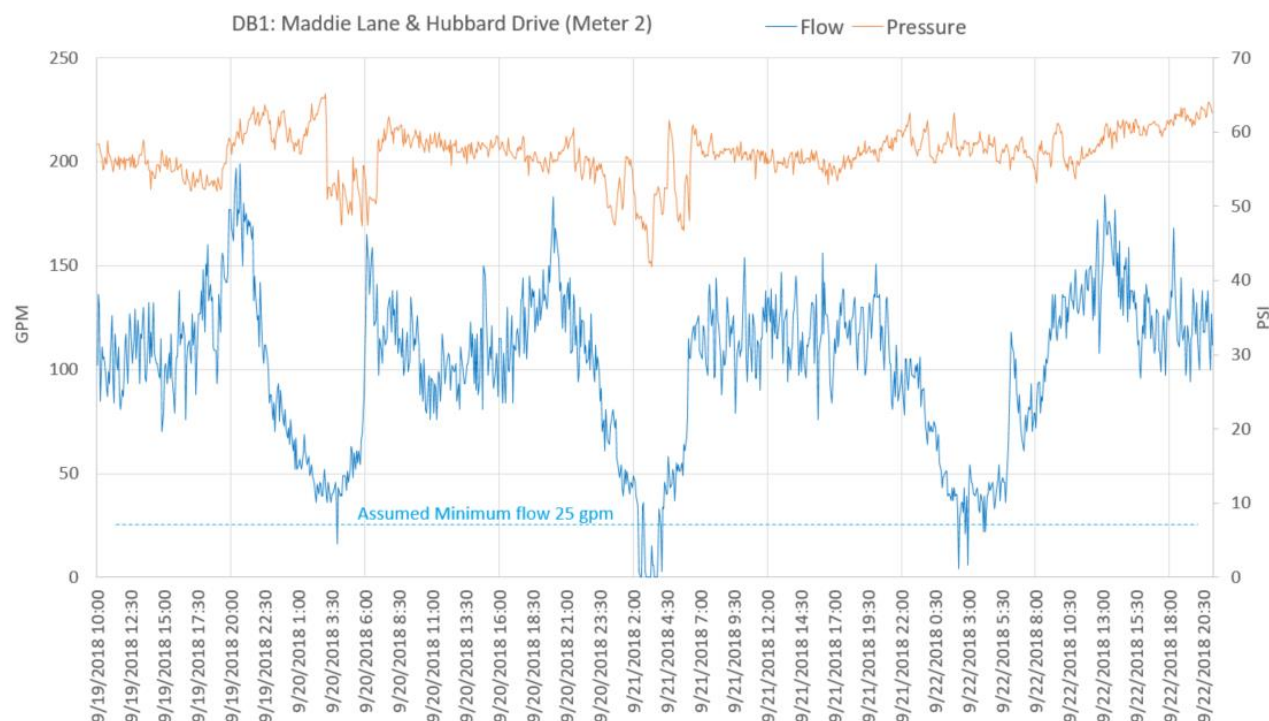
A replacement meter (Meter 2) was installed in the same location in DB1 on 9/18/2018. The internal diameter of the pipe was measured and the meter was calibrated in-situ using parameters recommended by M.E. Simpson. A new hydrant test was conducted and the resultant calibration curve indicated that the meter matched the flows at the hydrant more closely than the first meter.

Figure 2-30 Low Flow Adjustment for DB1 Meter 2

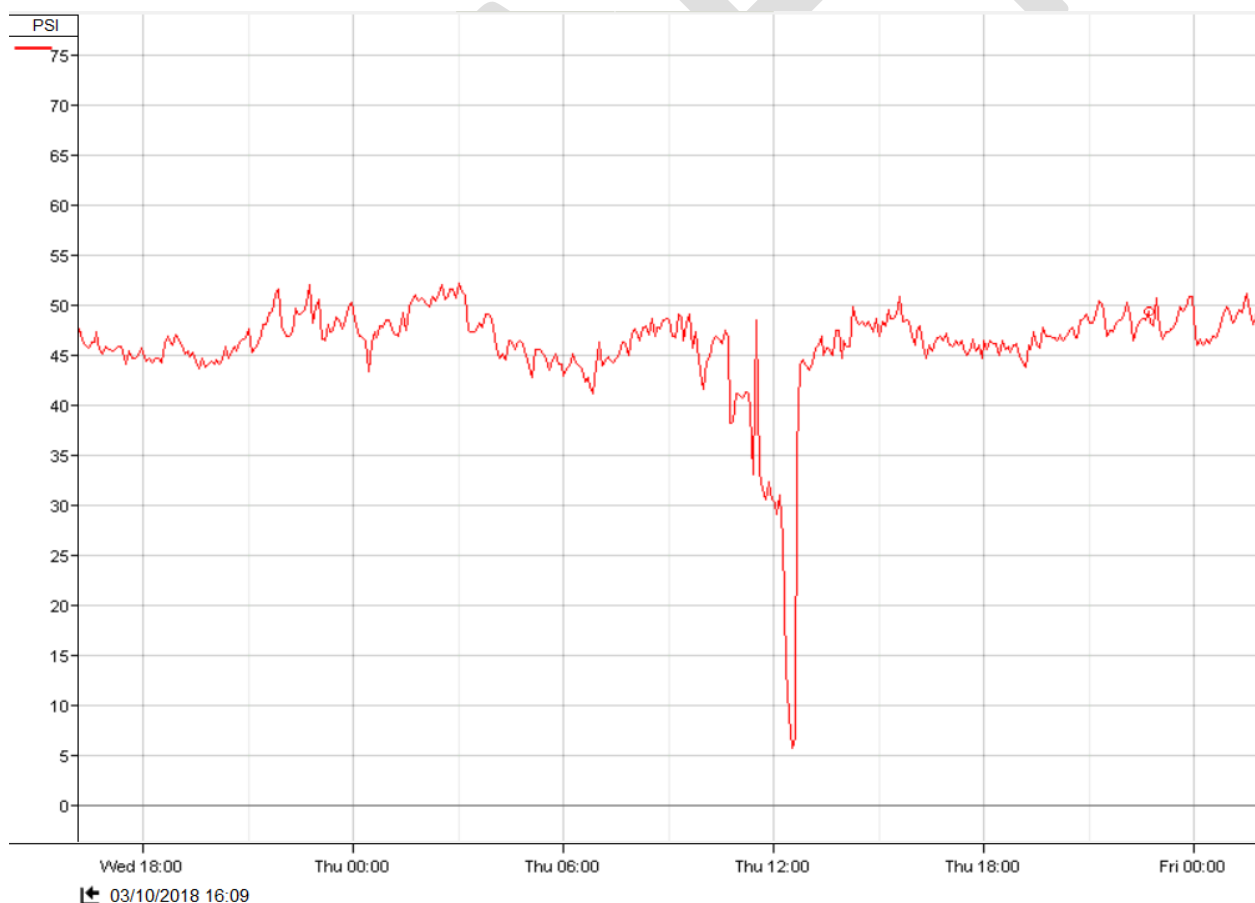
This DMA is situated in the northwestern corner of Dearborn bordering Dearborn Heights. Based on fire flow requirements, two meters were installed for this DMA which is in an area of lower pressure within the Dearborn system. The insertion meter was installed on Oak Street east of Denwood and a hydrant test performed on 9/21/2018. An 8" inline insertion mag meter was borrowed from GLWA and installed on Gully Road and Cherry Hill. A temporary SCADA cabinet was set up for the inline mag meter and communications were established to the WAMR system to monitor this meter. Alarms were configured on the pressure monitoring equipment and protocols for action in the event of a low-pressure alarm being triggered were put into place and tested. Retail meter reads were also initiated each business day starting 9/24/2018. The DMA was isolated and a pressure drop test performed on 10/3/2018 to confirm isolation. Flow was turned off to the inline mag meter and flow was controlled by the valve at the IMM location. Some difficulties were encountered before achieving isolation in DB2; several valves had to be exercised and hydrants were opened and closed as part of the effort to clear the valve seats. Following this activity, the boundary valves seated correctly and no flow could be heard passing. Pressure dropped significantly within the DMA (see Figure 2-31) and was restored by opening the gate valve at the IMM location. Monitoring began immediately after the successful pressure drop test.

Figure 2-31 Pressure Drop Test to Confirm Isolation in DB2
