**UNITS OF SERVICE FOR NON-
MASTER METERED CUSTOMERS
OF GREAT LAKES WATER
AUTHORITY AND SYSTEM WATER
AUDIT:
PHASE TWO REPORT**

GLWA PROJECT CS-039

Great Lakes Water Authority

29 NOVEMBER 2018

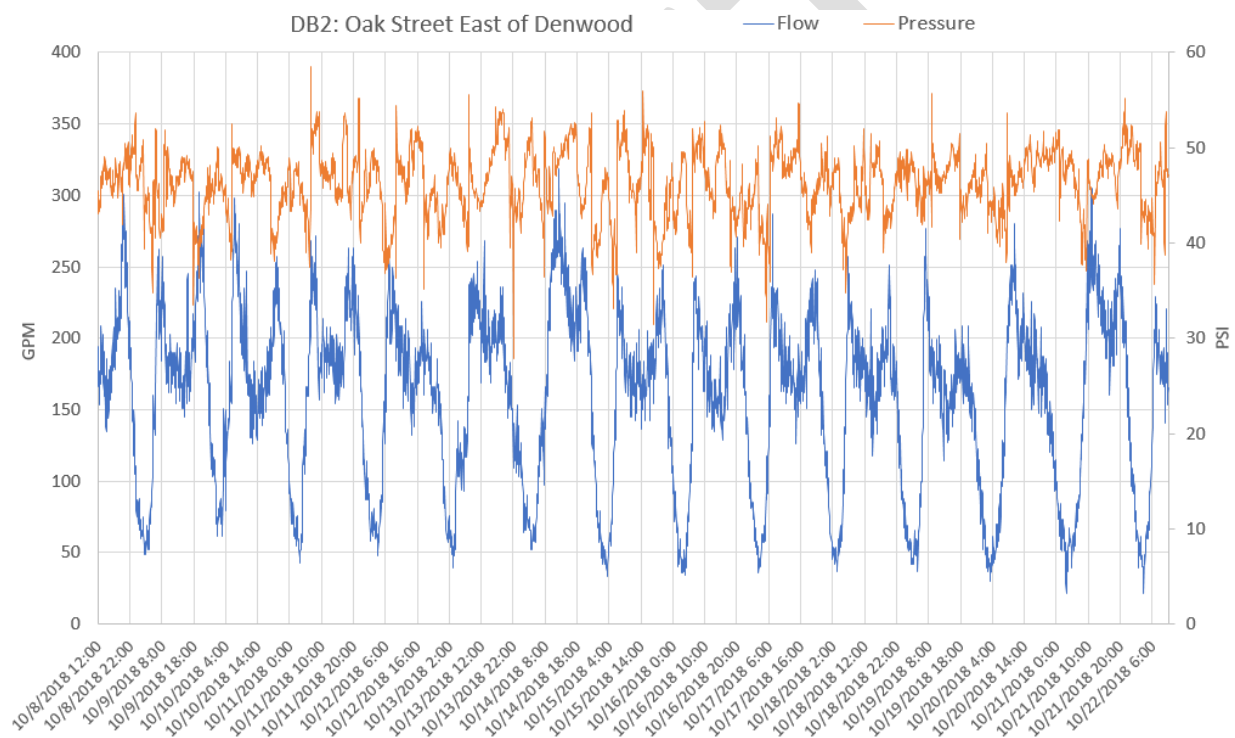
Figure 2-32 Flow and Pressure during DMA Monitoring in DB2

From Figure 2-32 it can be noted that night time flows in the DMA reduced noticeably in the middle of the monitoring period (10/15/2018). Lower consumption was also noted in the retail reads coinciding this with timeframe (Figure 2-33). This reduction in both input and consumption follows a weekend and one possible explanation is the turning off of automated sprinkler systems in the DMA.

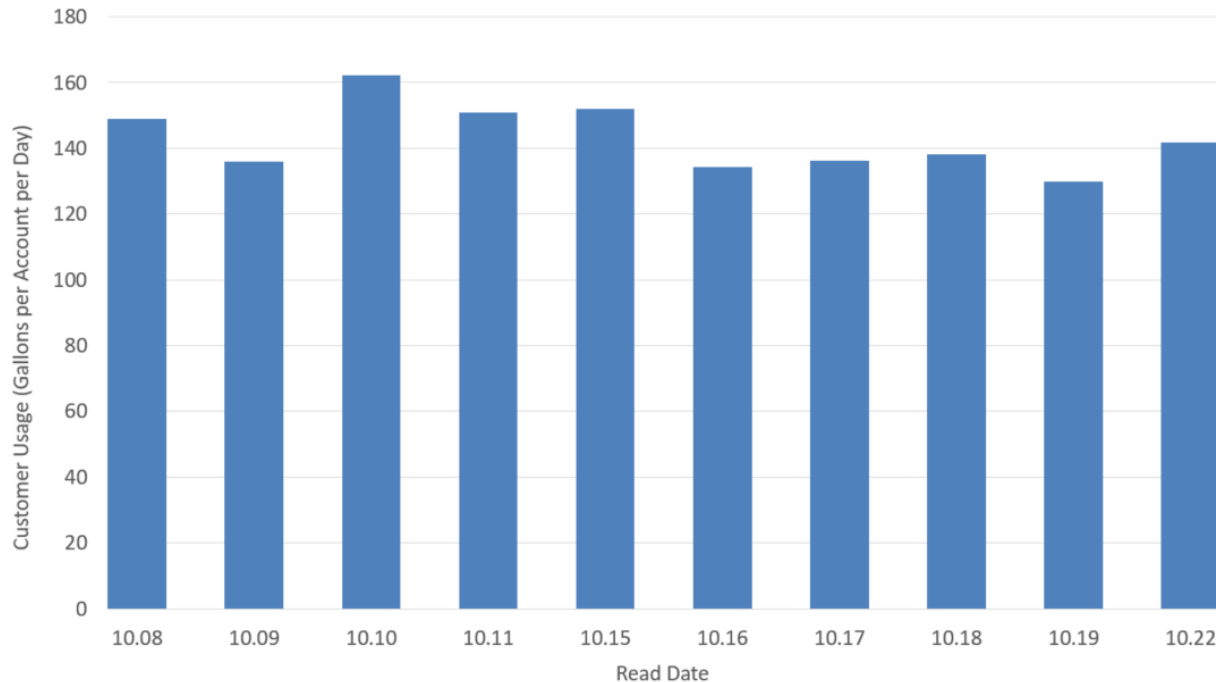
Figure 2-33 Retail Consumption in DB2 during DMA Monitoring

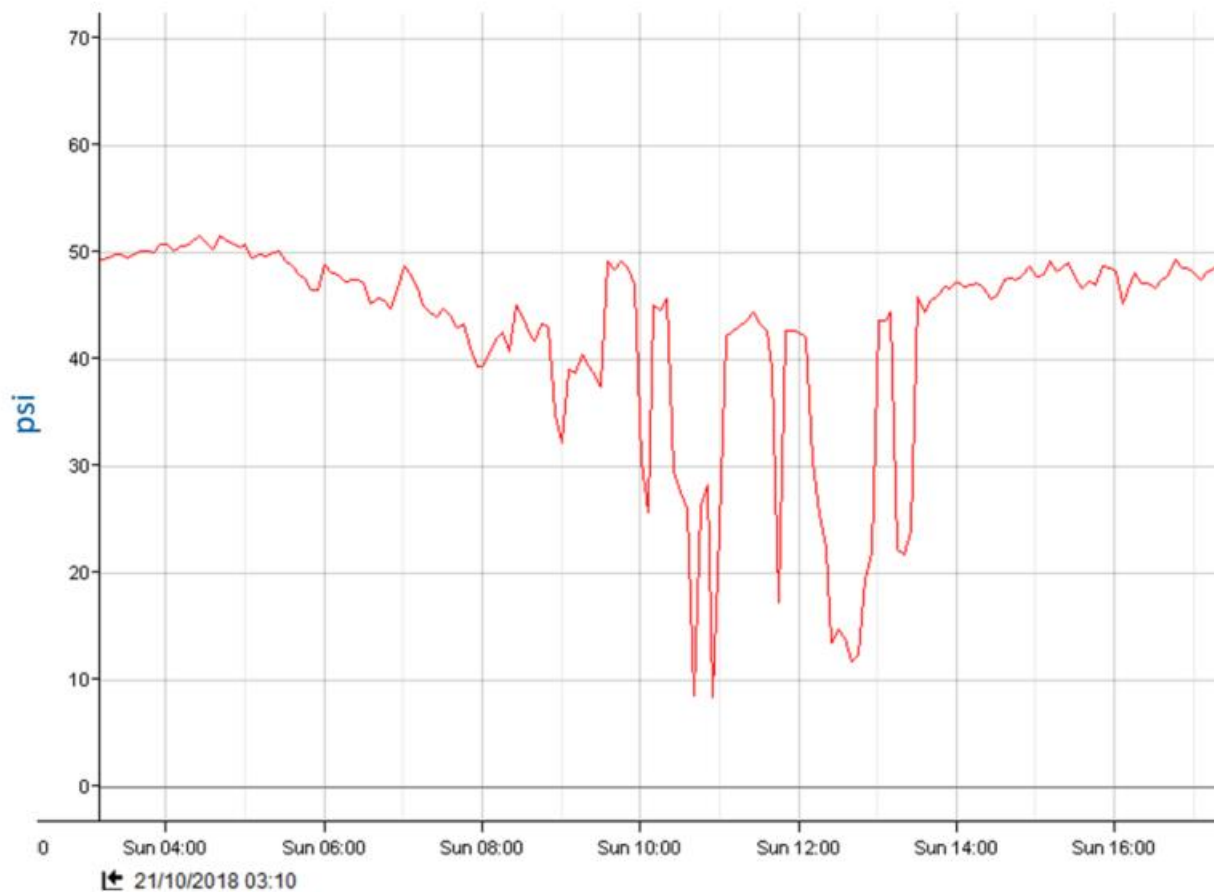
DMA isolation was attempted during the week of 10/15/2018, however isolation was not achieved. B&V reviewed the section maps and identified an additional valve required for closure. In addition, 17 accounts previously considered to be a part of the DMA were identified for exclusion from the retail analysis as they are served from the 16” line along Telegraph Rd. on the east of the DMA, however this line is not part of the DMA. Once the additional valve was closed isolation was achieved on 10/21/2018. The valve at DET-D NW was closed completely for the isolation test and the valve at DET-D SE was throttled to control the feed to the DMA and reduce the pressure for the test (Figure 2-35).

Figure 2-35 Pressure Drop Test at DET-D to confirm DMA Isolation

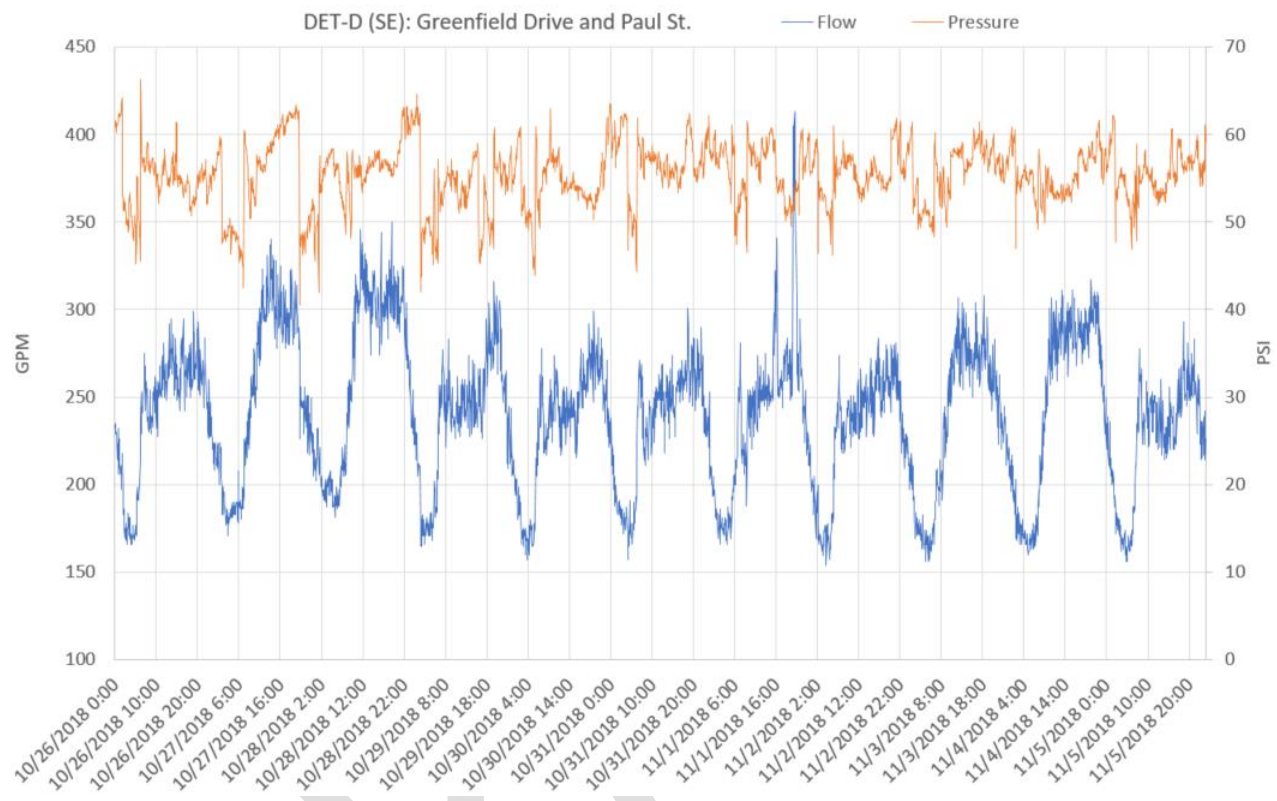
Figure 2-37 Flow and Pressure During DMA Monitoring in DET-D

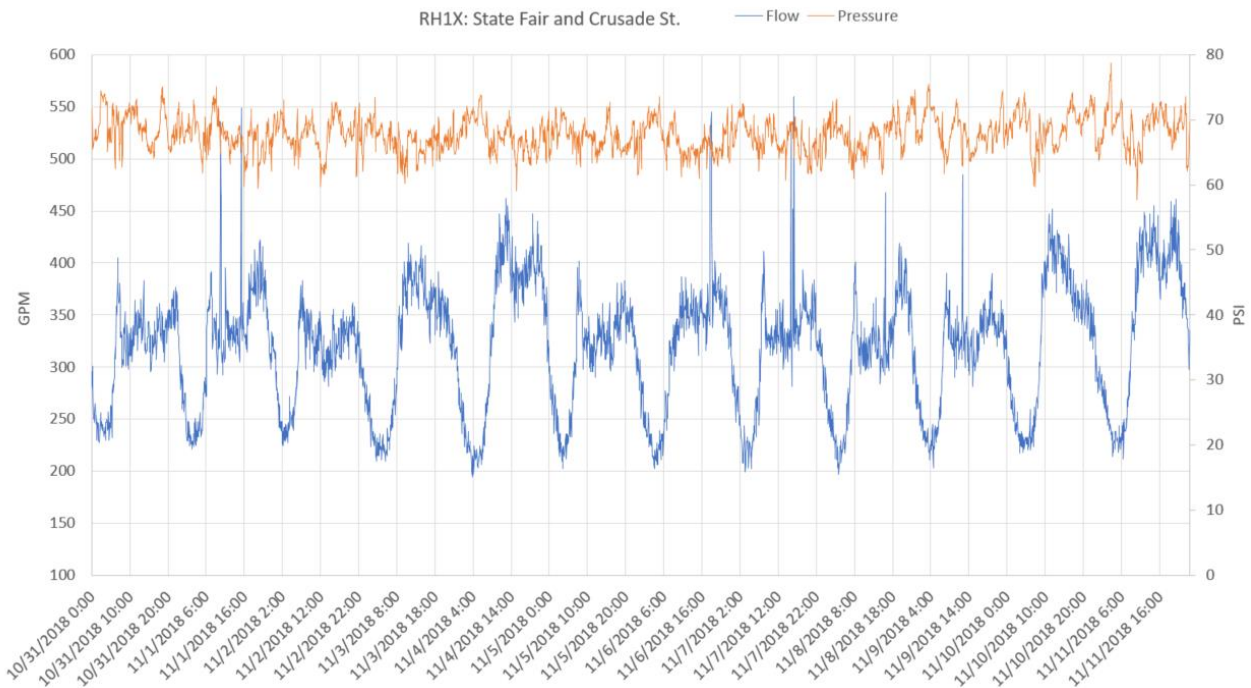
Figure 2-40 Flow and Pressure During DMA Monitoring in RH1-X

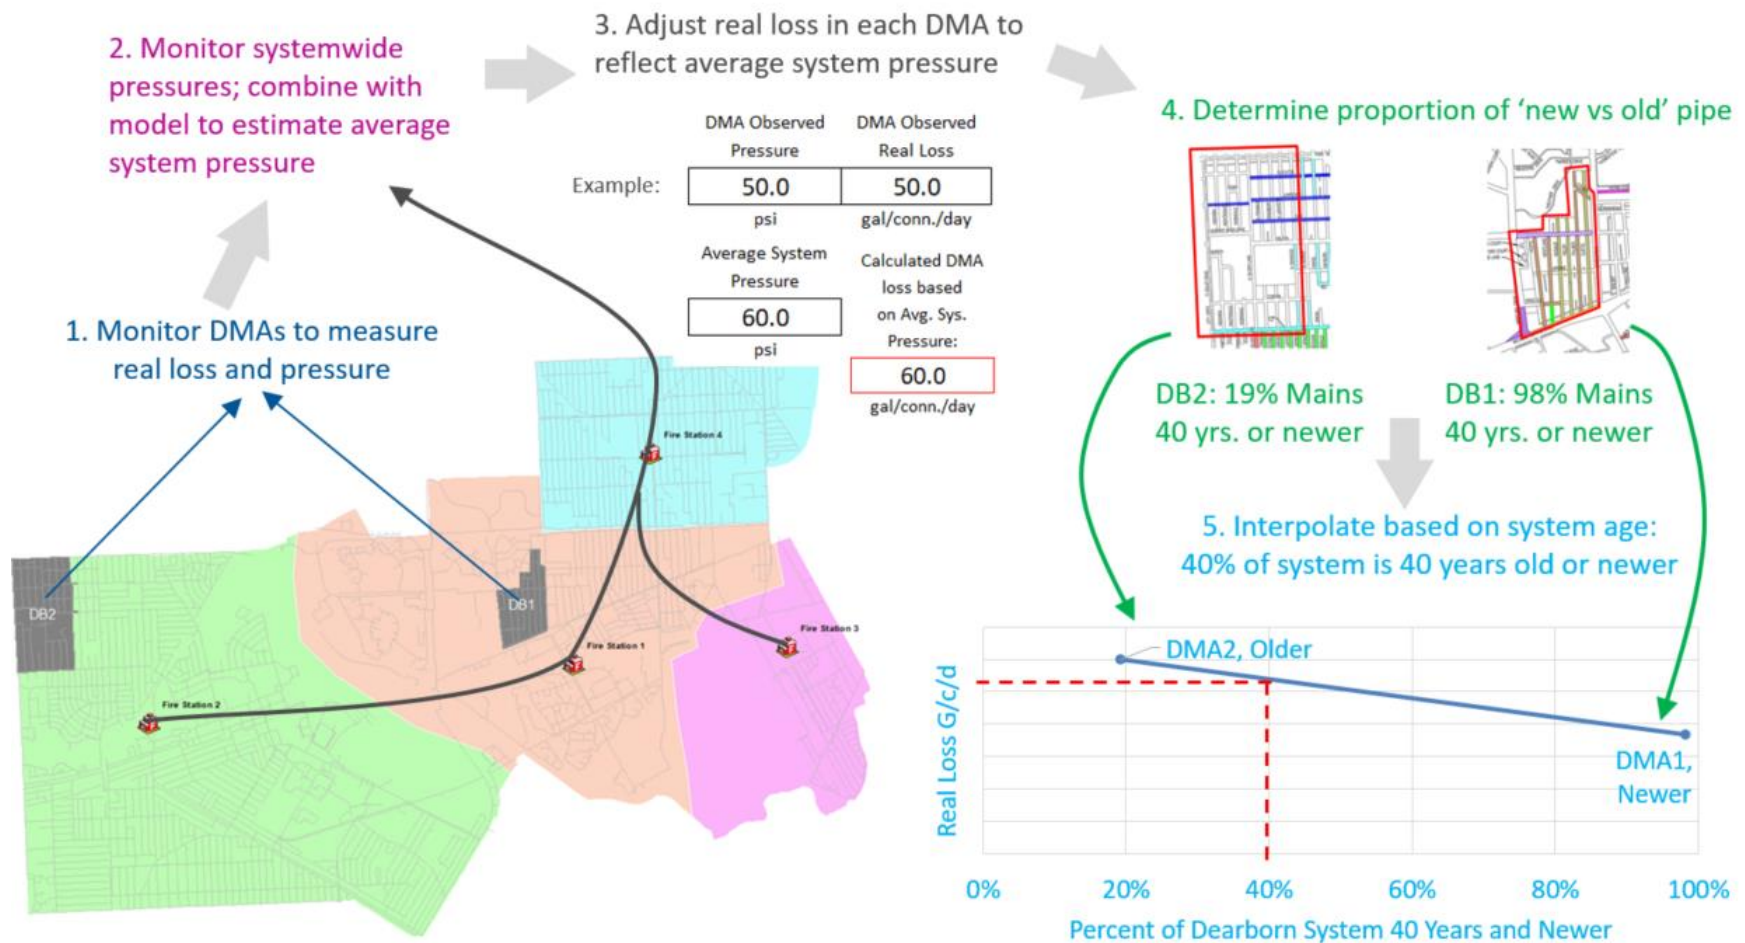
Figure 2-41 Dearborn Extrapolation Schematic

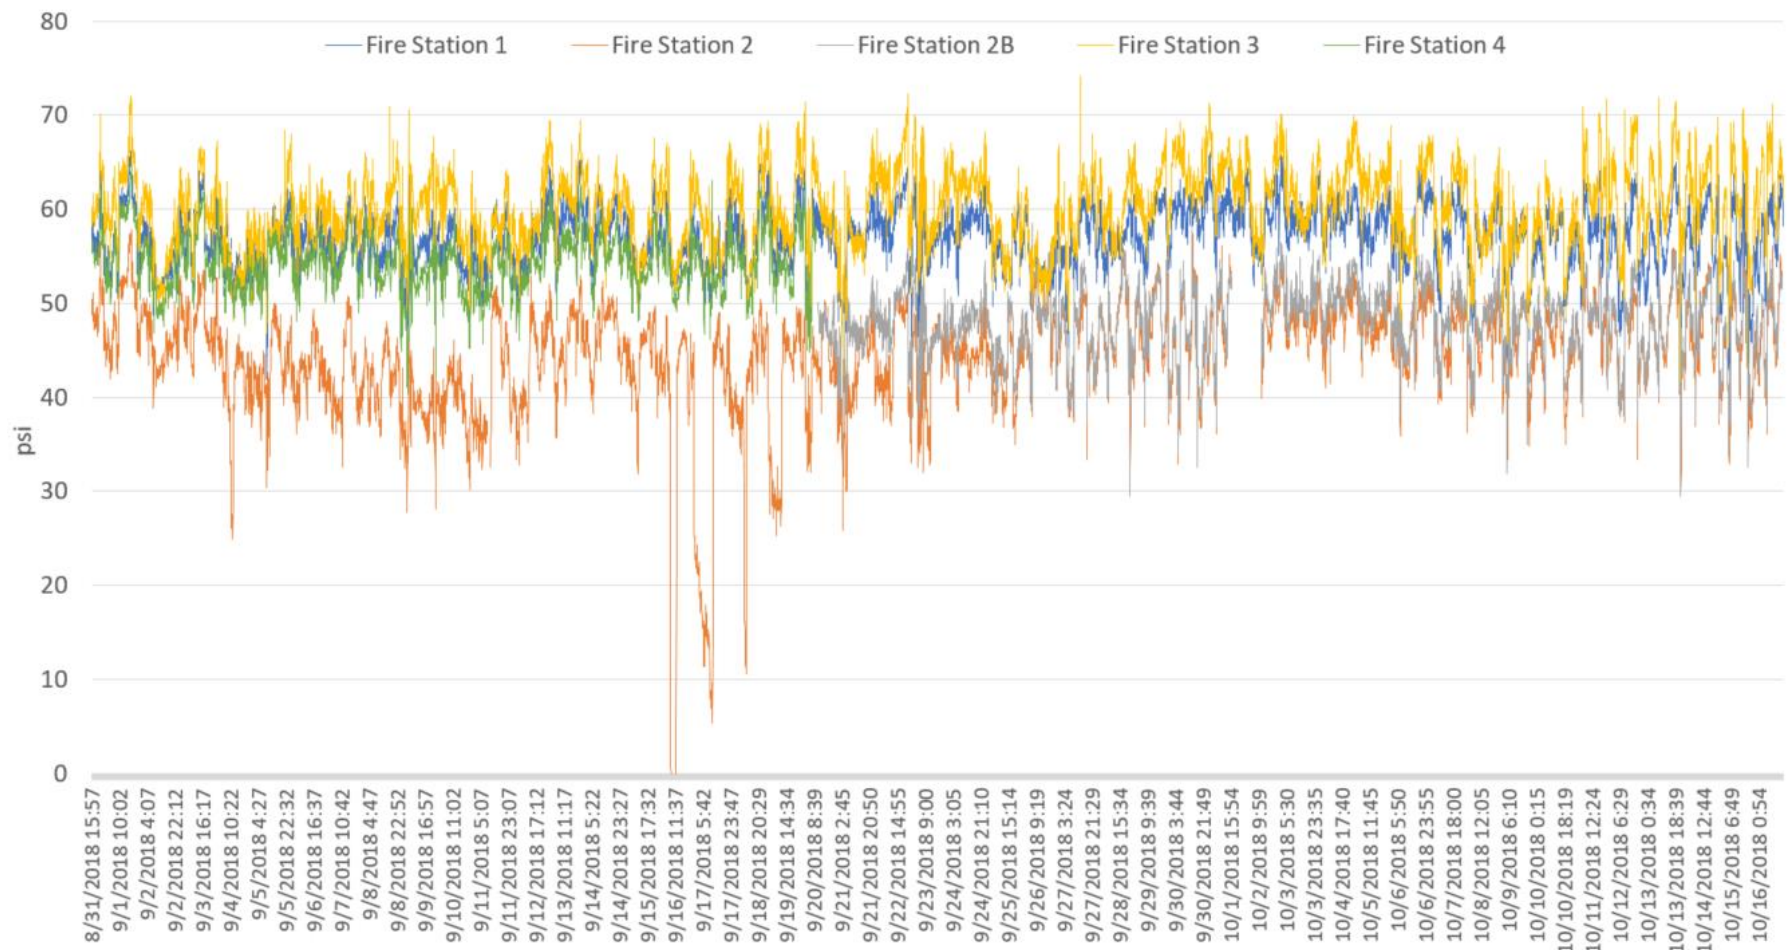
The results of the pressure monitoring are shown in Figure 2-42. The data were collected and shared with the project team by Benesch, consultant to the City of Dearborn. An issue was identified with the monitor at Fire Station 2. The monitor was replaced and new data collected as shown in Figure 2-42 as data series Fire Station 2B. Fire Station 2 data was not used in the pressure analysis.

Figure 2-42 Pressure Monitoring Results at Fire Stations in Dearborn

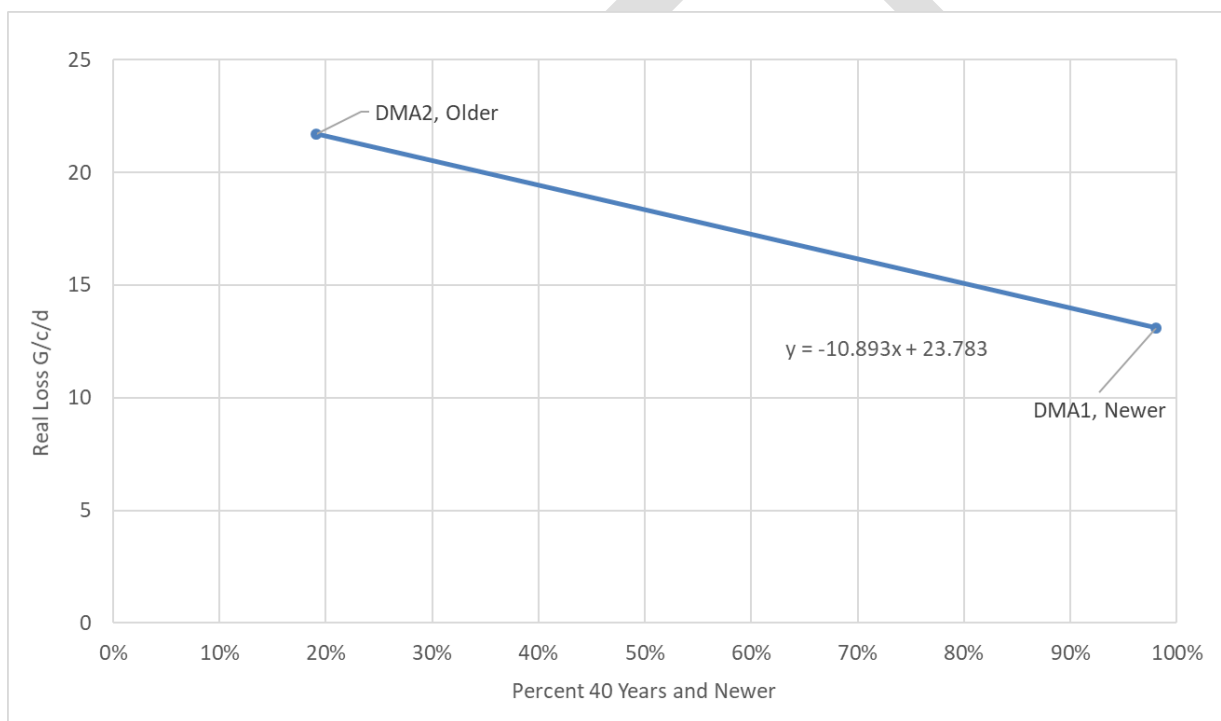
The interpolation step to arrive at a system-wide estimate of real loss is shown Figure 2-43. As 40% of Dearborn's pipe network is approximately 40 years or newer, the estimated system-wide real loss is 19.4 gallons per connection per day.

Figure 2-43 Interpolating Dearborn DMA results for System-wide Estimate of Real Loss

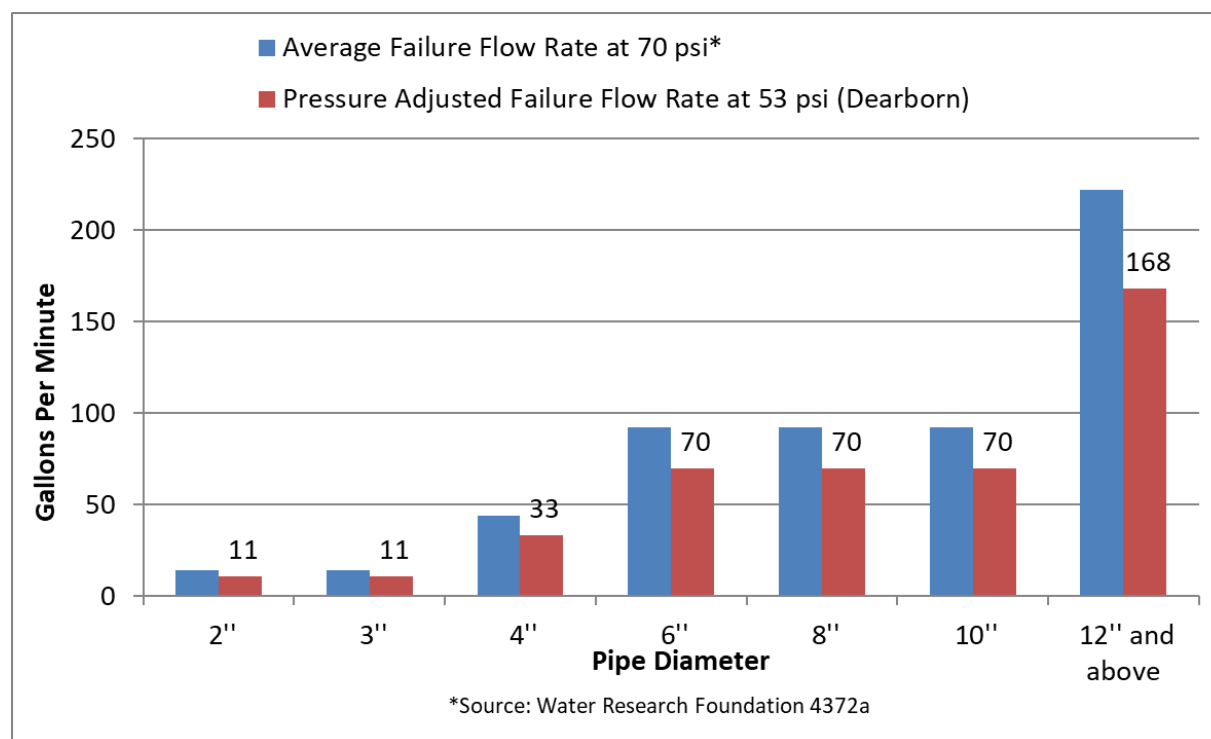
and a review of mains break by diameter for Dearborn which indicated 1% of breaks on 4" and smaller, 89% on 6-10", and 10% on 12" and above. The WRF data are adjusted for average system pressure in Dearborn as shown in Figure 2-44.

Figure 2-44 Pipe Failure Flow Rates: WRF and Dearborn

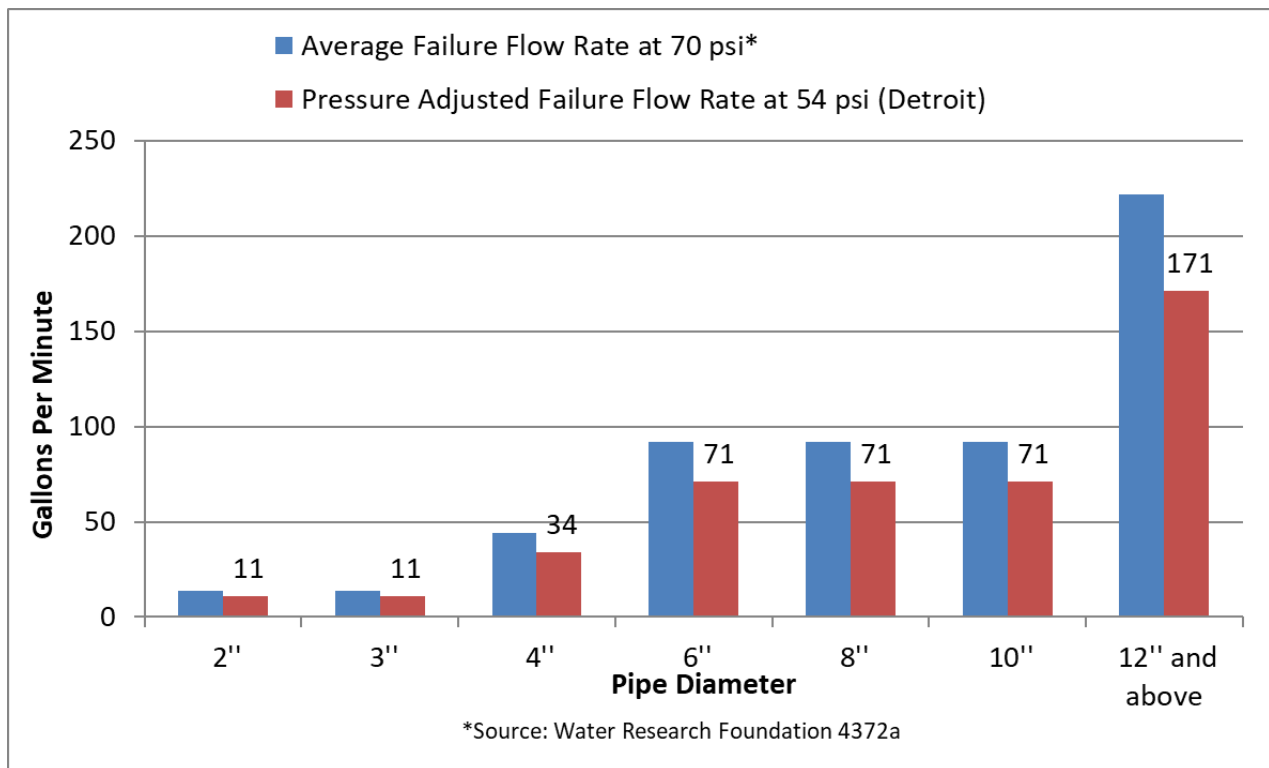
Figure 2-46 Pipe Failure Flow Rates: WRF and Detroit

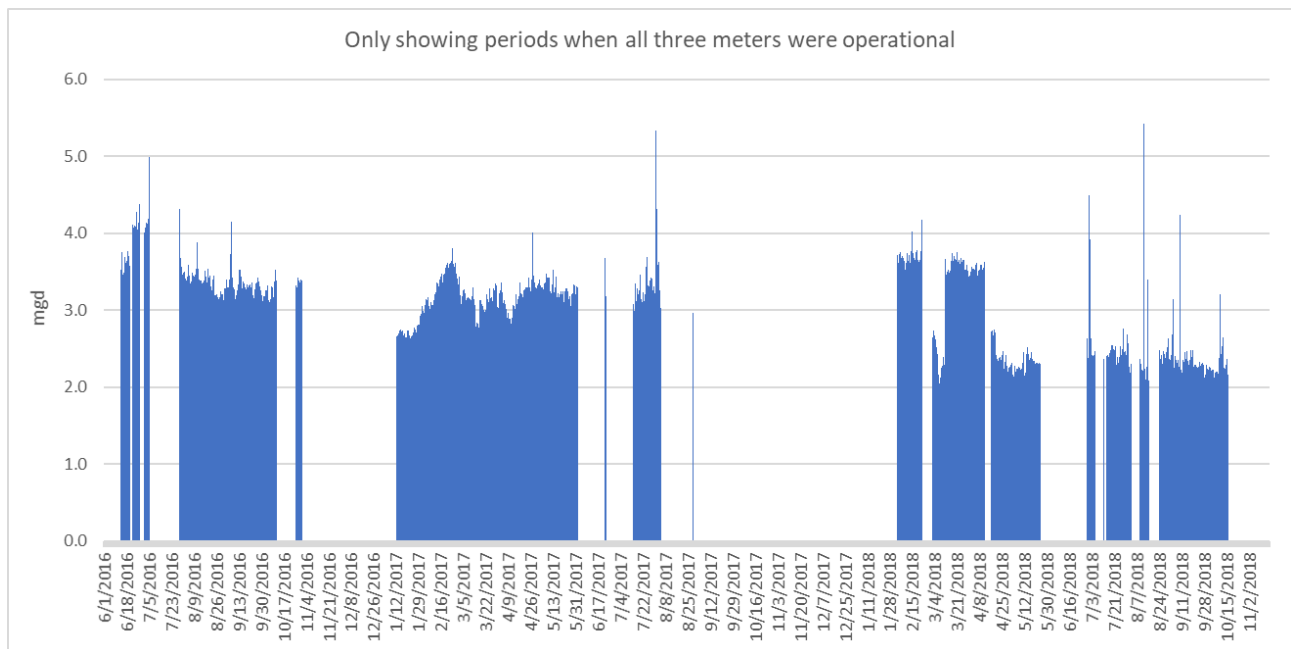
Figure 2-47 Hourly Data for Highland Park

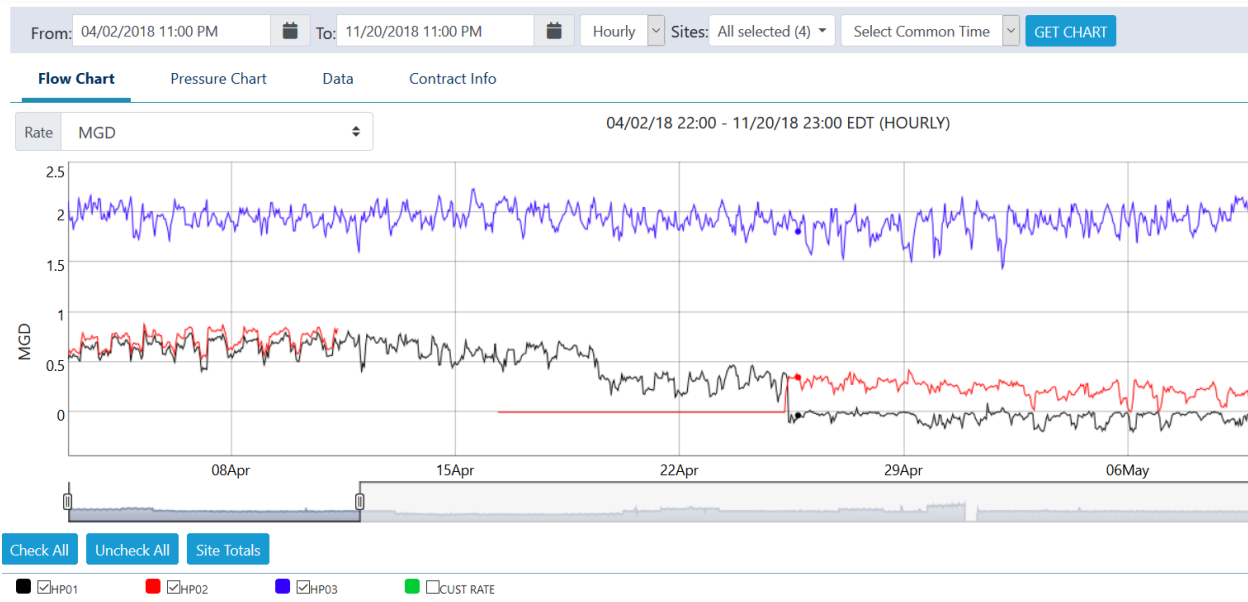
Since April 26, 2018, flows have averaged 2.18 mgd. Several large spikes in demand have been observed during the summer of 2018 which appear to be mains breaks. These breaks also appear to have been resolved quickly. The three insertion meters were removed, cleaned, and reinstalled by M.E. Simpson in August 2018. Flows have remained in a similar pattern after the reinstallation.

Figure 2-48 Change in Flow Pattern at Highland Park, April 2018

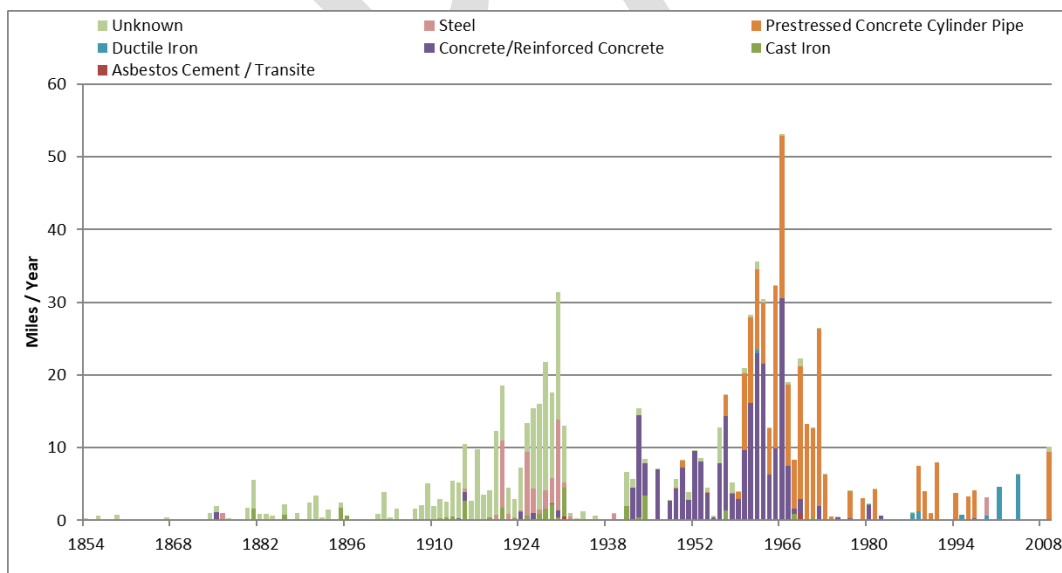
Figure 4-1 GLWA Transmission main age and material

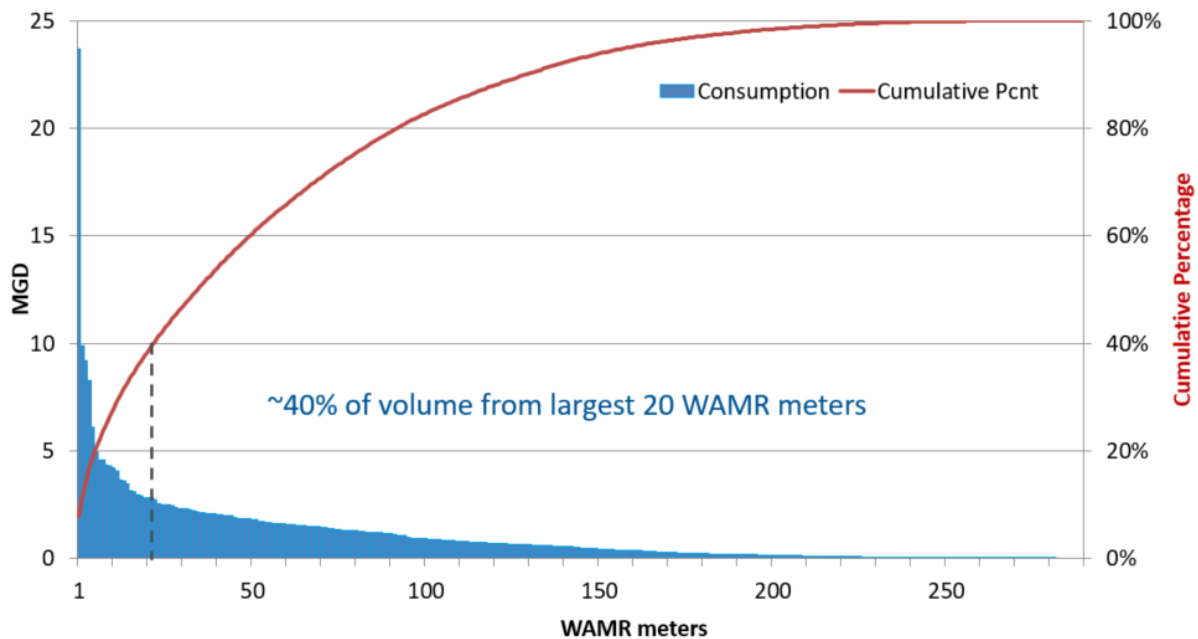
Figure 5-1 Ranking of WAMR Meters by Volume and Cumulative Percent of Total Volume

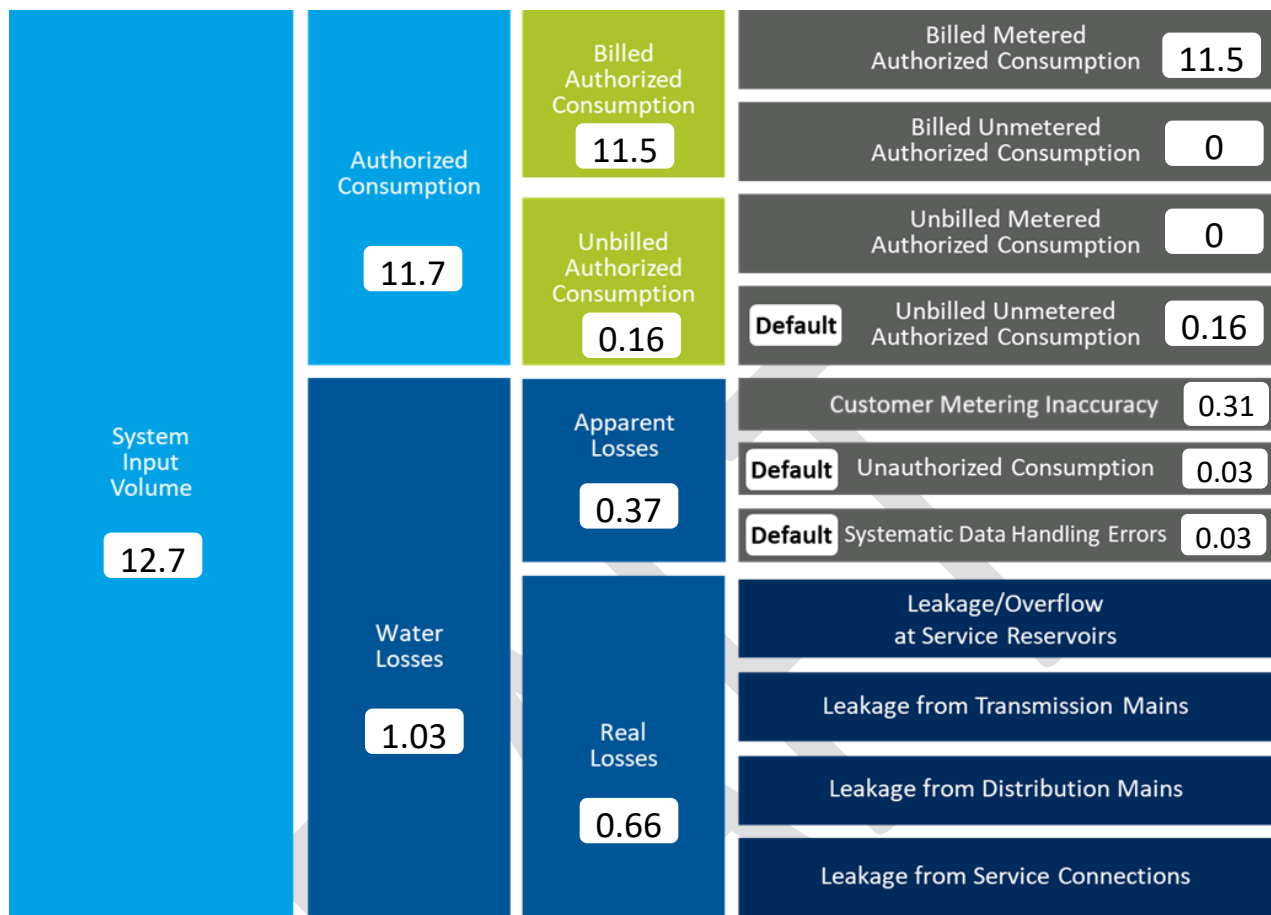
Figure 9-1 Dearborn Water Balance (Average Day)

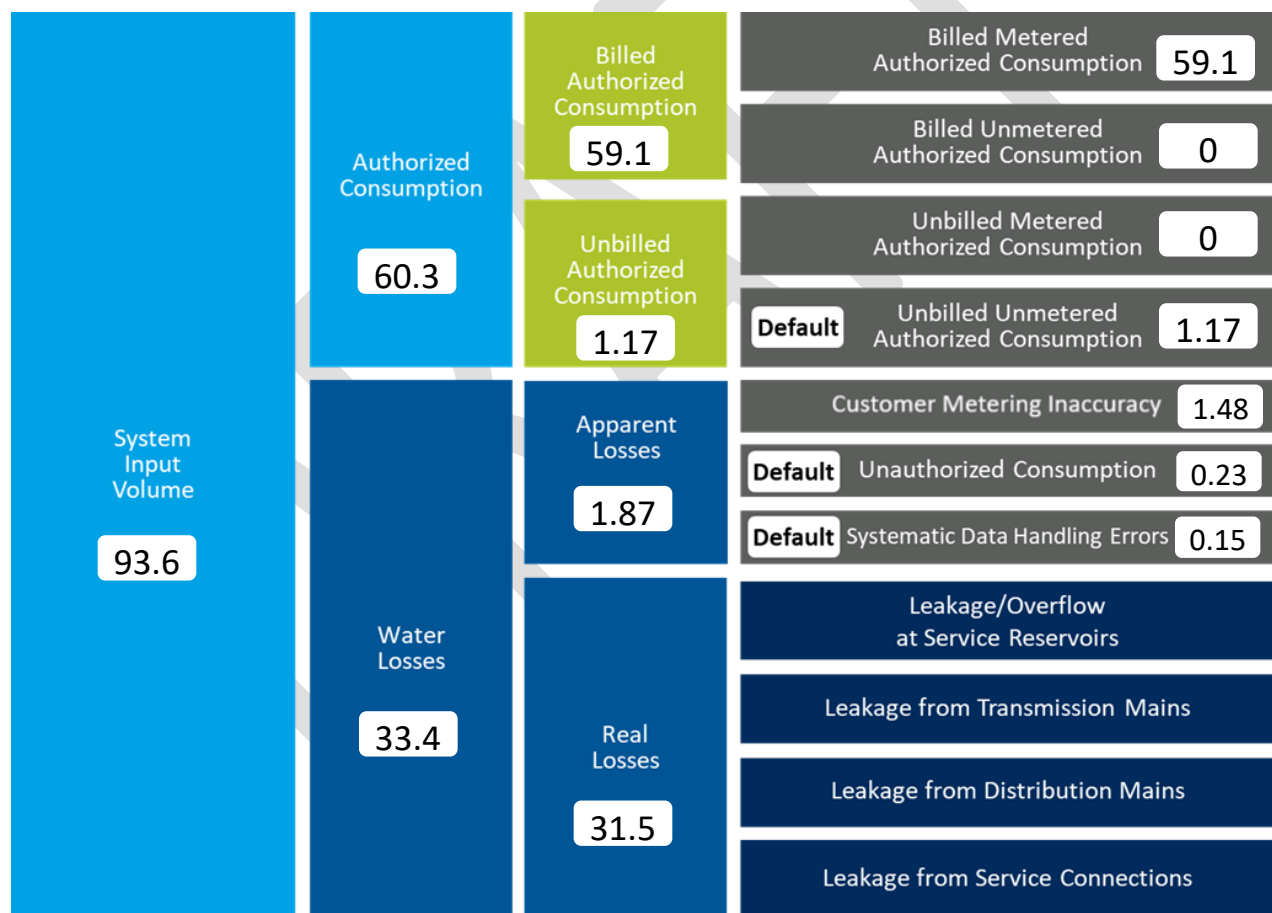
Figure 9-2 Detroit Water Balance (Average Day)

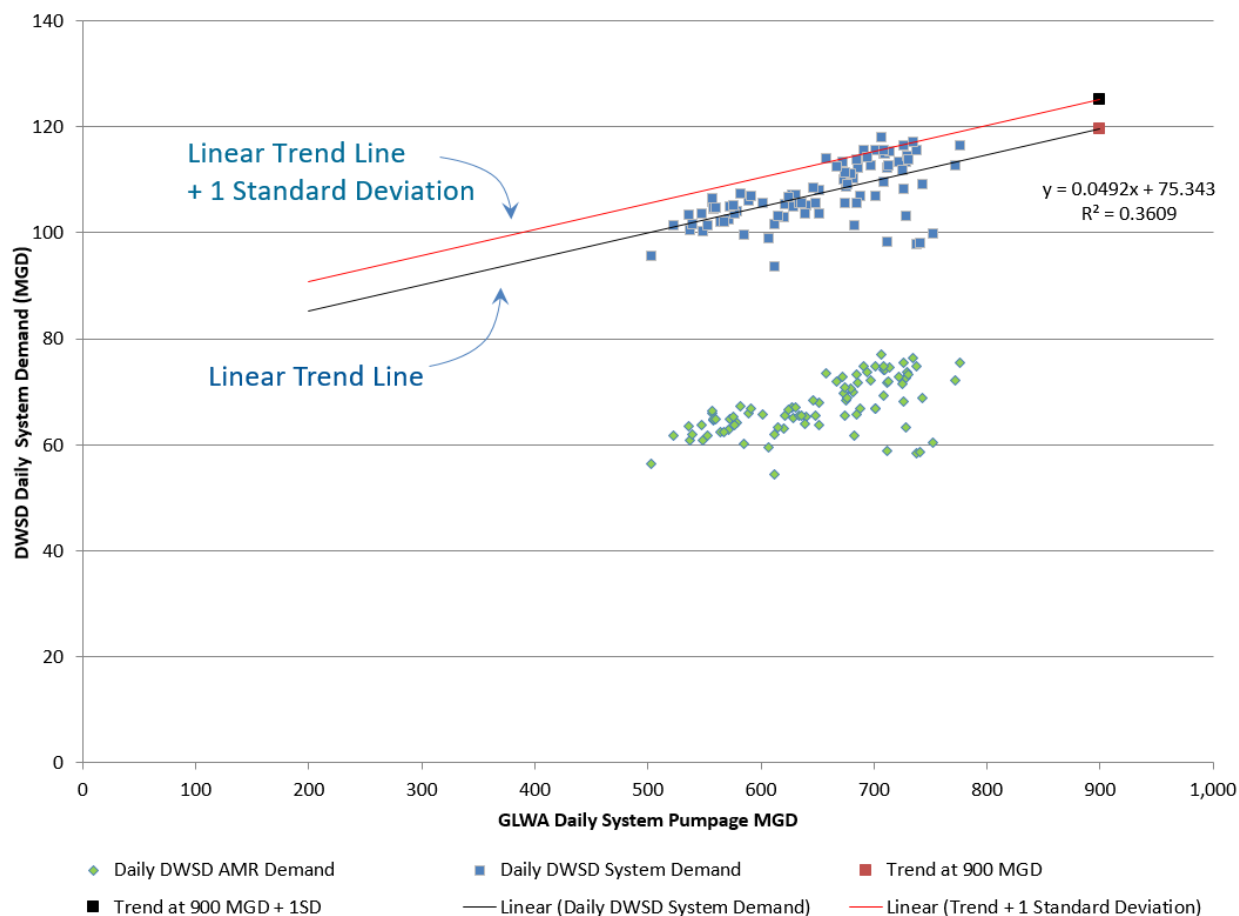
Figure 9-3 Scatterplot to Calculate DWSD Max Day Demand at 900 MGD System Pumpage

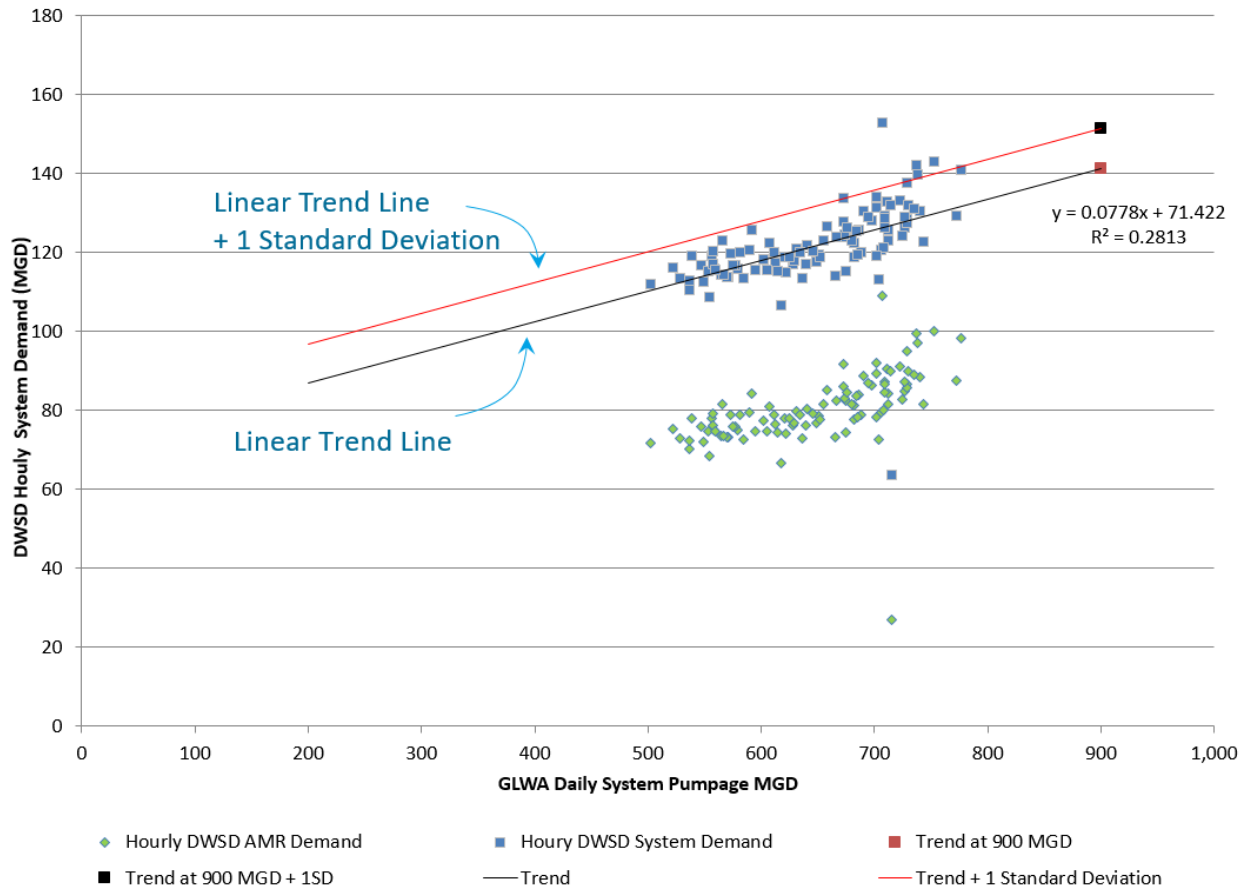
Figure 9-4 Scatterplot to Calculate DWSD Peak Hour Demand at 900 MGD System Pumpage

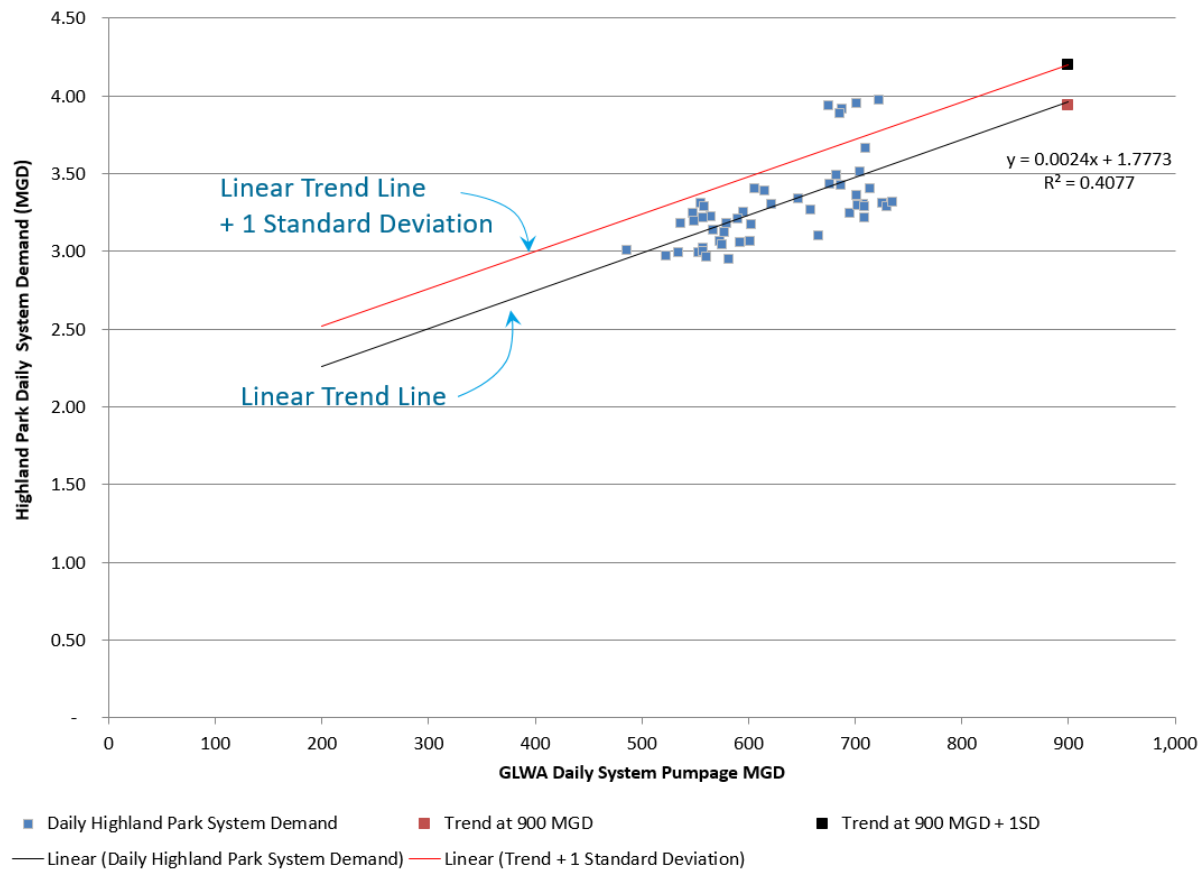
Figure 9-5 Scatterplot to Calculate Highland Park Max Day Demand at 900 MGD System Pumpage

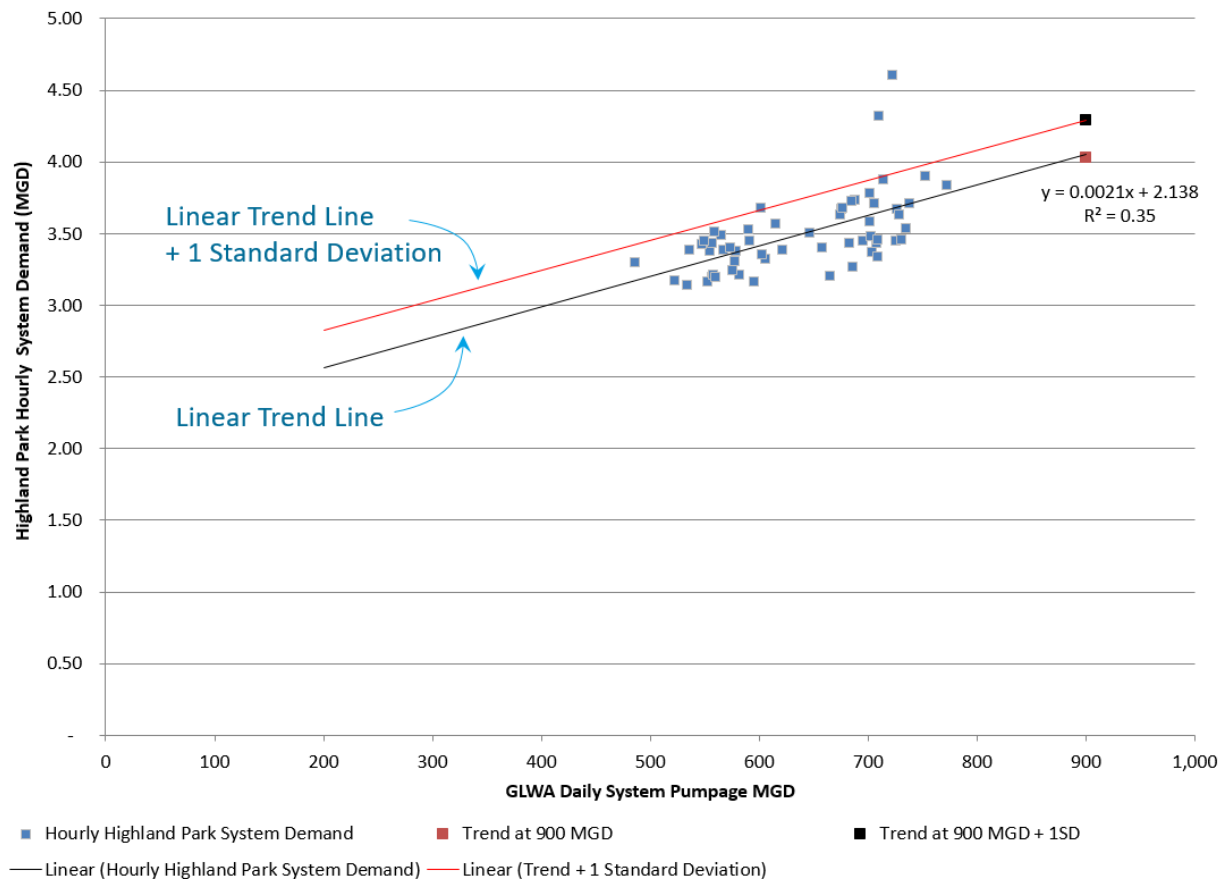
Figure 9-6 Scatterplot to Calculate Highland Park Peak Hour Demand at 900 MGD System Pumpage

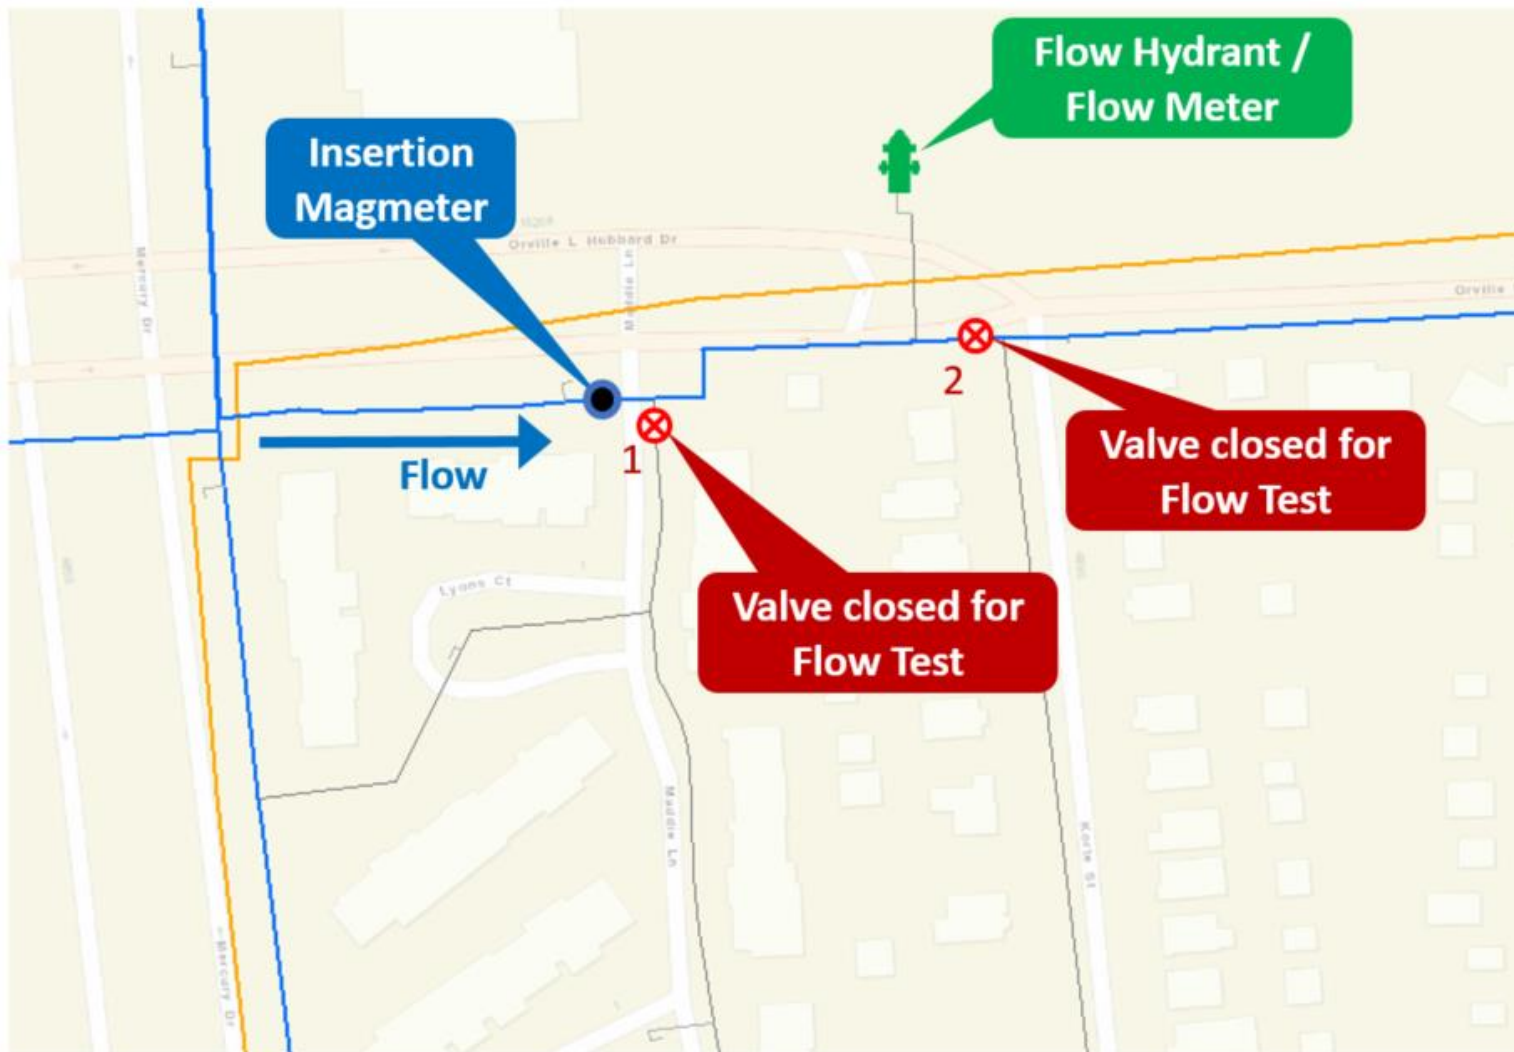
Hydrant Flow Test Results Meter 1 Install:
