**UNITS OF SERVICE FOR NON-
MASTER METERED CUSTOMERS
OF GREAT LAKES WATER
AUTHORITY AND SYSTEM WATER
AUDIT:
PHASE TWO REPORT**

GLWA PROJECT CS-039

Great Lakes Water Authority

29 NOVEMBER 2018

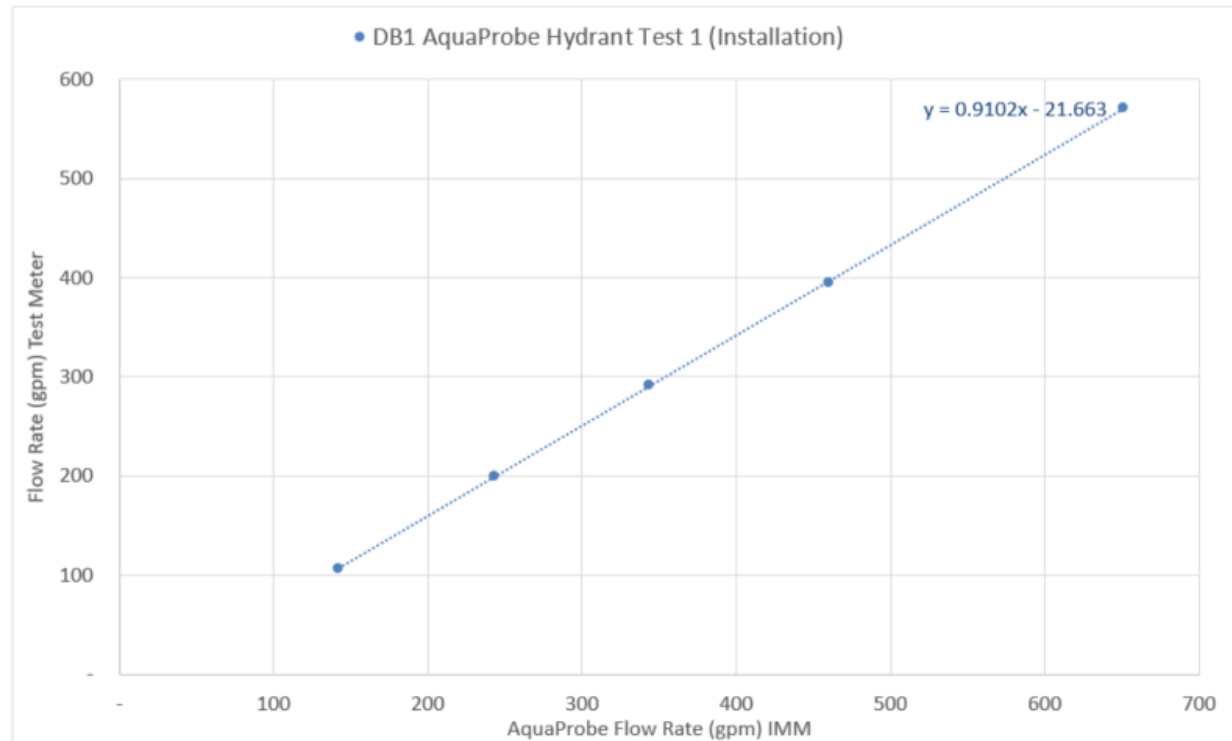
Hydrant Flow Test Results Meter 1 Removal:

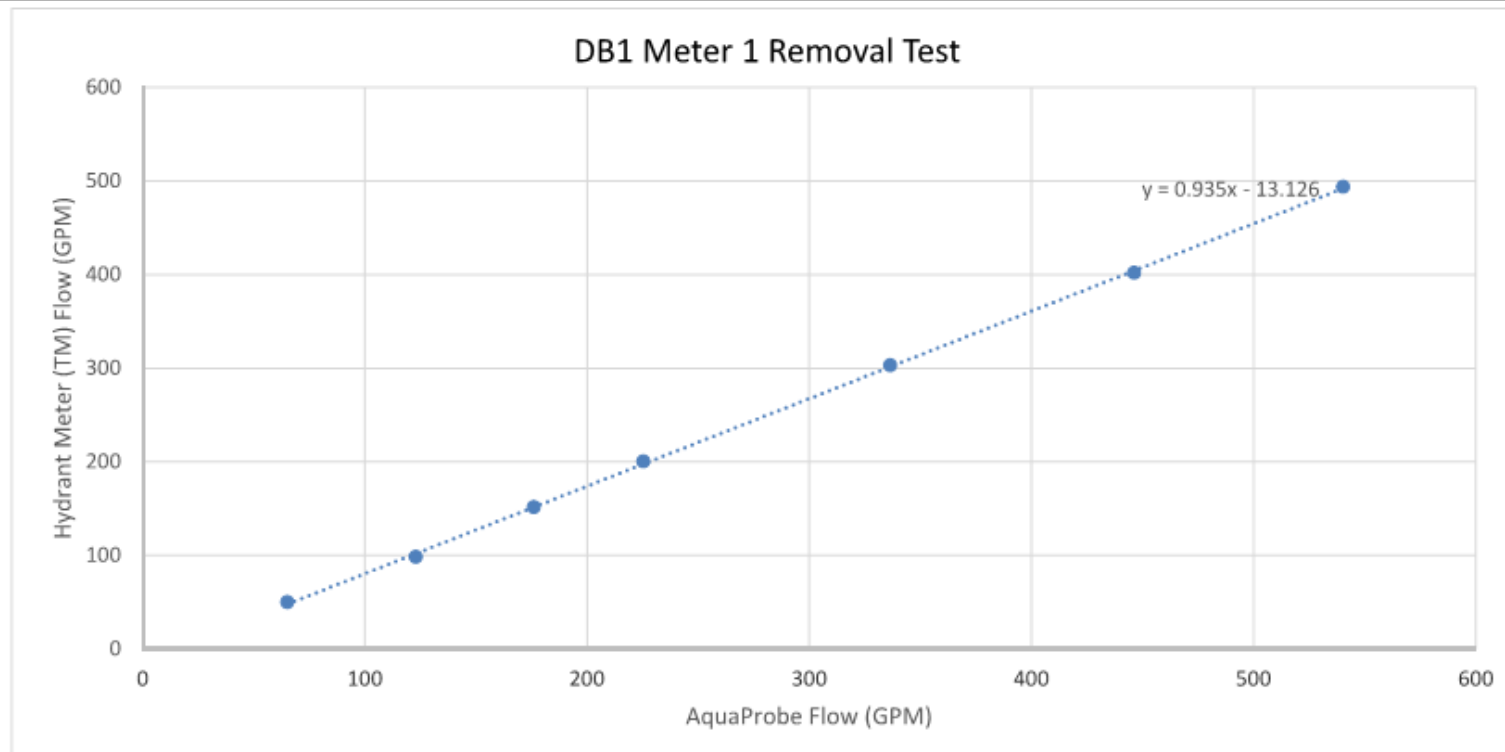
Hydrant Flow Test Results Meter 2 Installation:

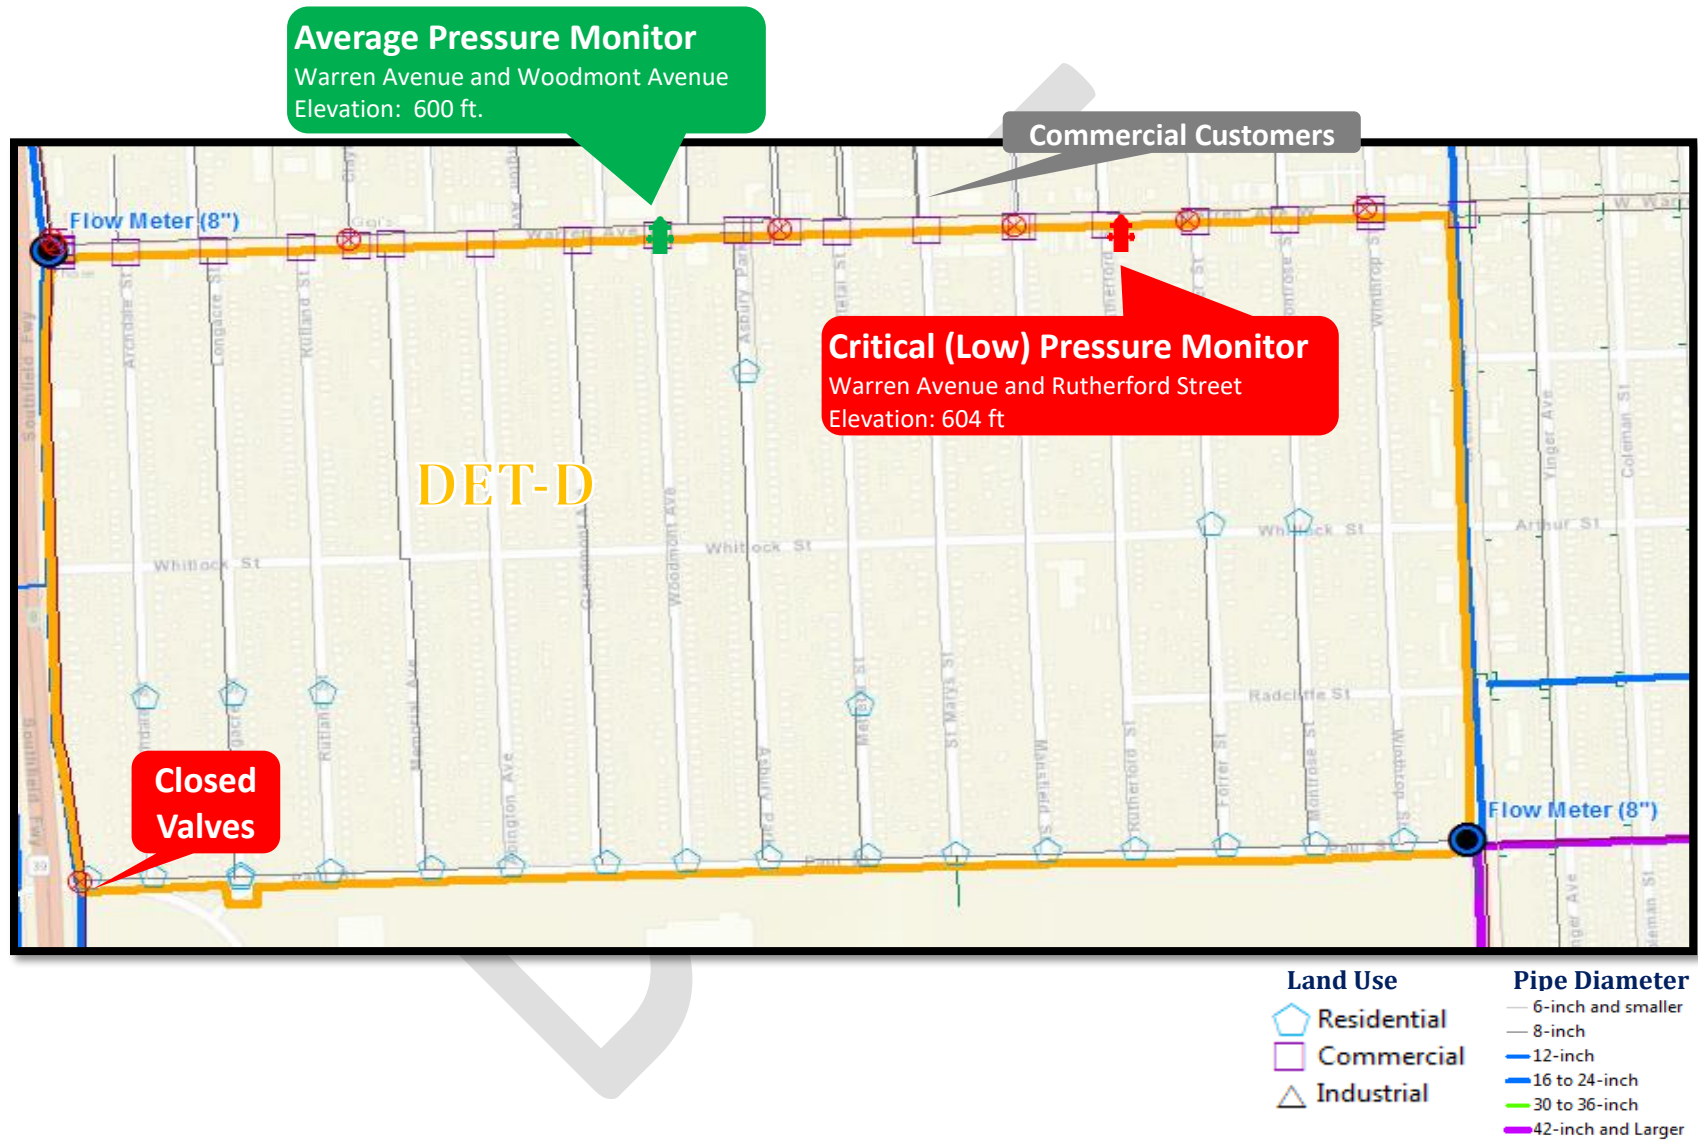
Figure 10-1 DET-D Overview

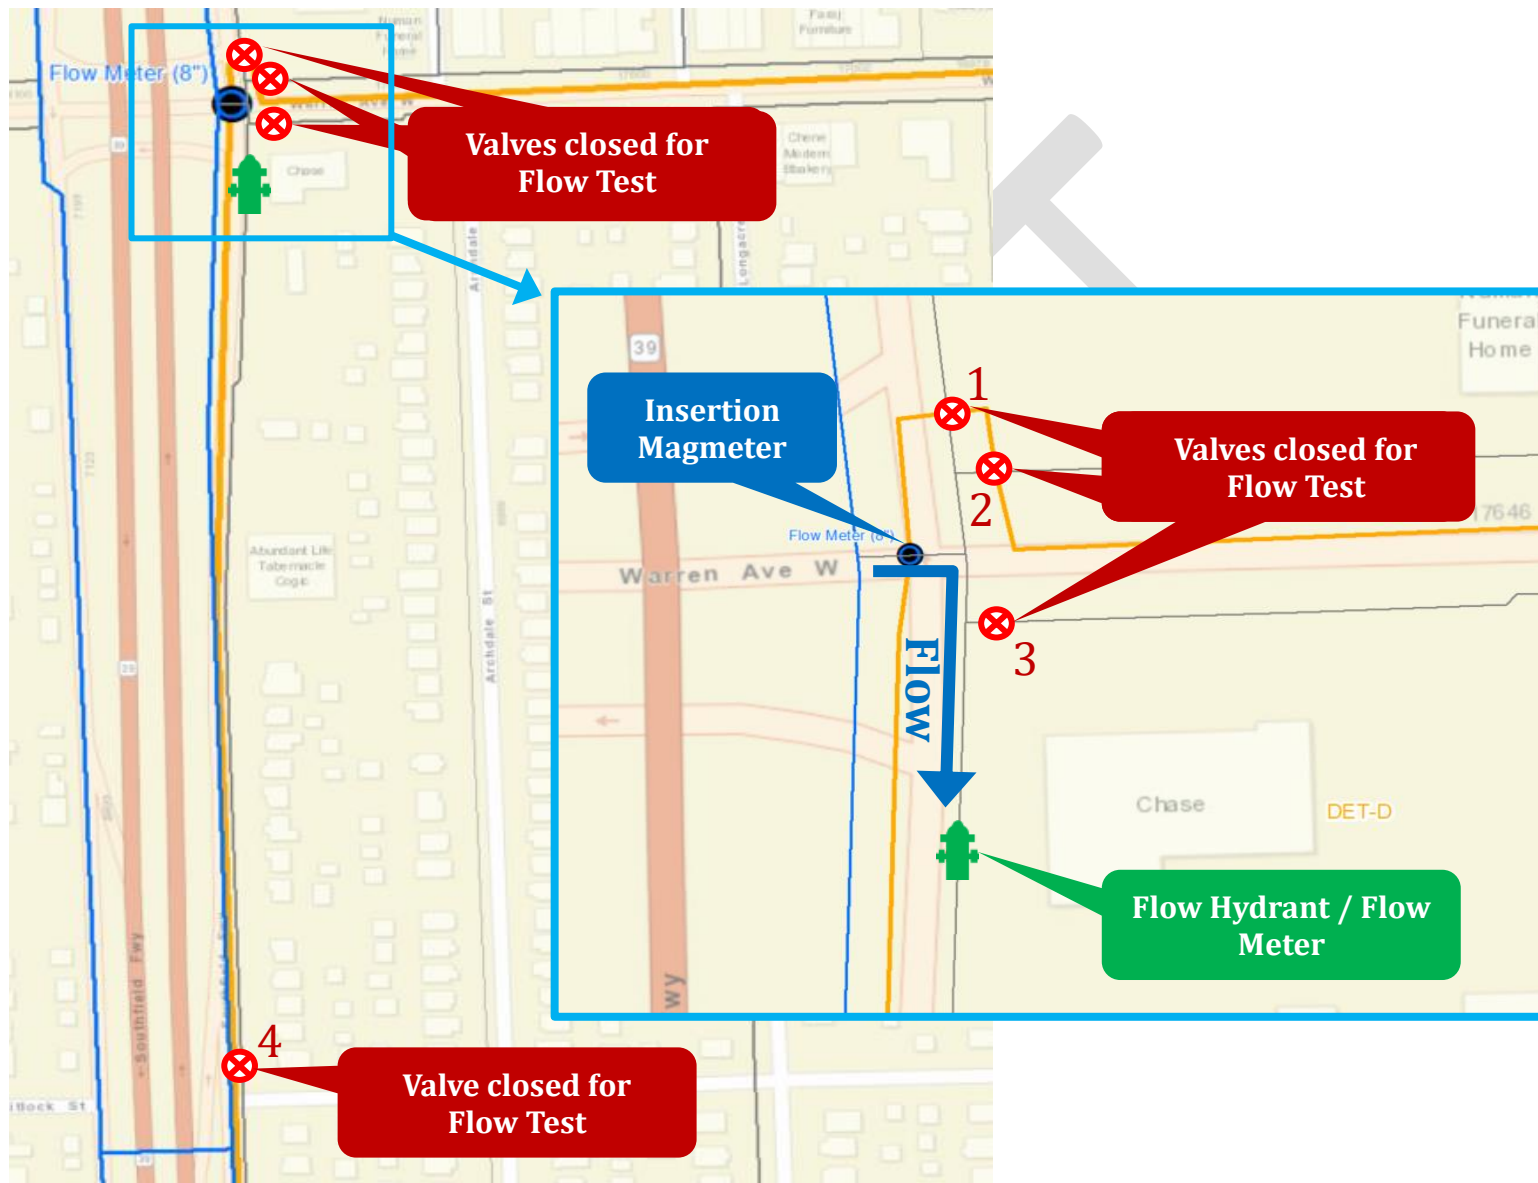
Figure 10-3 In-Situ Flow Test on Warren Ave. West Meter

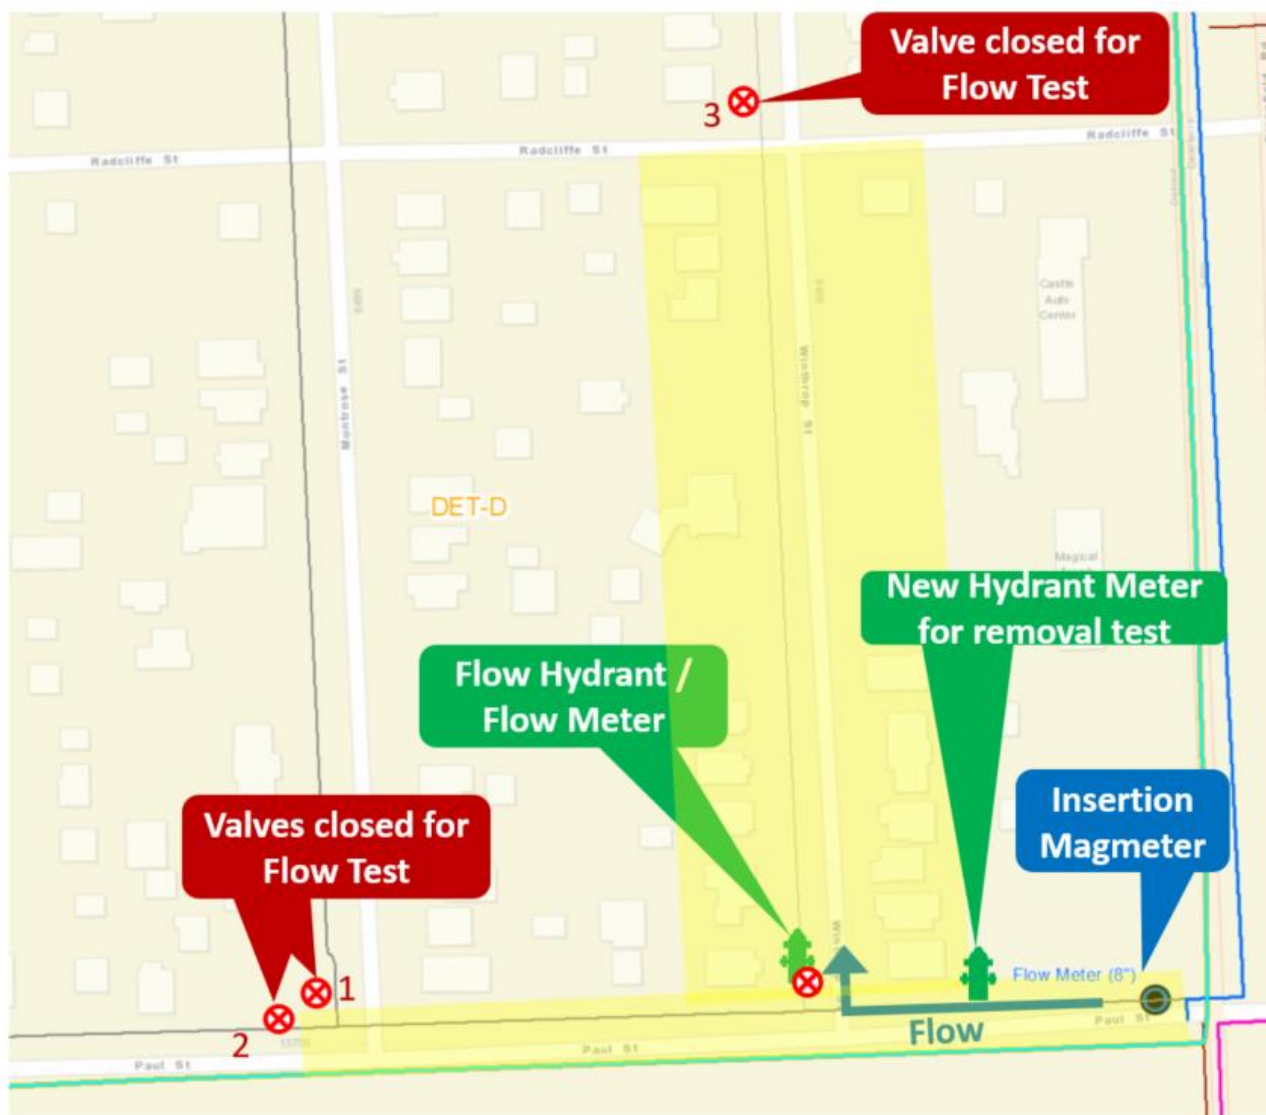
Figure 10-4 In-Situ Flow Test on Paul St. Meter

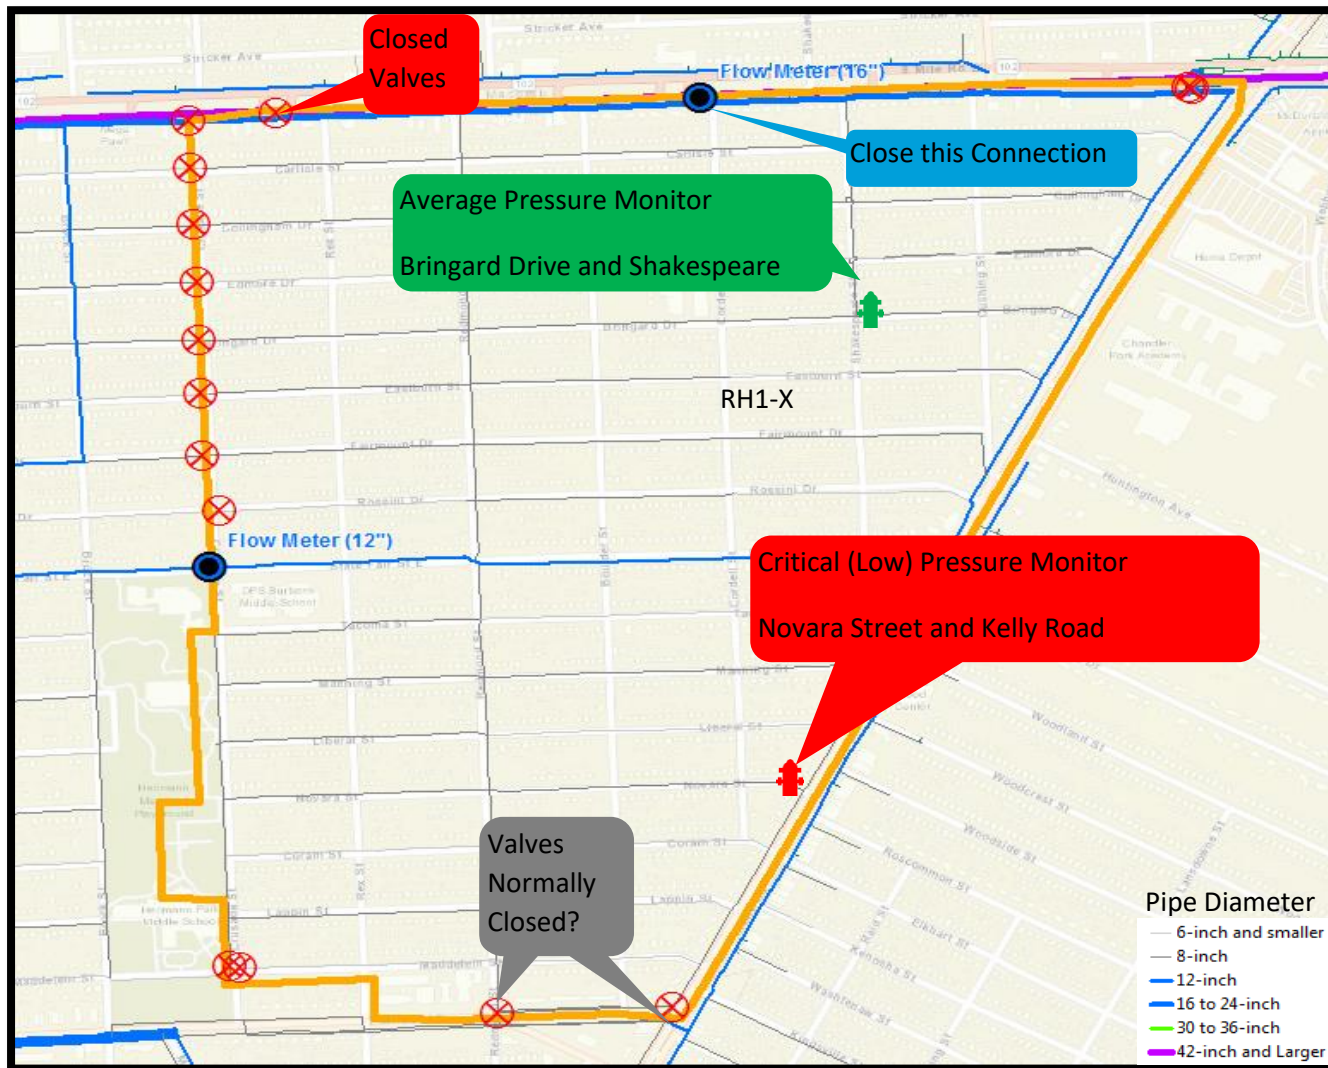
Figure 10-5 RH1-X Overview

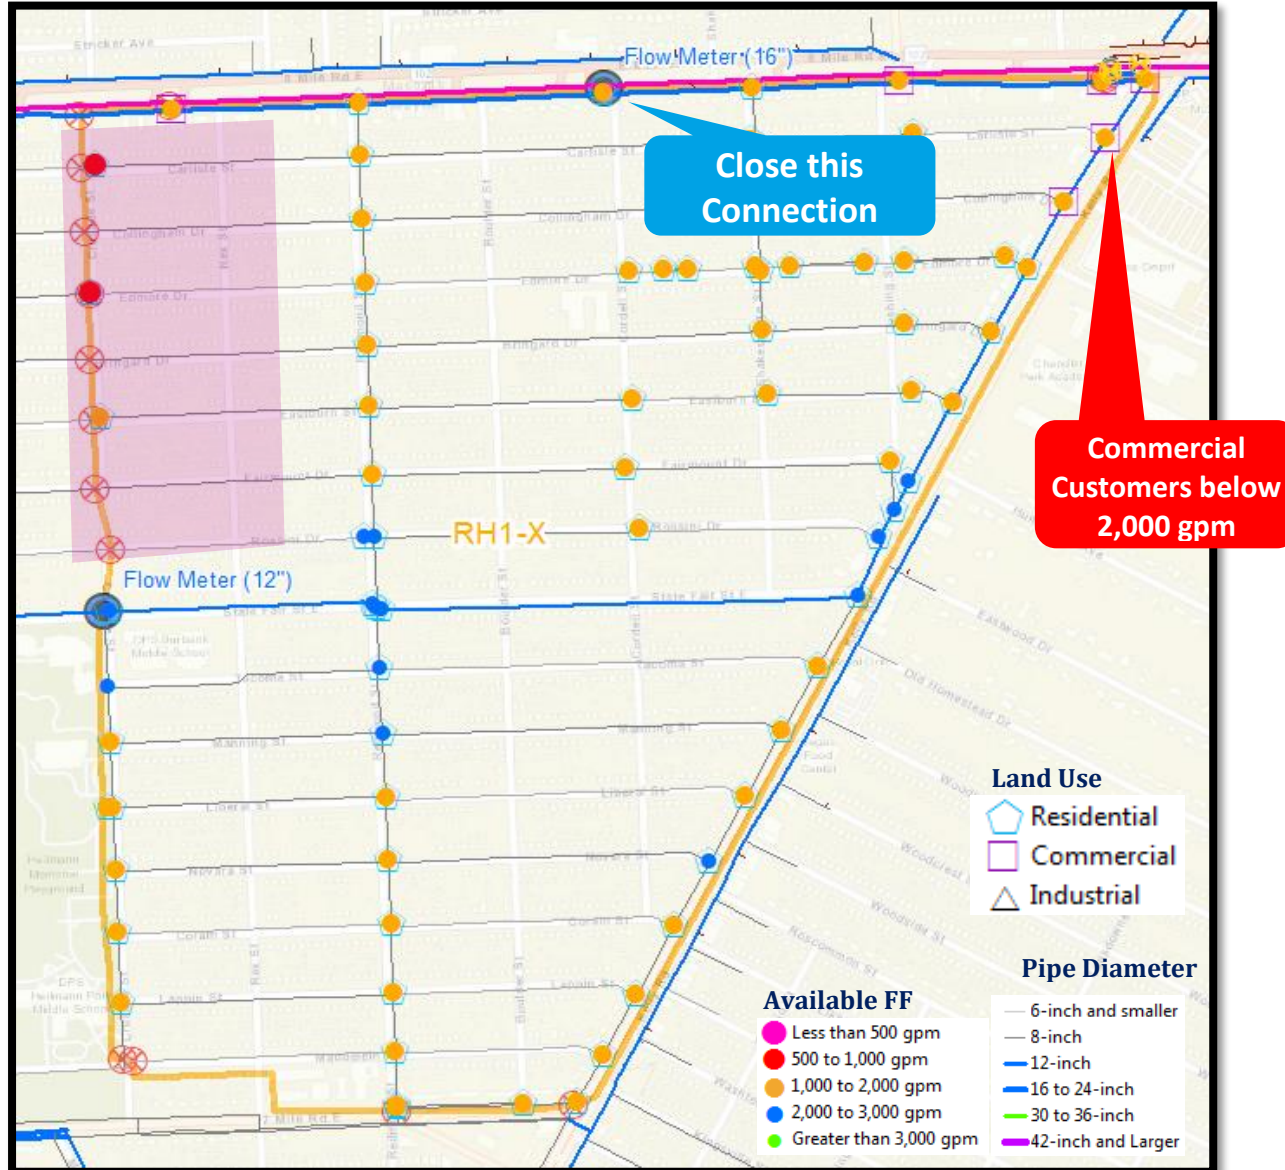
Figure 10-6 RH1-X Fire Flow Planning (One Input Scenario)

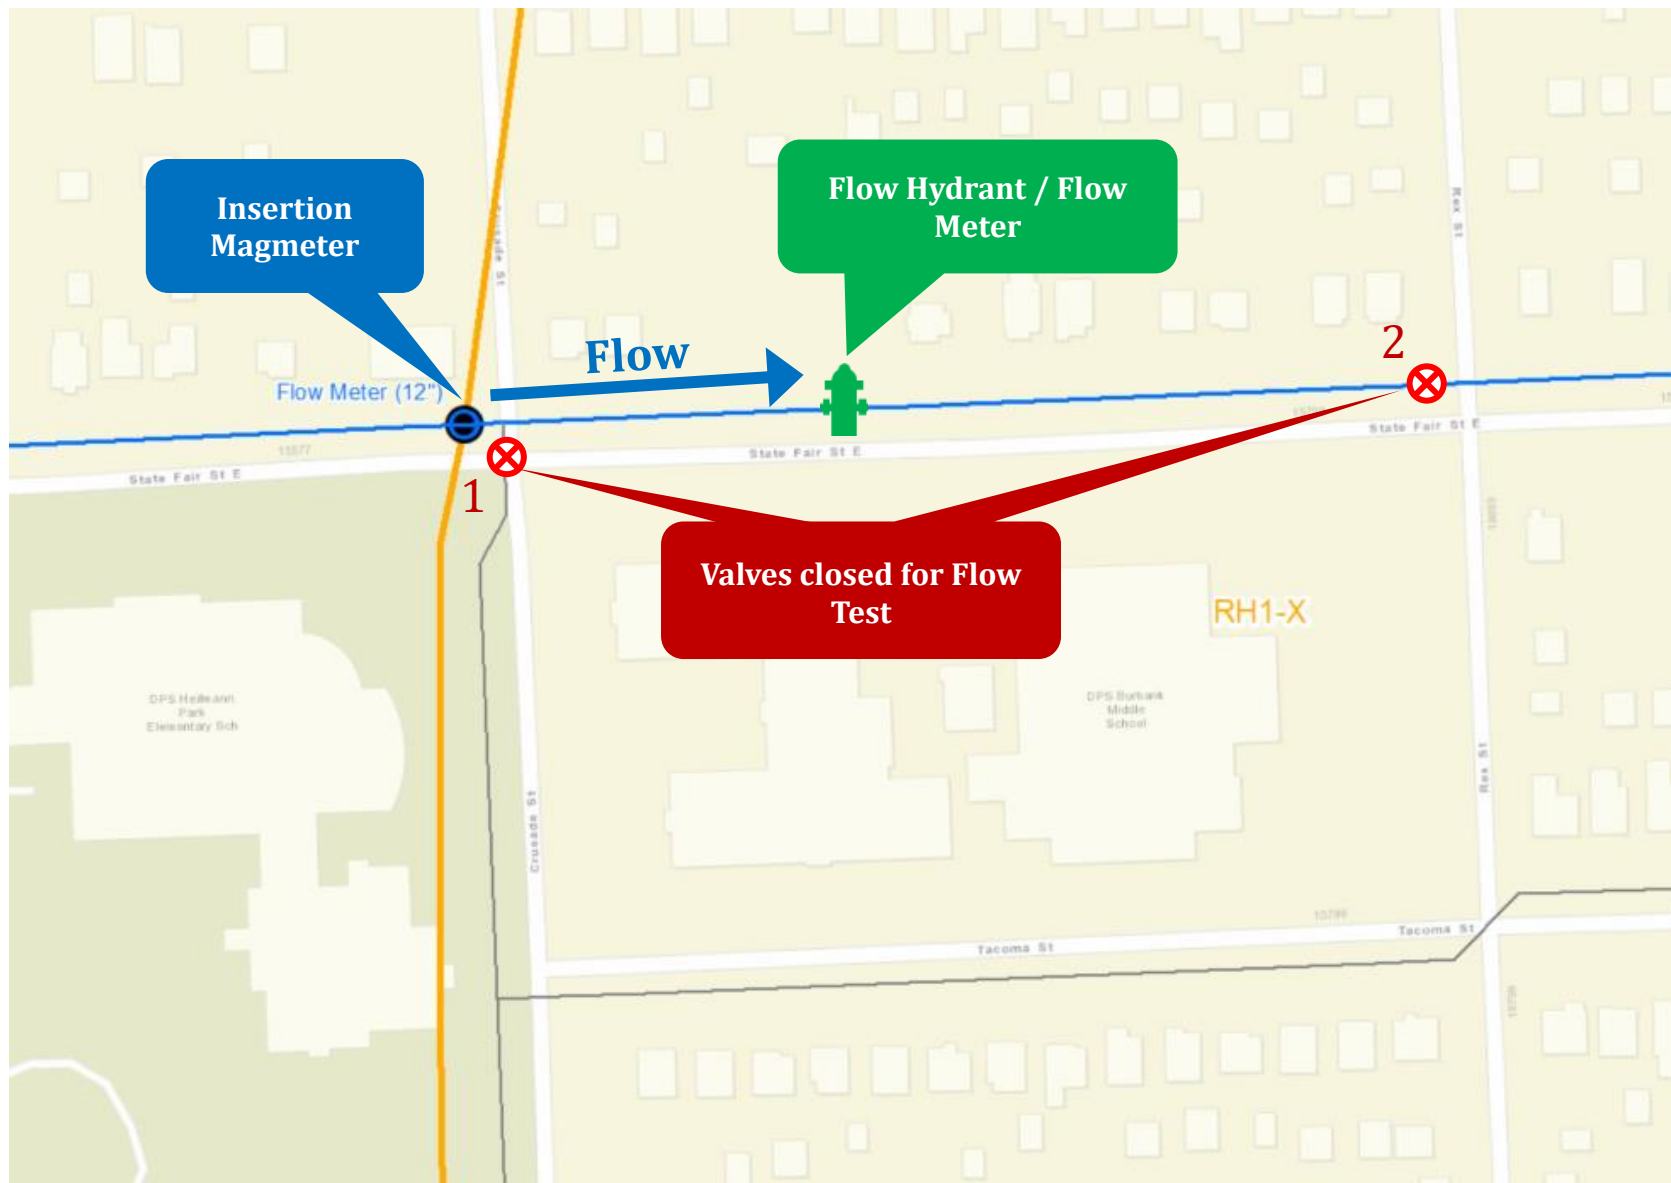
Figure 10-7 In-Situ Flow Test on State Fair St. E Meter

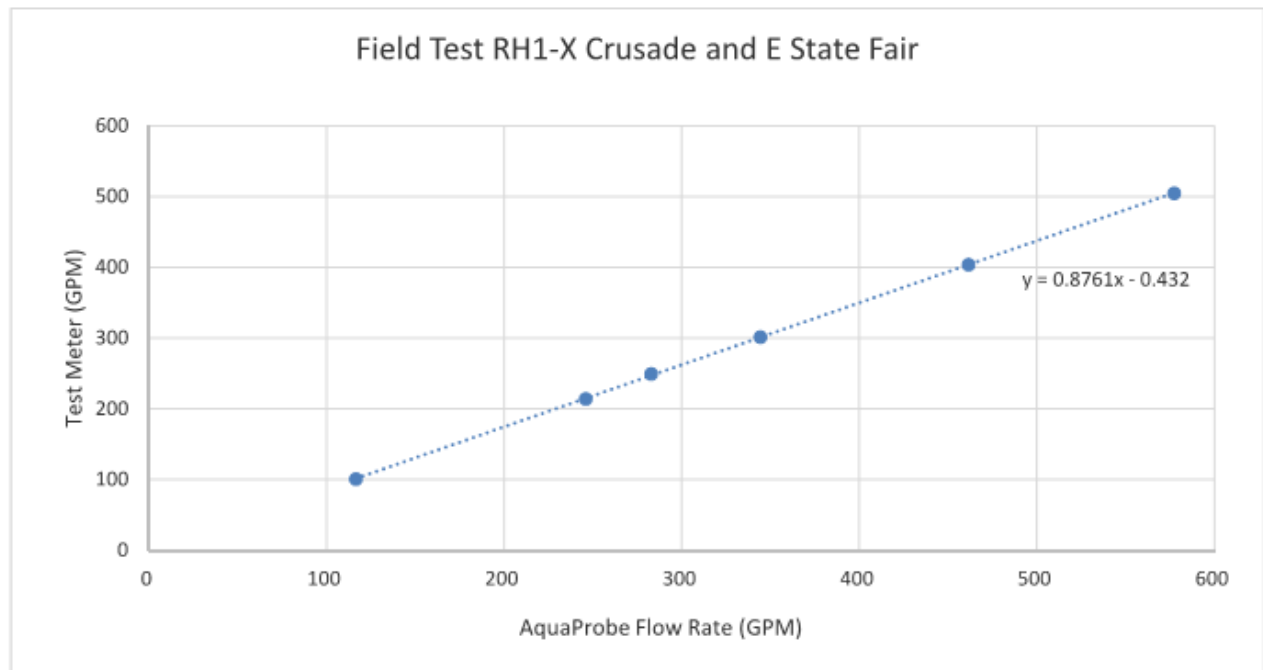
Hydrant Flow Test Results (Removal Test)

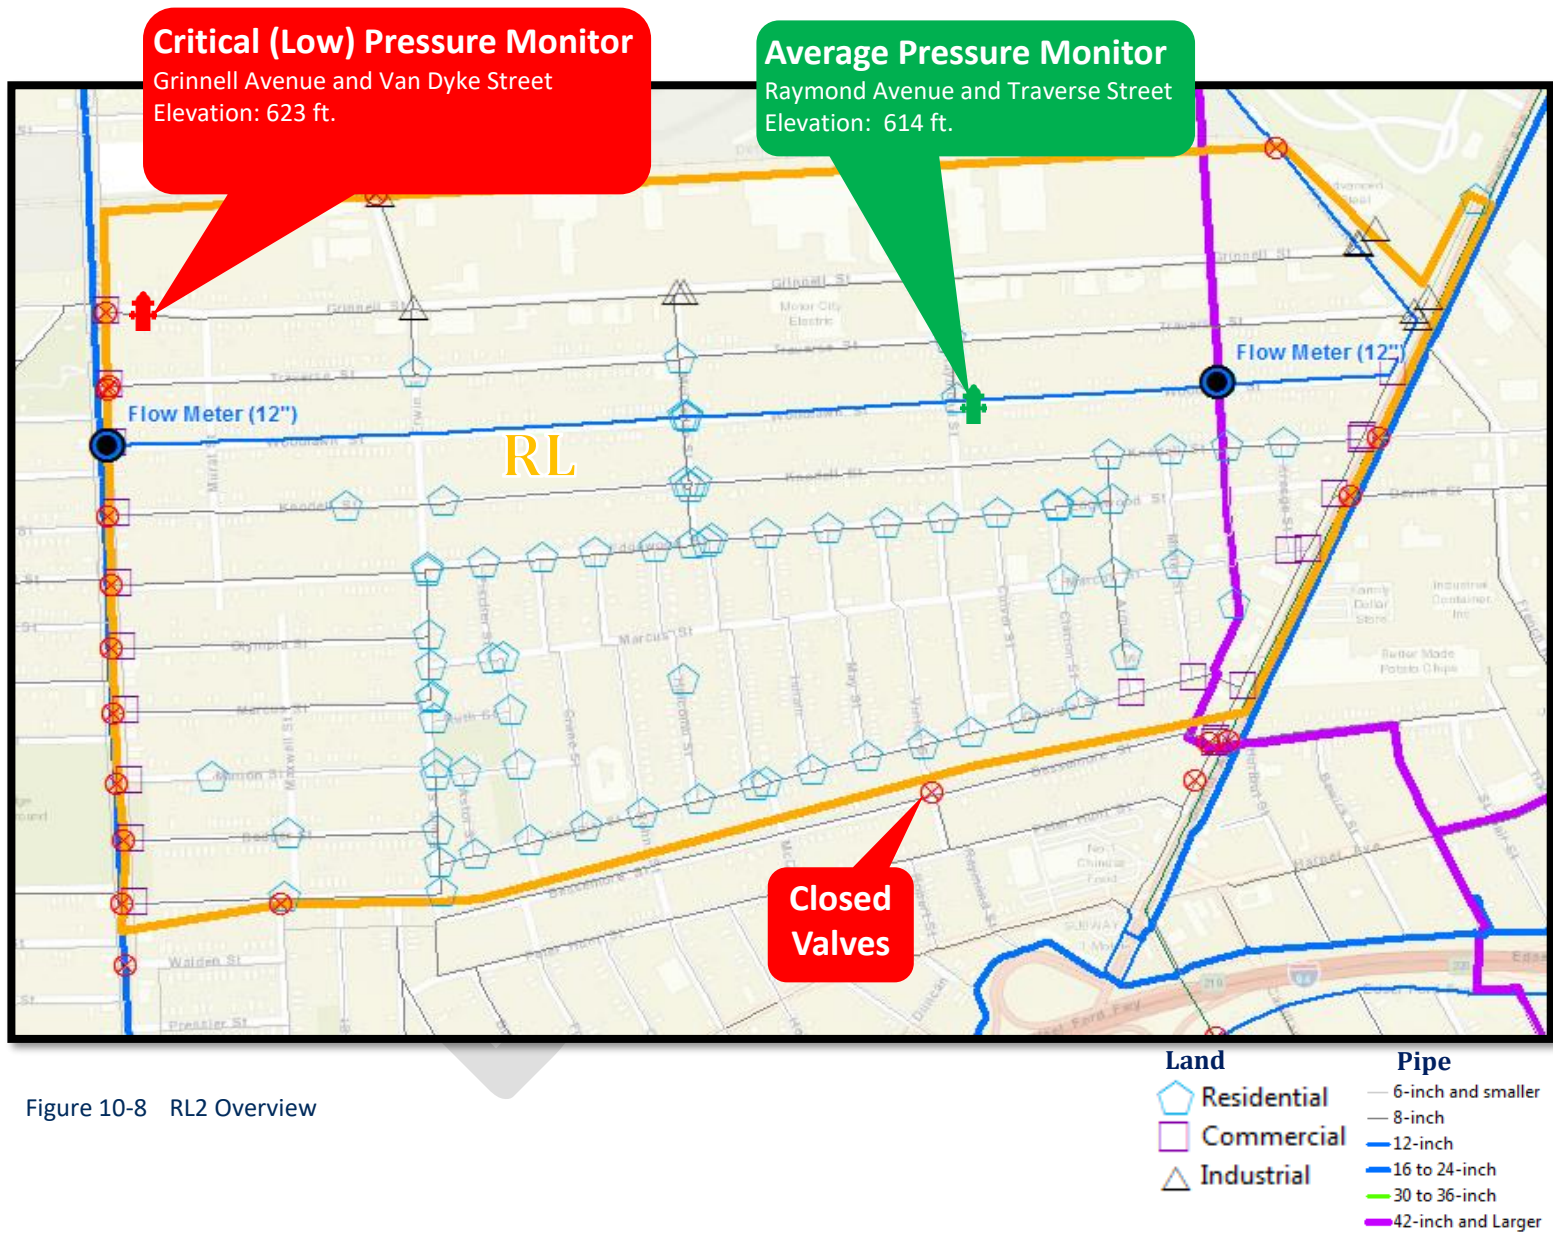
Figure 10-8 RL2 Overview

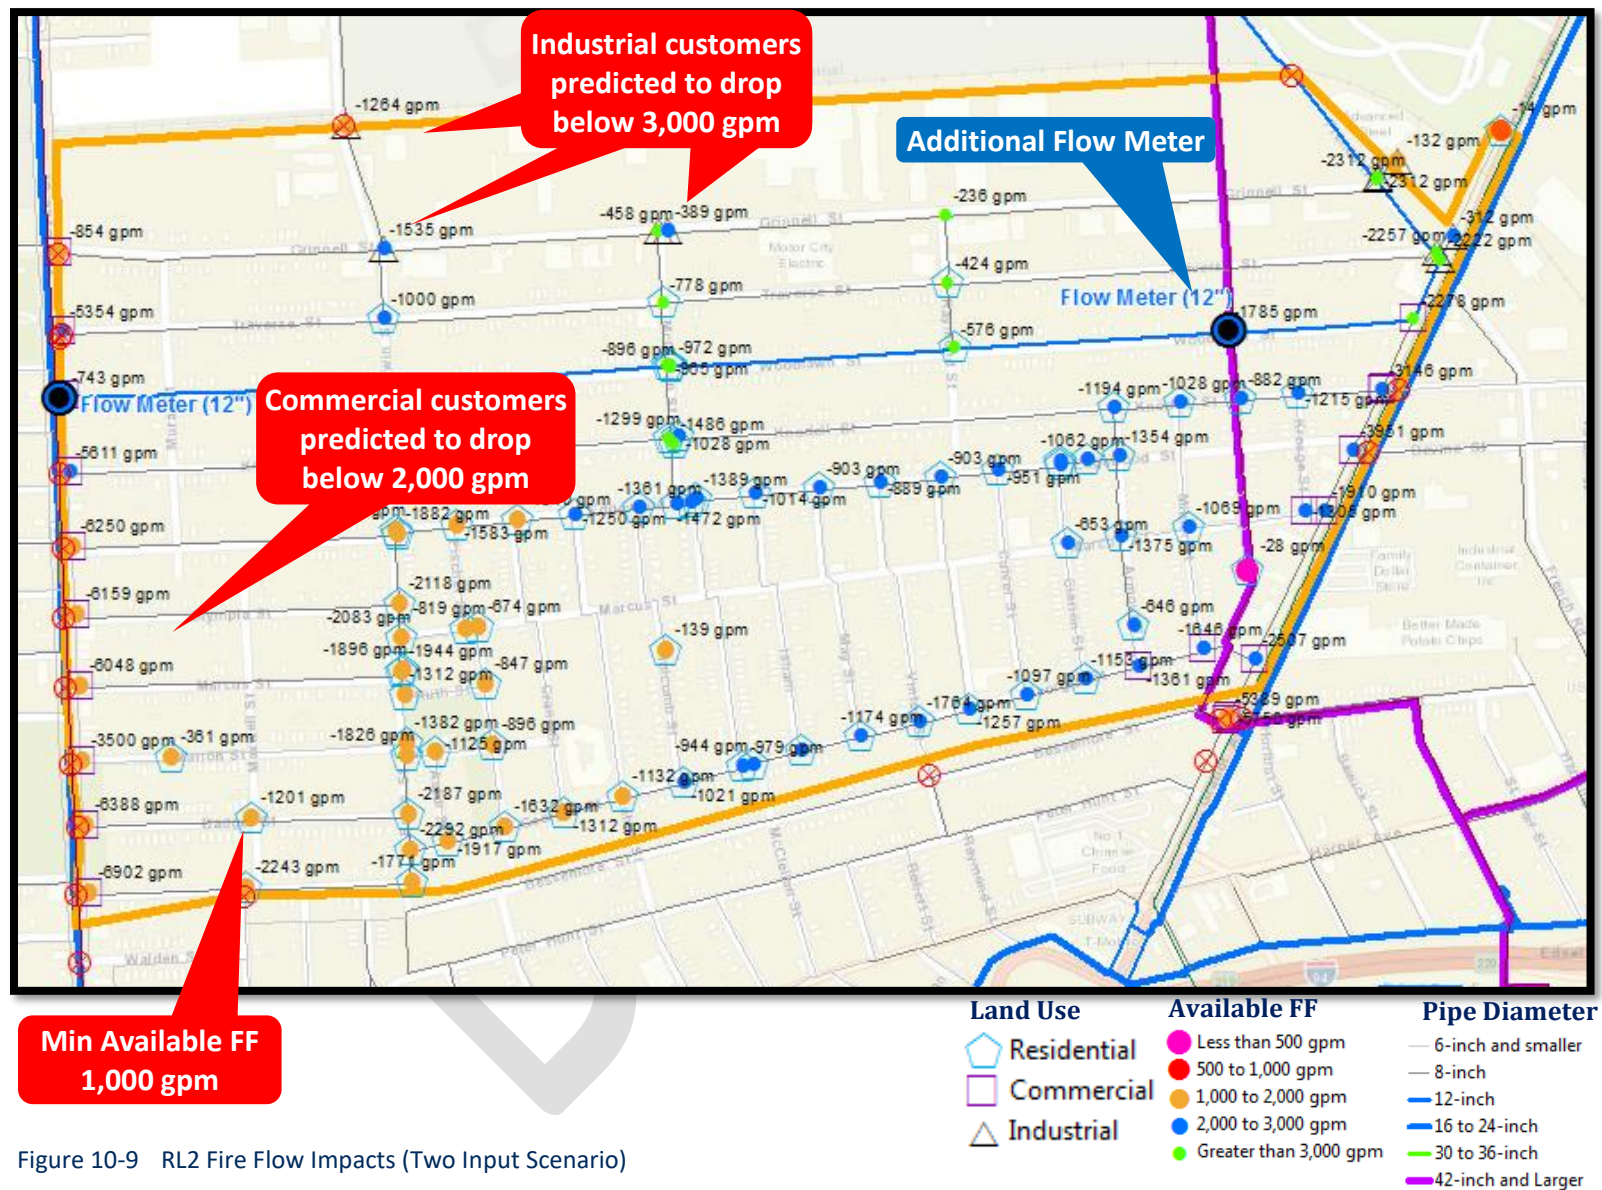
Figure 10-9 RL2 Fire Flow Impacts (Two Input Scenario)

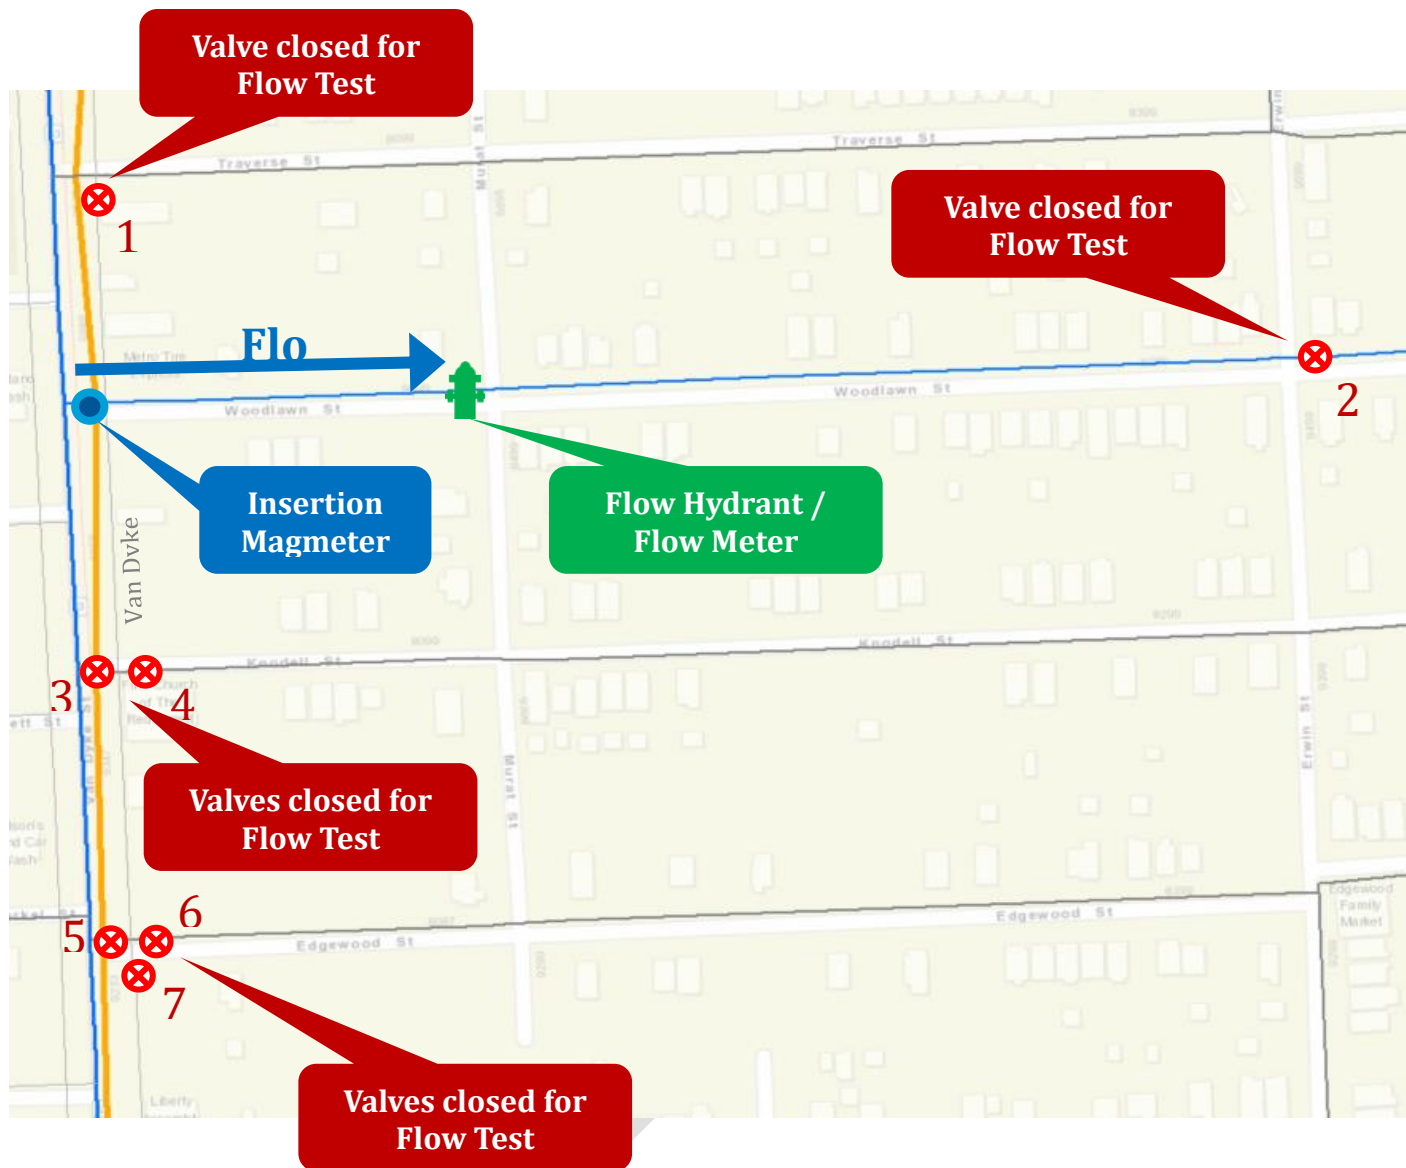
Figure 10-10 In-Situ Flow Test on Woodlawn St. Meter

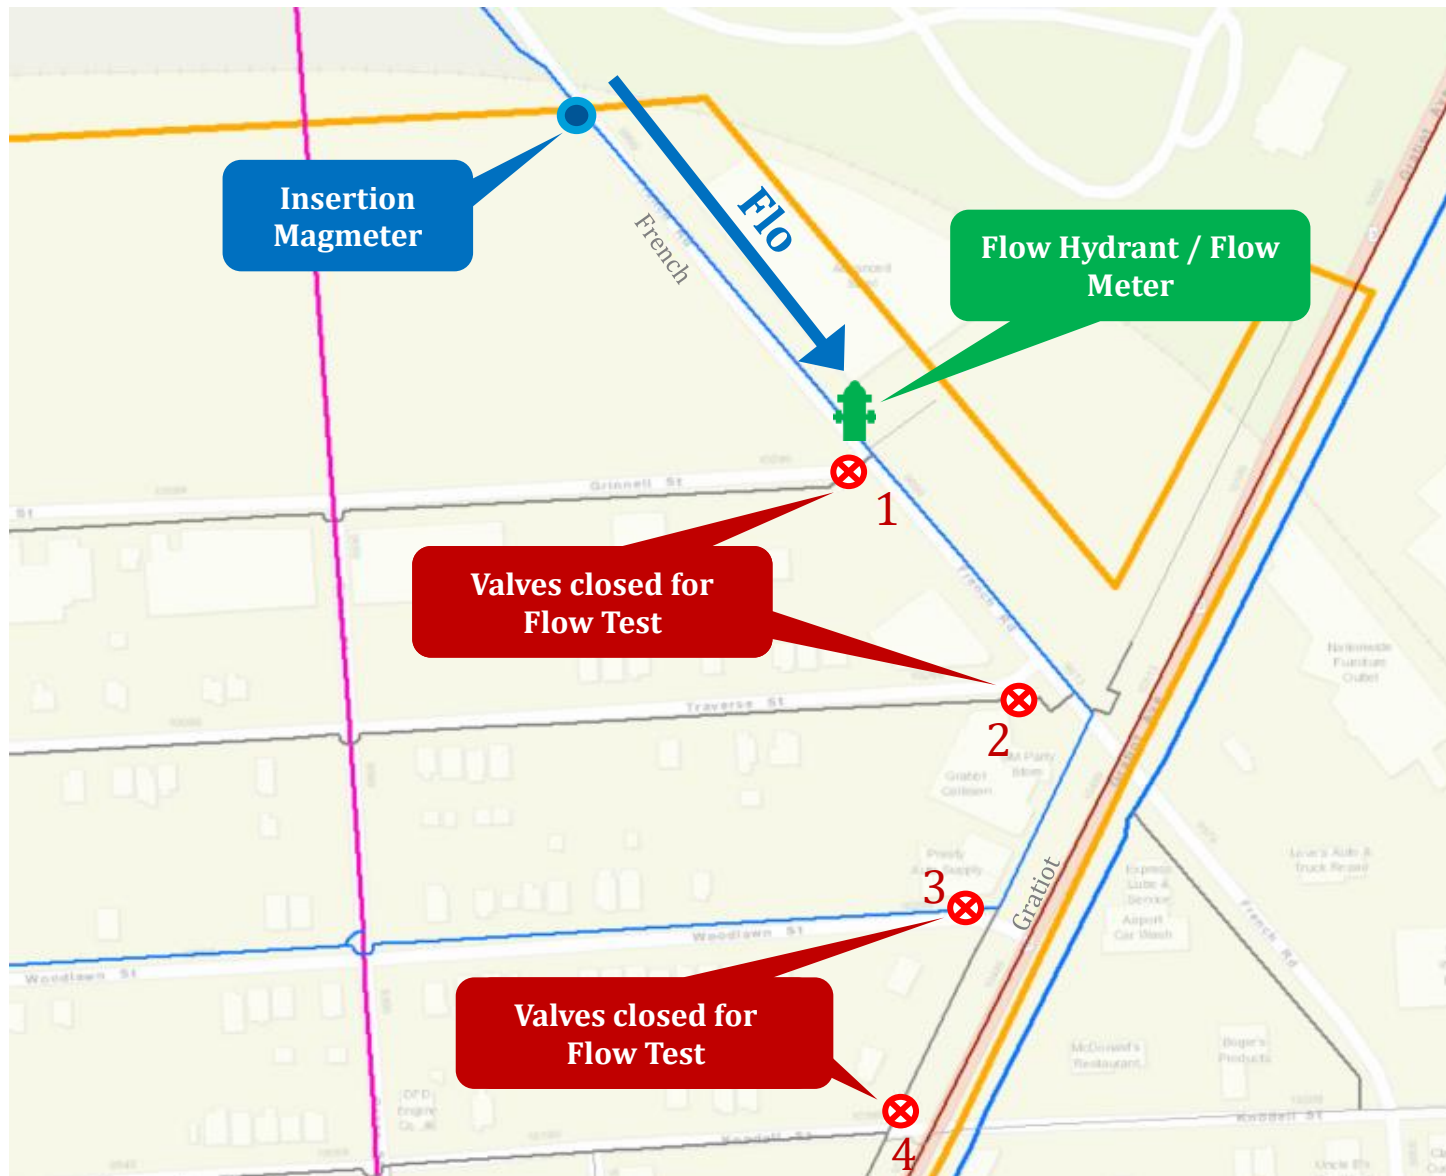
Figure 10-11 In-Situ Flow Test on French Rd. Meter

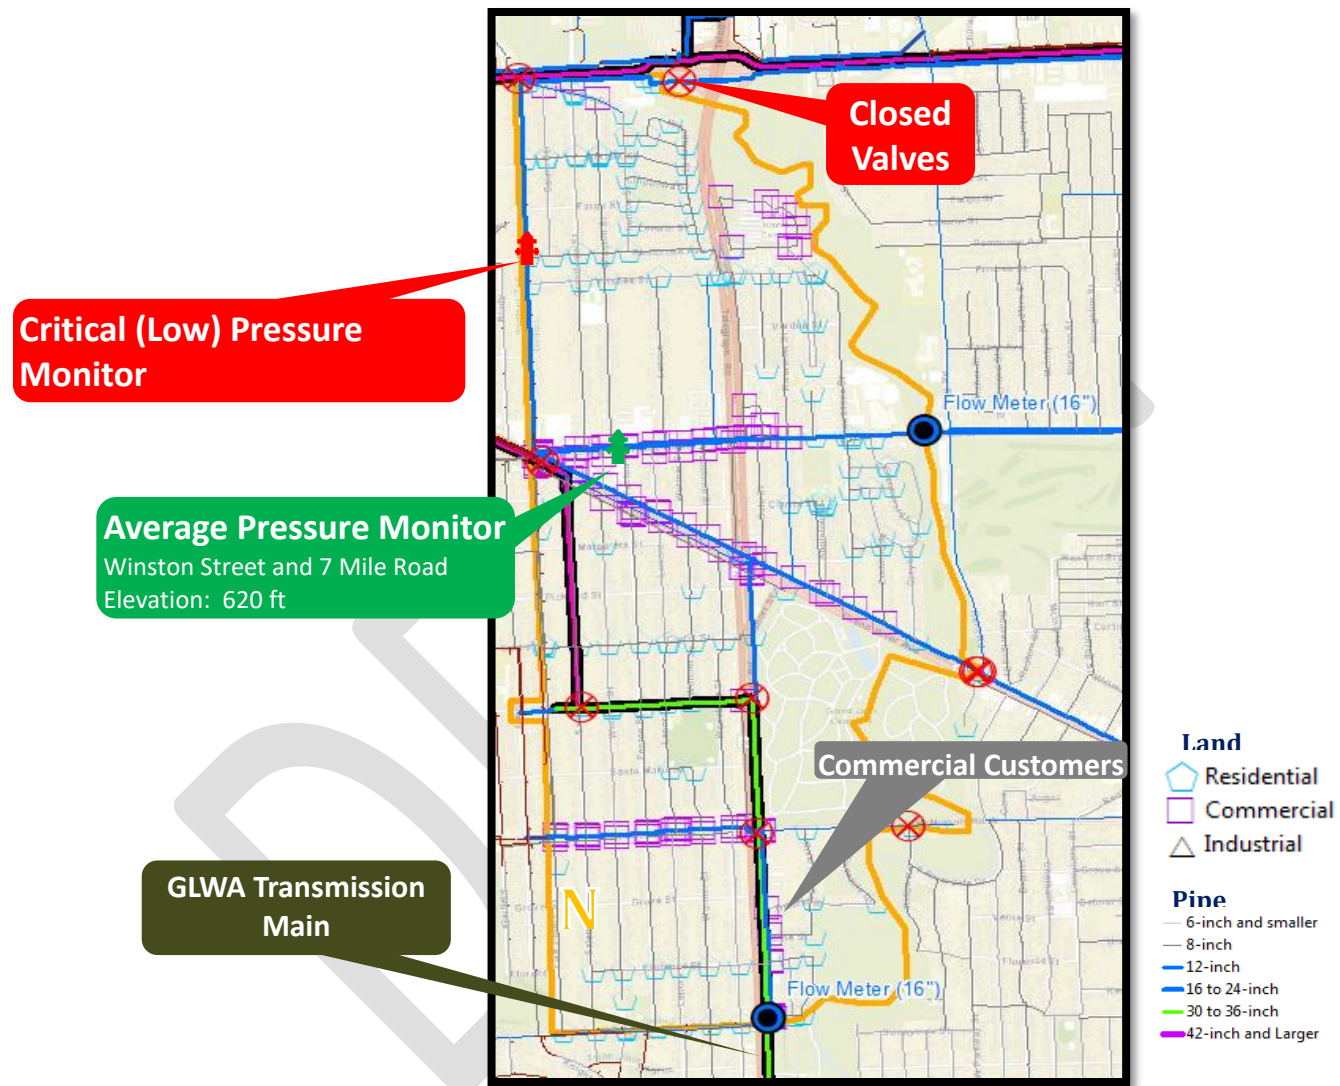
Figure 10-12 NW Overview
