**UNITS OF SERVICE FOR NON-
MASTER METERED CUSTOMERS
OF GREAT LAKES WATER
AUTHORITY AND SYSTEM WATER
AUDIT:
PHASE TWO REPORT**

GLWA PROJECT CS-039

Great Lakes Water Authority

29 NOVEMBER 2018

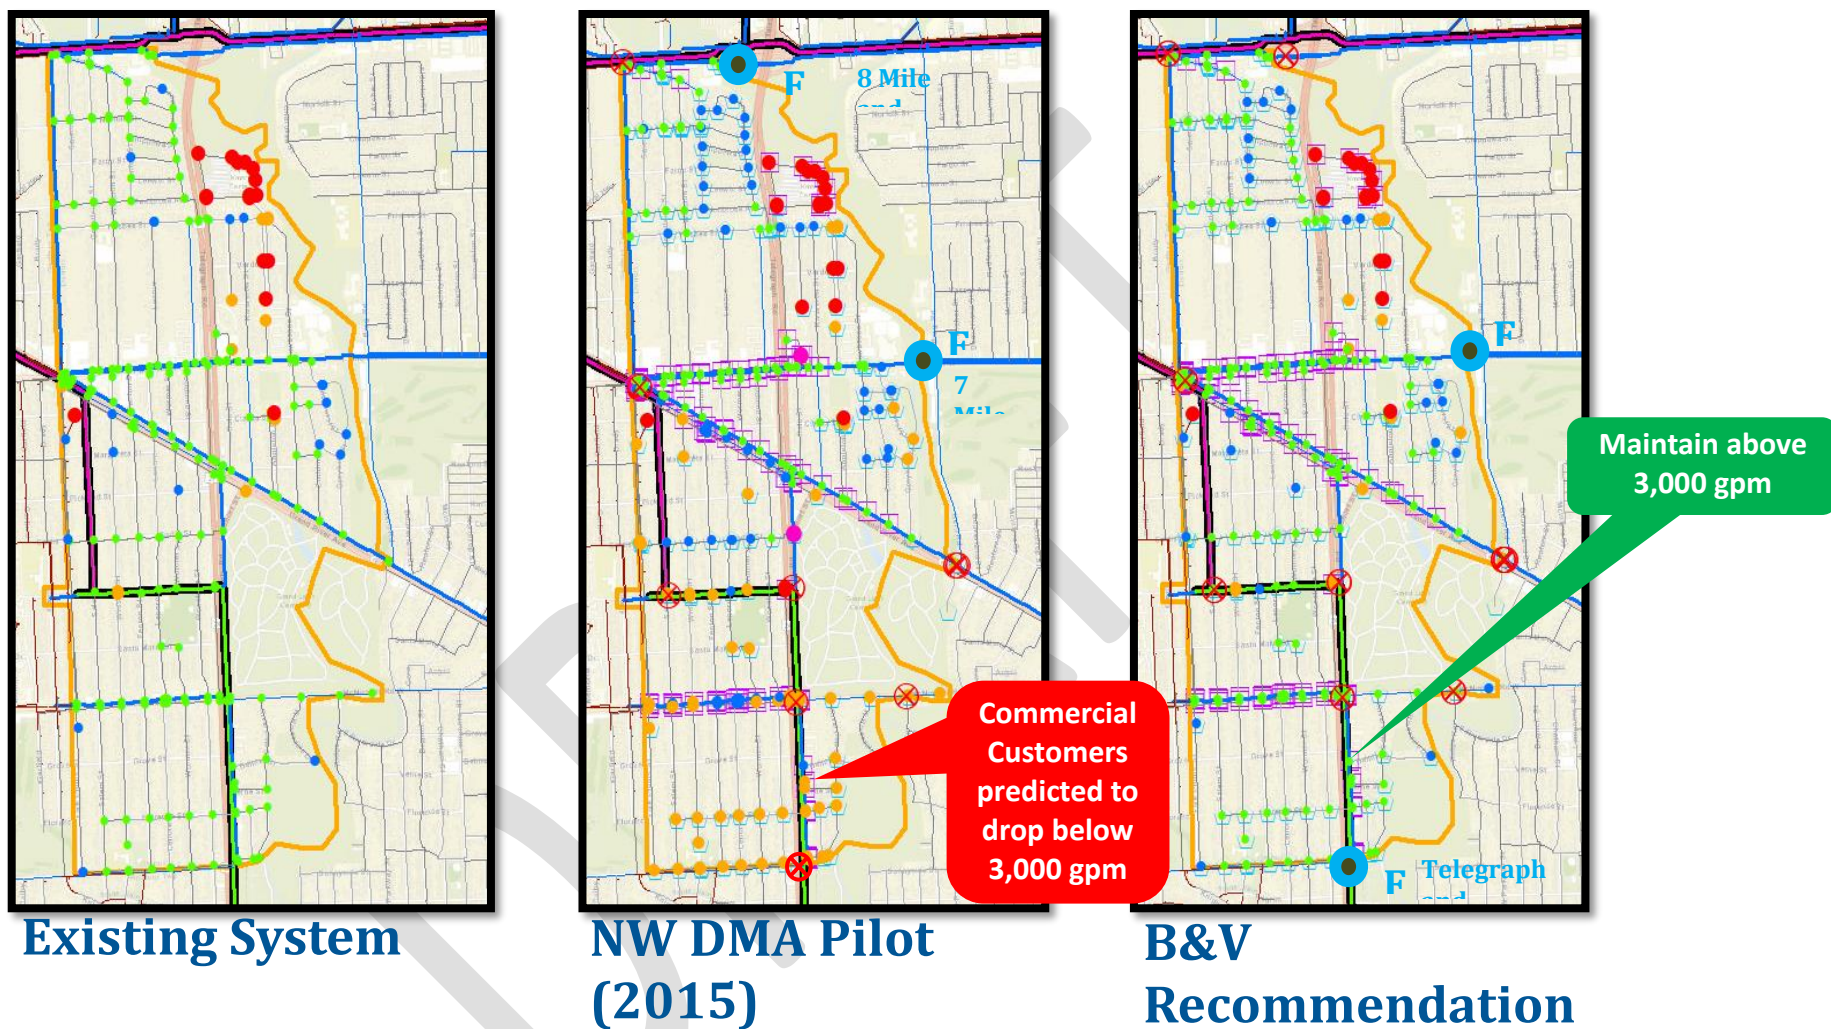
Figure 10-13 NW Flow Meter Location Analysis (Available FF Comparison)

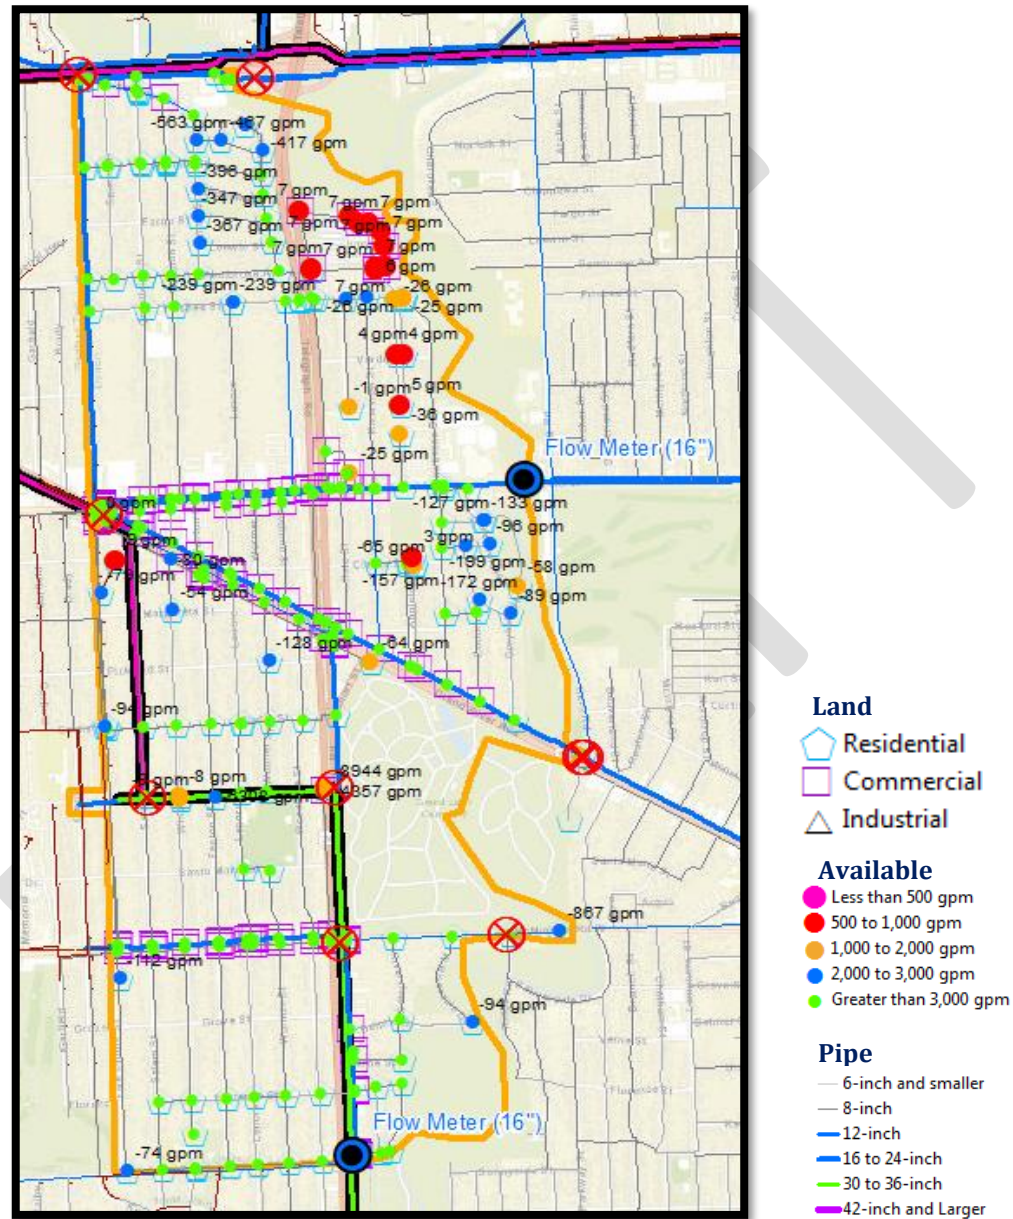
Figure 10-14 NW Fire Flow Impact

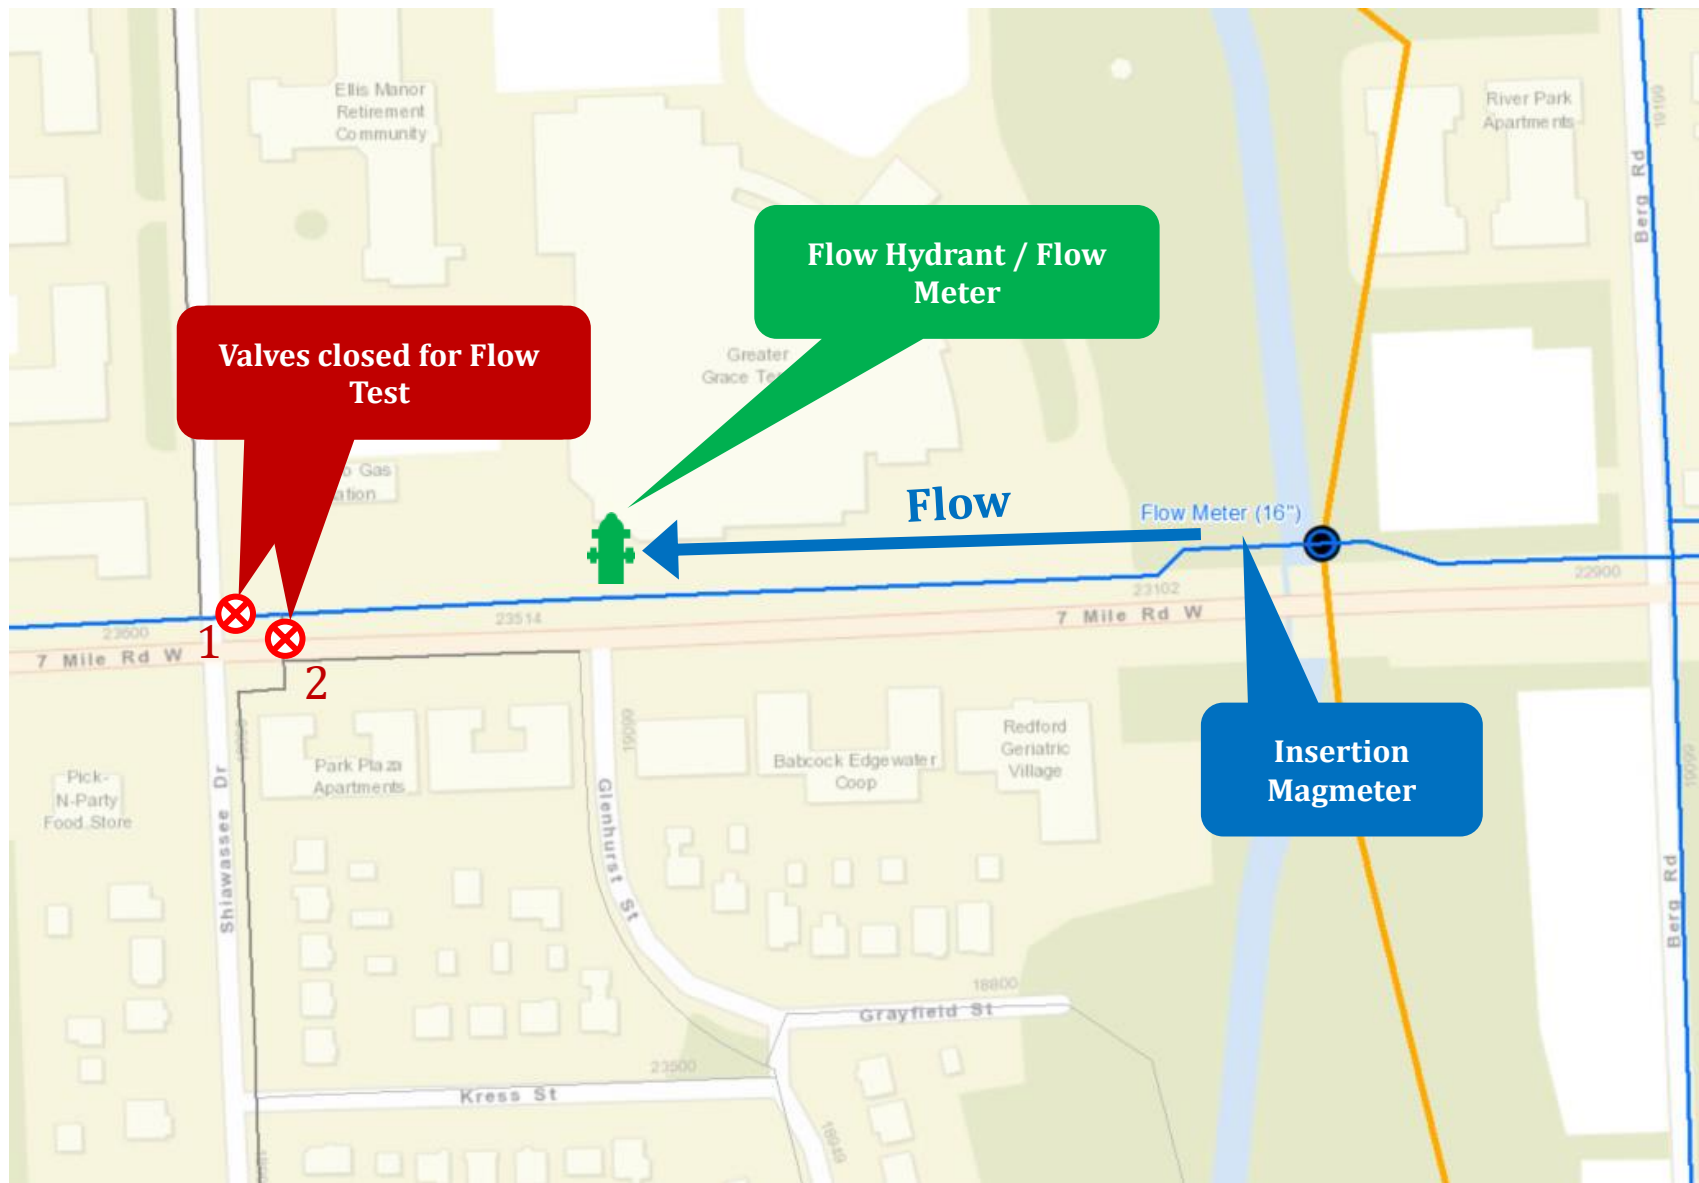
Figure 10-15 In-Situ Flow Test on 7 Mile Rd. W Meter

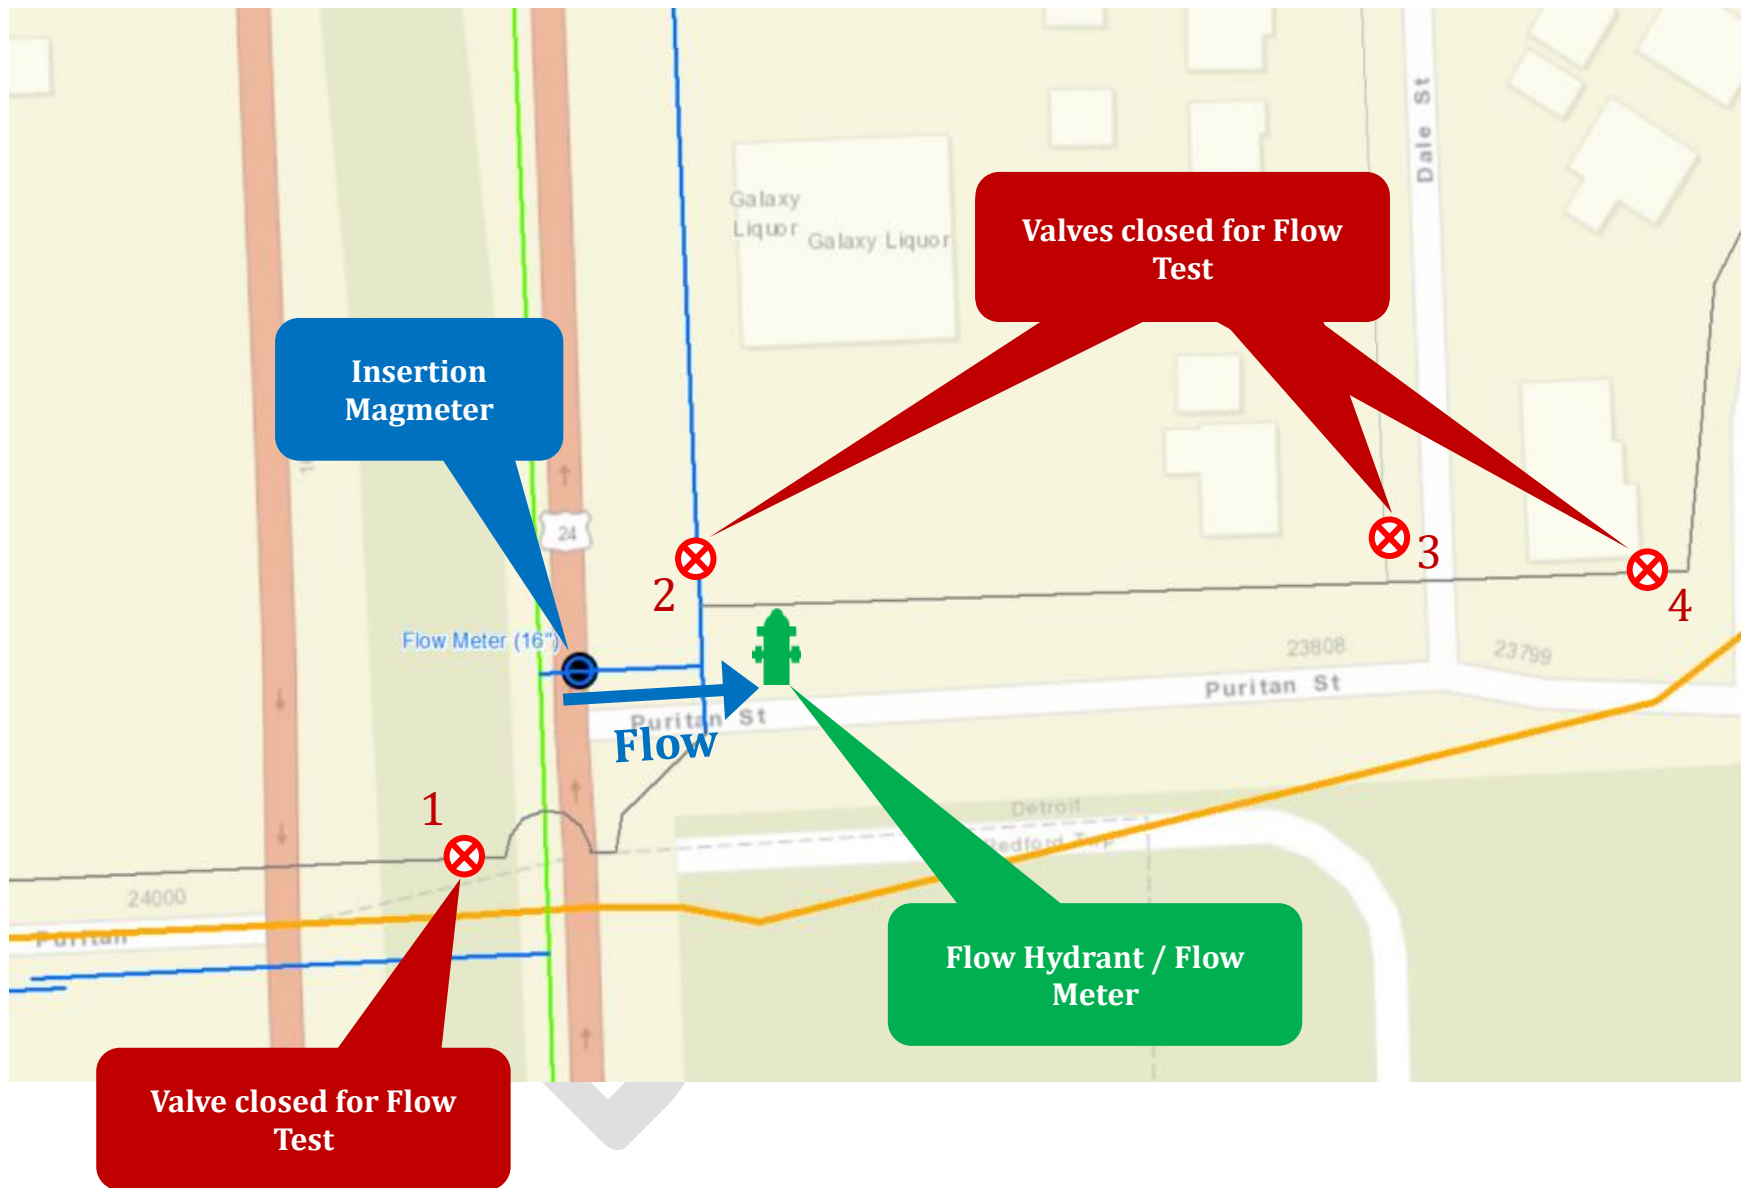
Figure 10-16 In-Situ Flow Test on Puritan St. Meter

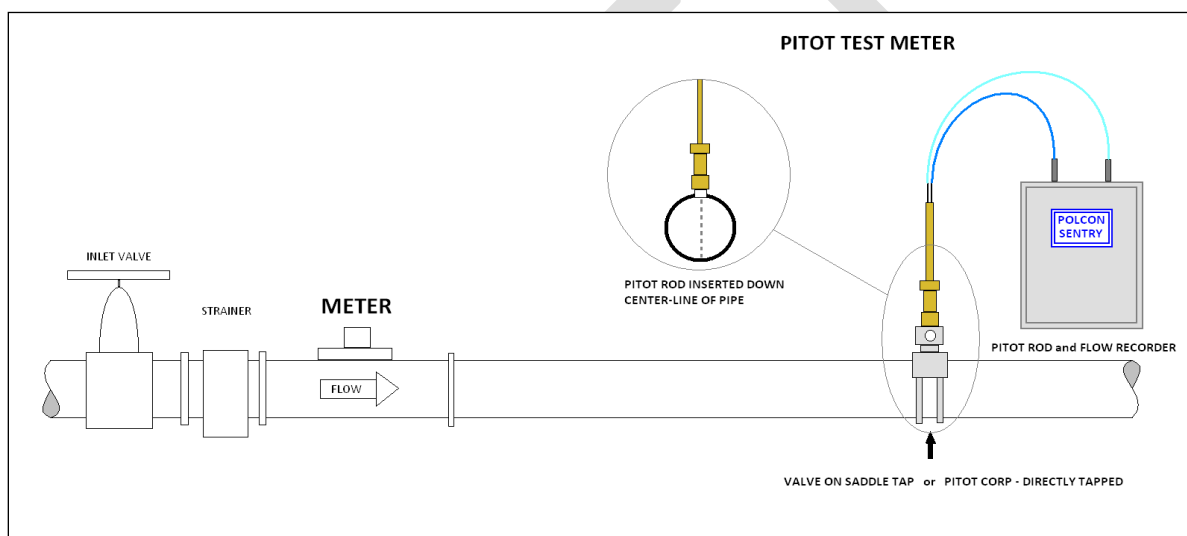
Figure 1. Polcon® Pitot Test Schematic
